Domestic Property Surveys

# BUILDING SURVEY REPORT

SURVEY DATE 1 Mar 2024

REF 35785

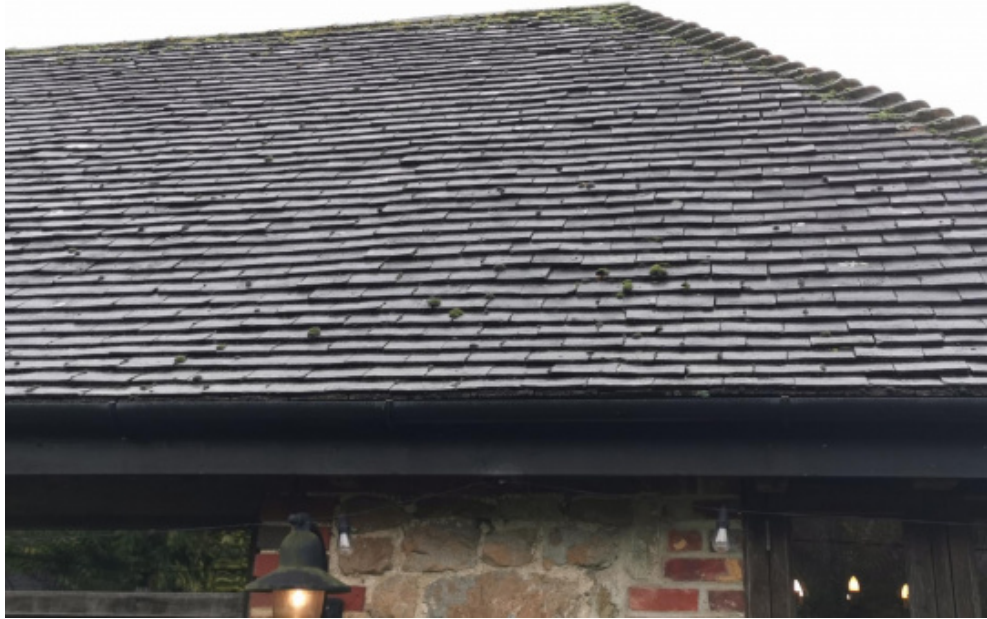
<h2>4.2 Roof Coverings</h2>	<b>Condition rating</b>	<b>2</b>
<b>Construction &amp; Type</b>	<p>The main roof is of pitched design and is covered with clay tiles and finished with half round ridge tiles bedded in mortar.</p>		
<b>Nature of inspection and Limitations</b>	<p>The roof pitches were examined from ground level for possible defects including sagging, collapse, broken/missing/damaged tiles, holes, and other evidence of failure.</p>		
<b>Condition</b>	<p>The roof and ridge tiles are all reclaimed tiles.</p> <p>Some of the tiles/slates have slipped/are missing, caused by nail sickness/poor maintenance/defective design/poor workmanship.</p> <p>Repair works at high level would generally cost more than works at low level, as specialist access equipment such as scaffolds, long ladders or hydraulic platforms may be required. Other parts of the property close to the affected area may also have to be disturbed to carry out the repair, which would also increase the cost.</p>

Uneven tiles

<b>Action Required</b>	<p>Any slipped, missing or broken tiles on the roof pitches should be repaired and replaced. You should carry out a thorough visual inspection at least once a year, ideally in the Spring to identify and repair any damage that could have been caused by winter weather. Any missing mortar at the verges and beneath any hip or ridge tiles should be replaced. Any moss or other accumulated plant matter should be cleared</p> <p>A roof of this age and type will require regular maintenance and repair.</p>

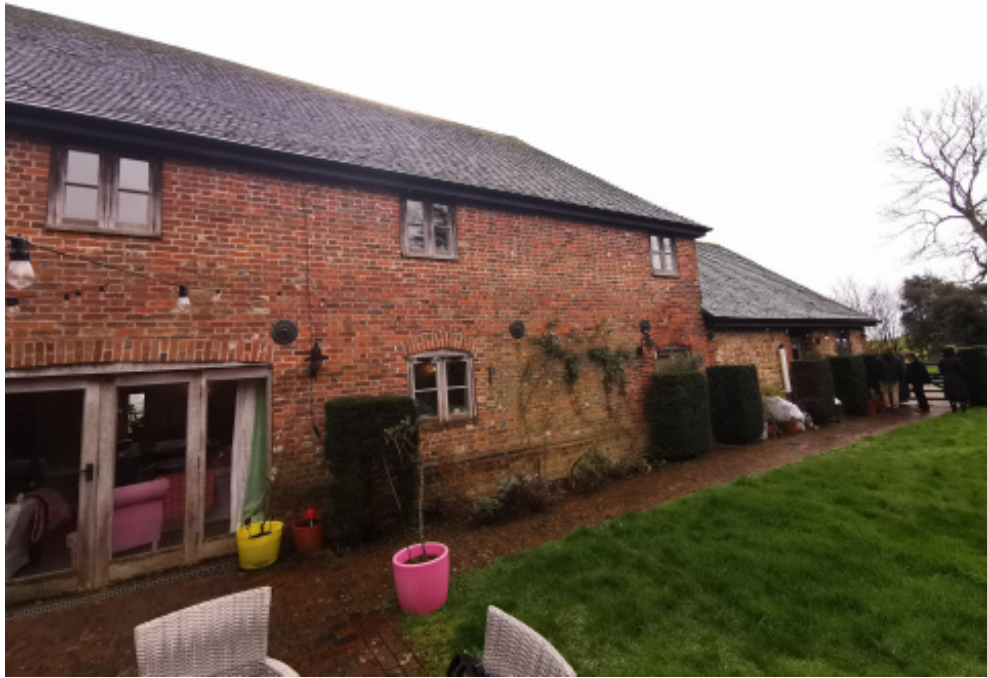
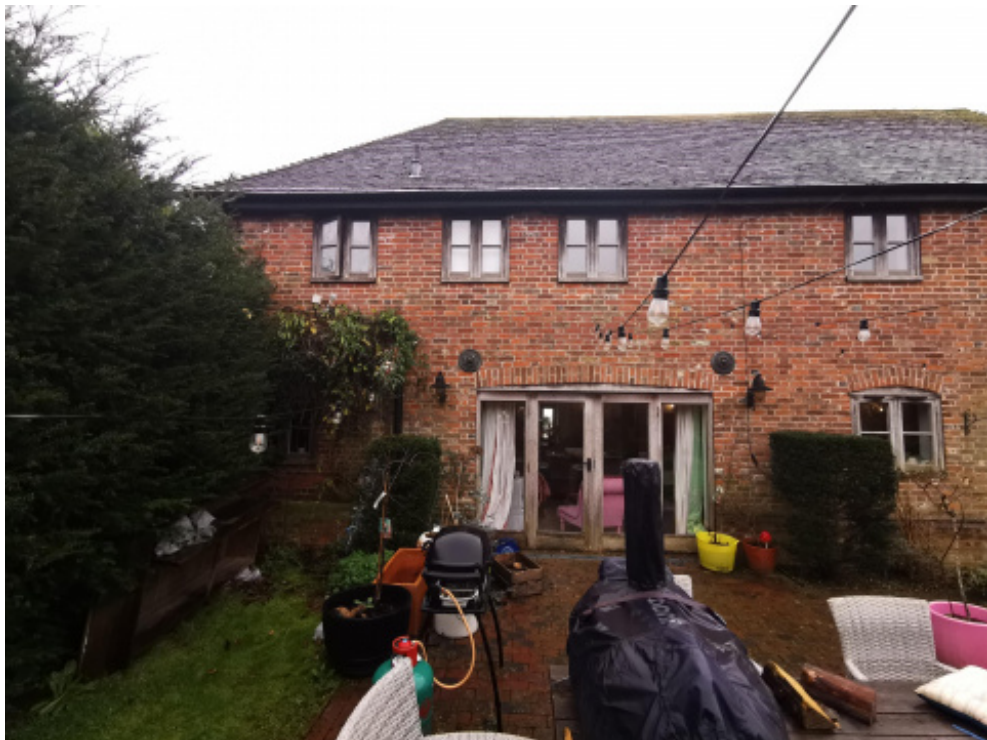
Front wall

<b>Condition</b>	<p><b>Foundations</b> I have not undertaken exposure of the foundation structures during the course of my inspection, as this generally proves impractical in a building survey of this type.</p> <p>Whilst I am unable to confirm the depth to which these foundations bear, taking into account the age of the property it is likely that these remain of shallow formation, and as such are unlikely to be considered consistent with current standards. However, this is applicable to a large proportion of the housing stock and the property should not, therefore, be considered unusual in this respect.</p> <p><b>Movement</b> There is a vertical crack to the front elevation, which is probably quite new and which may be indicative of localised movement.</p> <p>The external wall to the rear elevation is bowed, but is tied into the timber structure.</p>		
<b>Action Required</b>	<p>The crack to the front wall should be monitored carefully to ensure that it is not ongoing, in which case extensive further investigation will be required.</p>

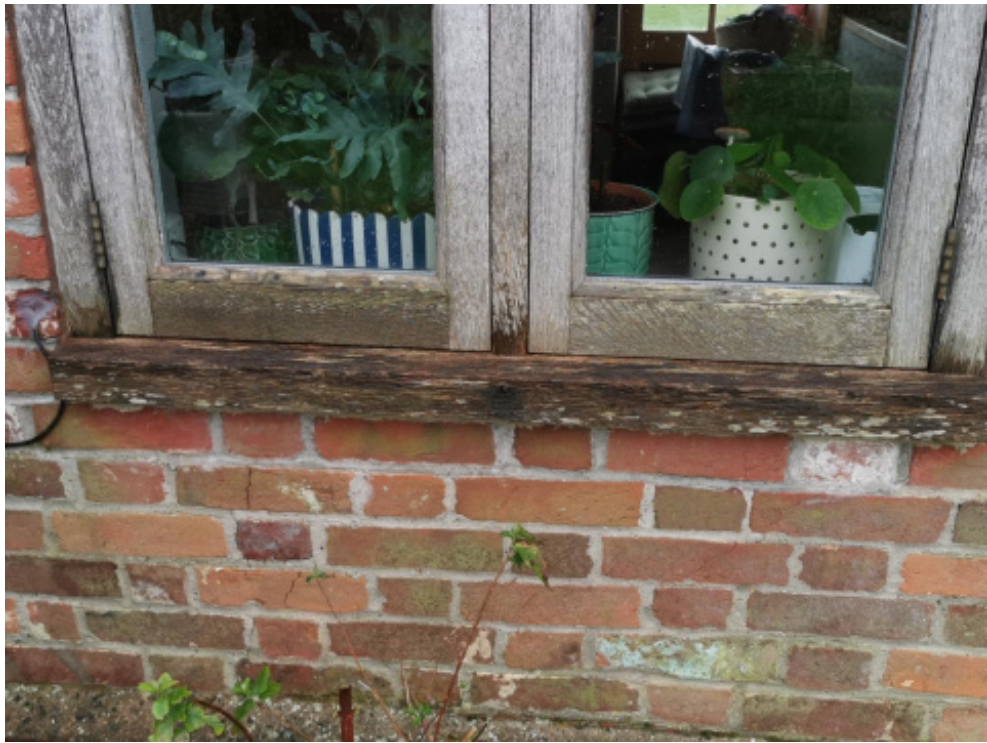
Rotten sills

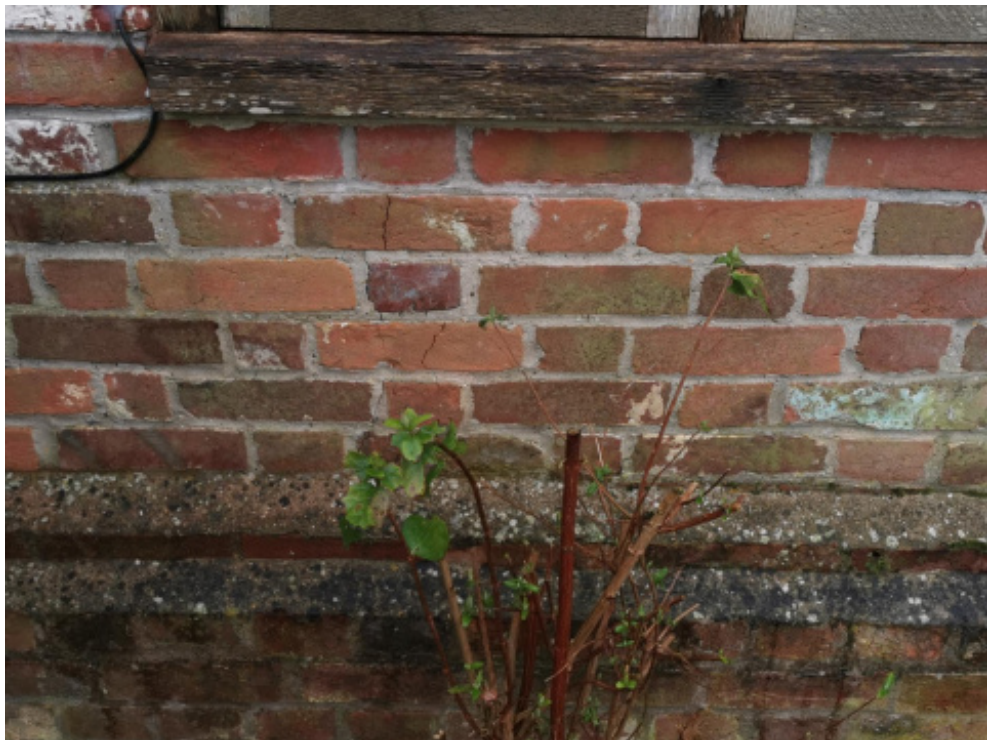
- 1) There is a vertical crack that runs the length of the front external wall above and below the window in the reception room. This crack looks quite new.

Vertical crack below front window

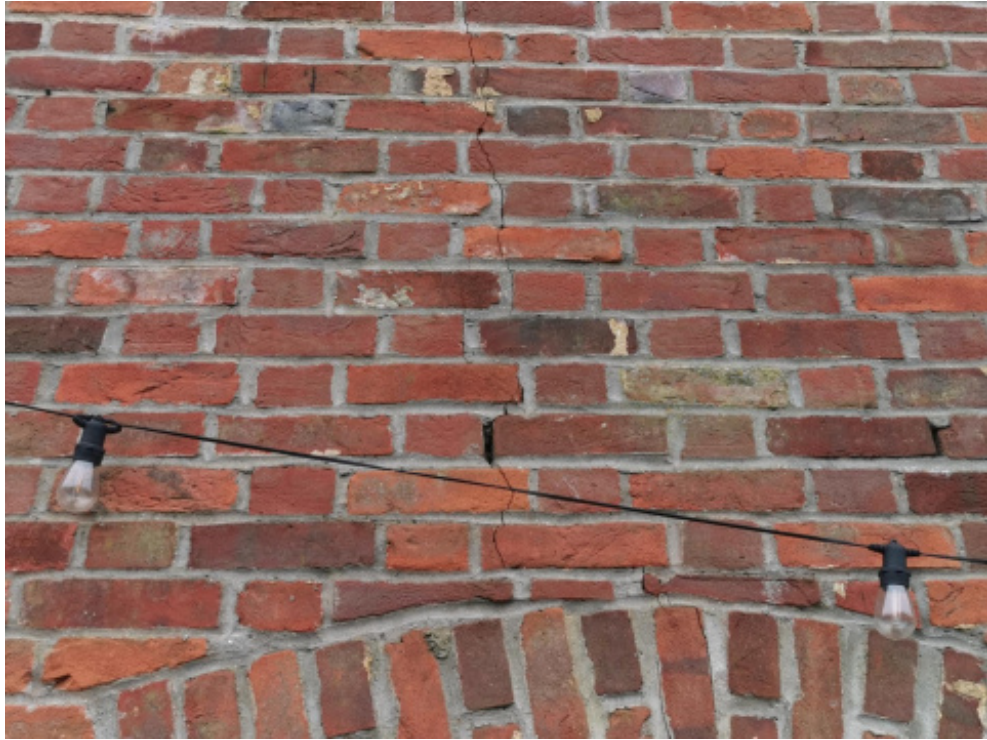
Crack detail

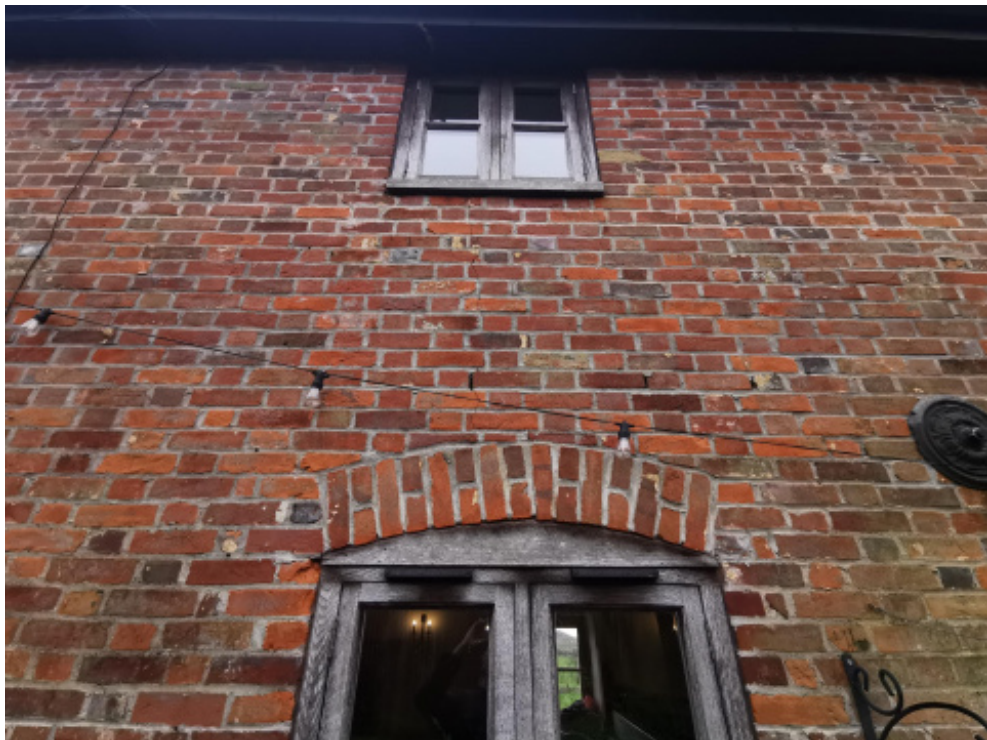
Vertical crack above front window

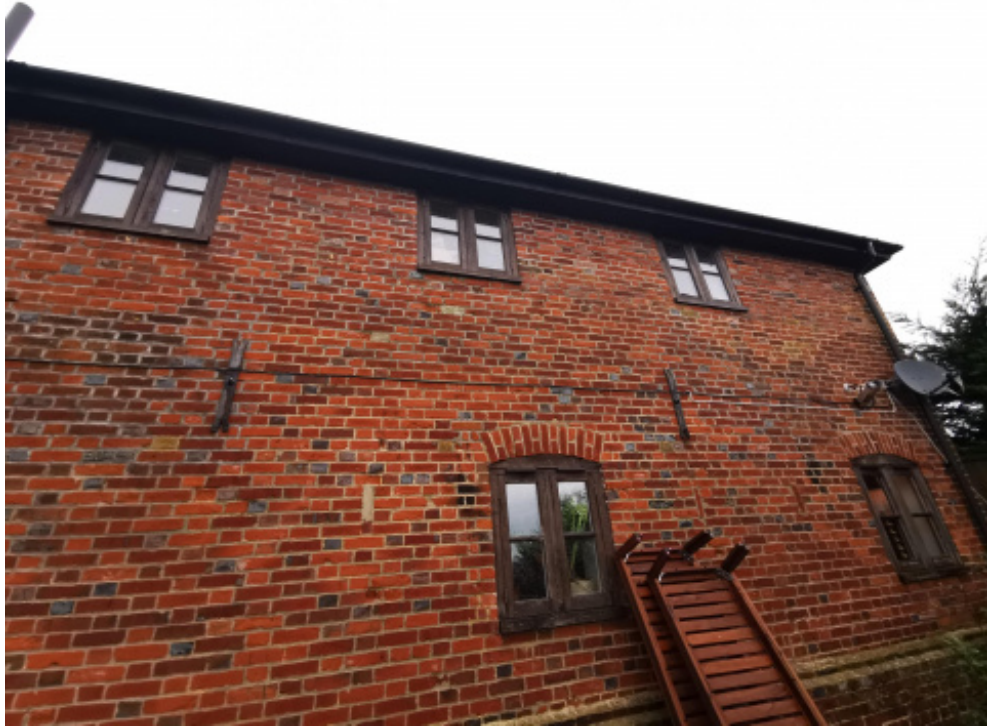
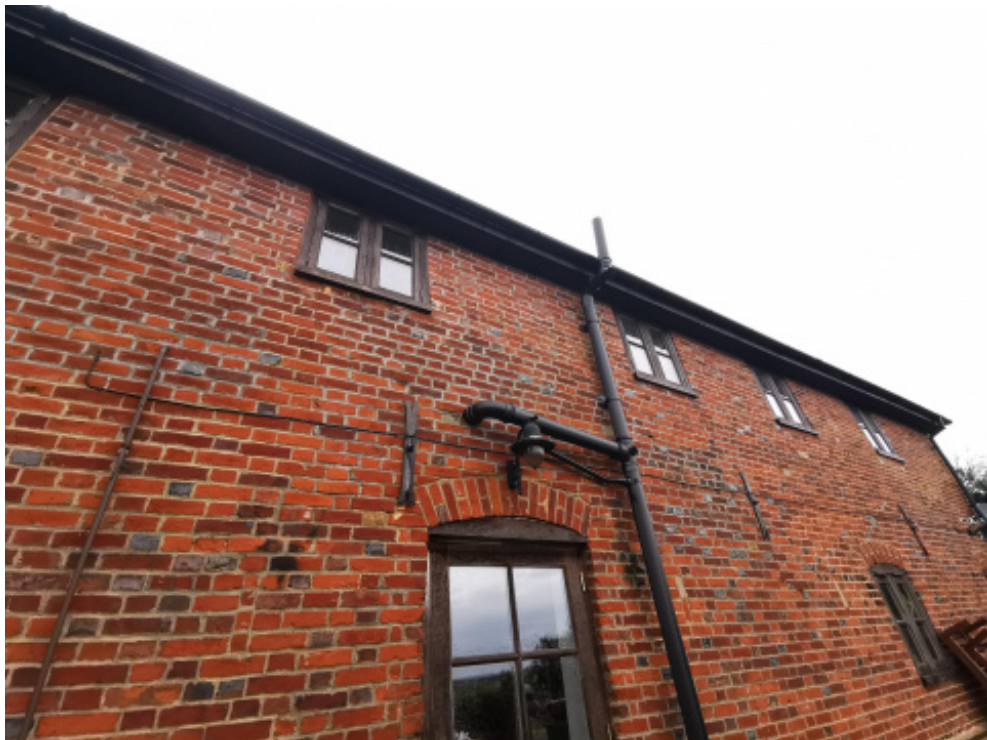
Bowing rear wall

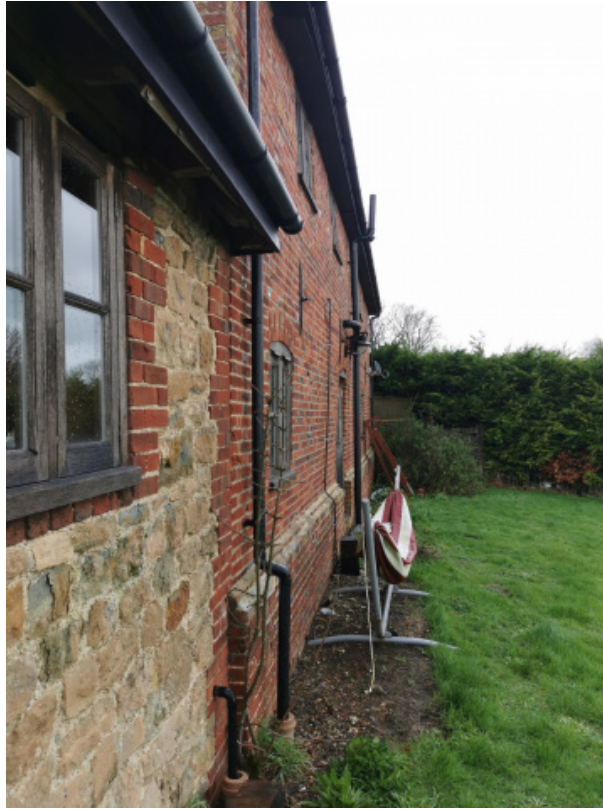
Bow to rear

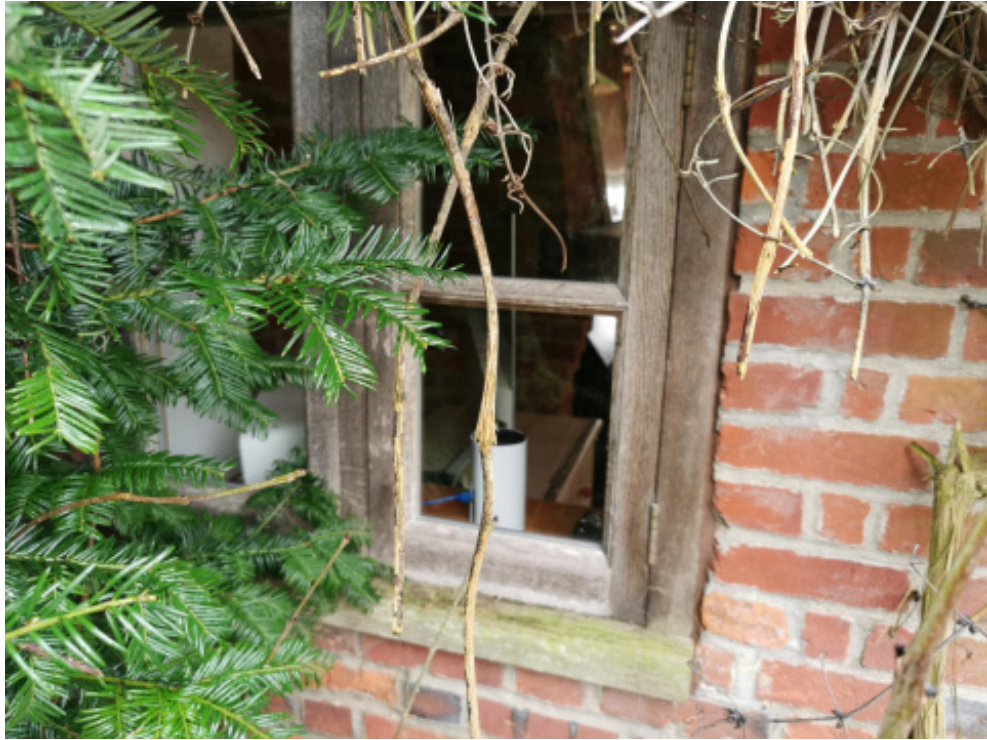
Rotten window frames

<b>Action Required</b>	<p>Any blown double glazing units will require replacement and it should also be considered that, where some sealed units within a window have failed, others may also fail in due course.</p> <p>Normal maintenance of frames, hinges and locks is required.</p> <p>Be aware that previous owners may have distributed multiple sets of keys for the windows and doors to individuals not known to you. When purchasing a property, you should consider the cost of replacing all of the door and window locks as soon as possible after you take up occupation. When doing this you should consult your insurers to ensure that you meet their requirements for security, and obtain any discounts that may be available by improving the security of the property.</p>

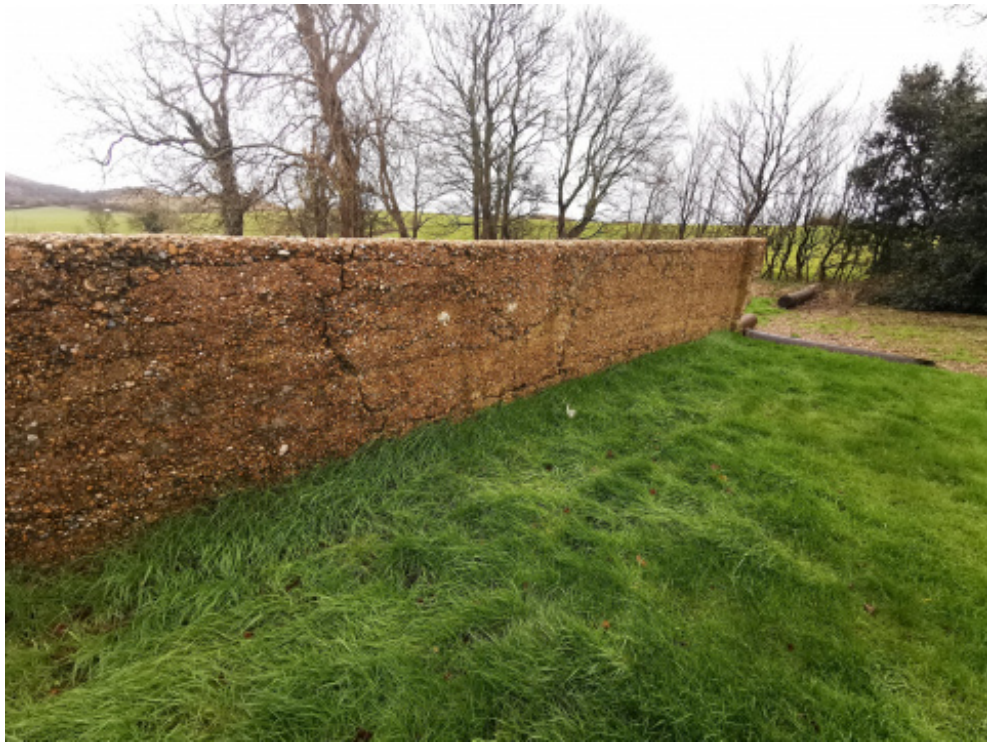
Cracks in concrete walls
