Mi HOME BUYER SURVEY

HOME BUYER SURVEY REPORT

PROPERTY 12 Anyroad Close
Sometown
AB12 3CD

REF 2632

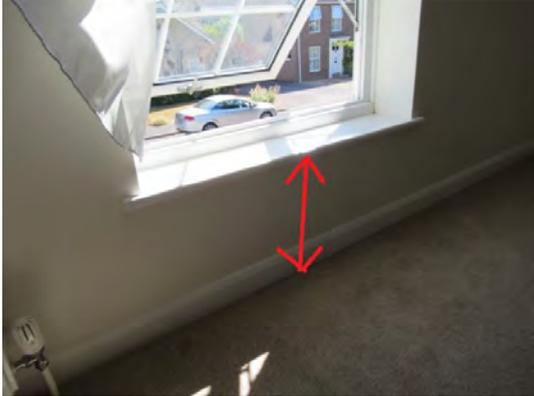
</div> <p style="text-align: center;">Low sill in bedroom 1</p>
Unsafe Fittings	No issues were noted by the Surveyor. Fittings within the property, where possible, were checked for normal everyday use, but have not been inspected or tested for safety purposes.
Insect and Rodent Infestations	No issues were noted by the Surveyor.

3.2 - Health & Safety related matters	
Fire Risk	Although fire alarms are fitted at the property they have not been tested. You should ensure that there are sufficient devices fitted at the property and that they are all in good working order.
Safety Glass	No issues were noted by the Surveyor.
Lead Pipes	No issues were noted by the Surveyor.
Risk of Falls	<p>Window sills on the first floor are low to the floor for example in bedroom 1, increasing the risk of falls, especially for the very young. You should consider fitting window opening restrictors.</p> <div style="text-align: center;">

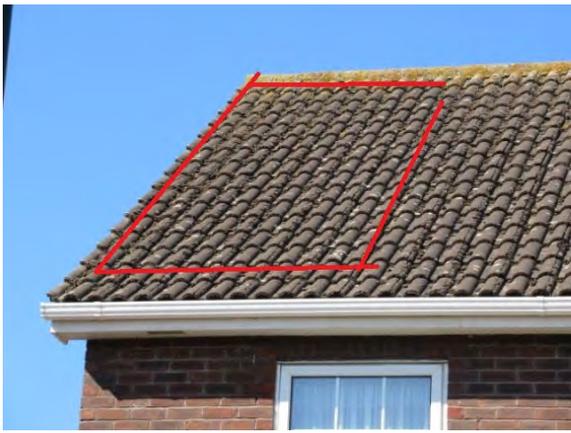
<p>Moss growth on the front roof pitch</p>

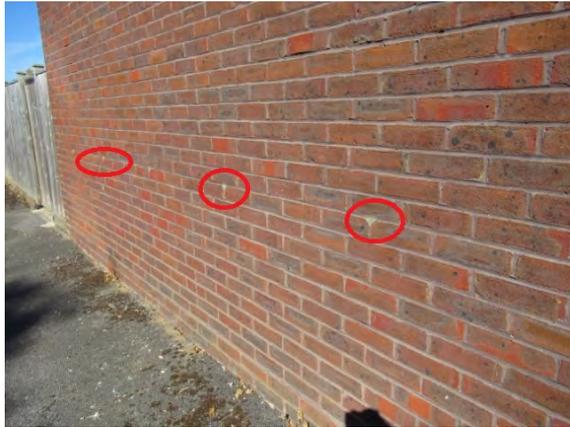
Cavity Wall Insulation drill marks

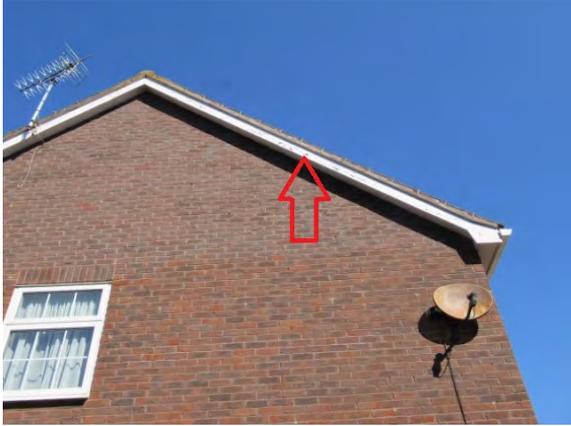
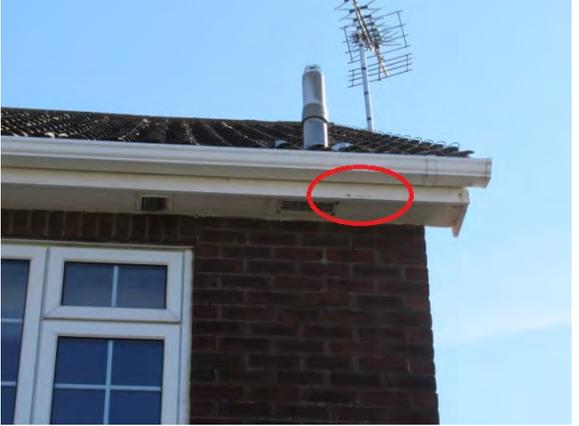
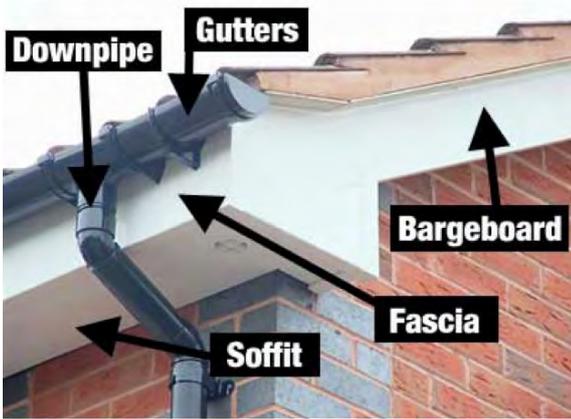
<h2 style="margin: 0;">4.6 External Joinery and Finishes</h2>		Condition rating	2
<p>Construction & Type and Limitations</p>	<p>This includes such items as woodwork at the roof edges, trim panels and any timber porch/canopy. Soffits are the horizontal timbers joining the fascia boards to the house walls. Fascia boards are the vertical timbers to which the gutters are normally fixed. Barge boards are the diagonal boards at the roof edge on the gable end of the house.</p> <p>All such materials were examined from ground level and with the aid of binoculars from vantage points within the grounds of the property and suitable public areas around. Decorations were examined for indications of poor maintenance, rot and other defects.</p>			
<p>Condition</p>	<p>No significant defects were noted. However, the joinery is in a poorly maintained condition requiring stripping and redecorating to all sides of the property. In such circumstances, many new owners would consider replacing the existing fascias, soffits and bargeboards with low maintenance PVC.</p>

Poorly maintained bargeboards on the left side

Poorly maintained fascia at the back

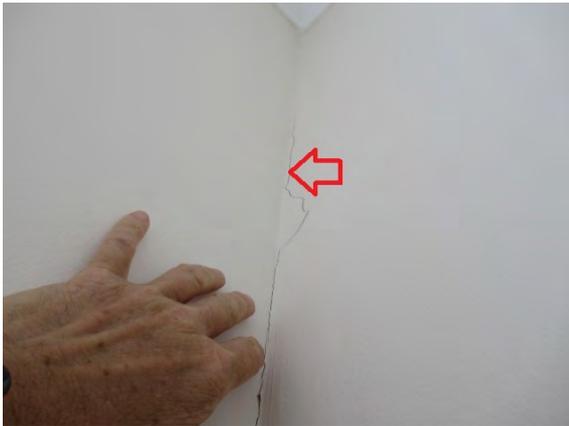
<p>Cracking of the plaster to the front left corner of bedroom 3</p>

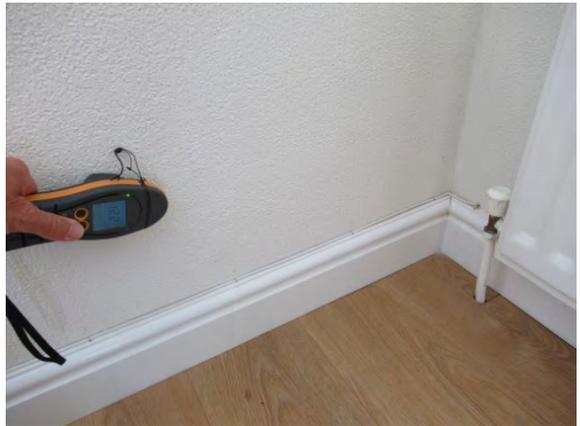
<p>Normal moisture reading on the front wall of the living room</p>

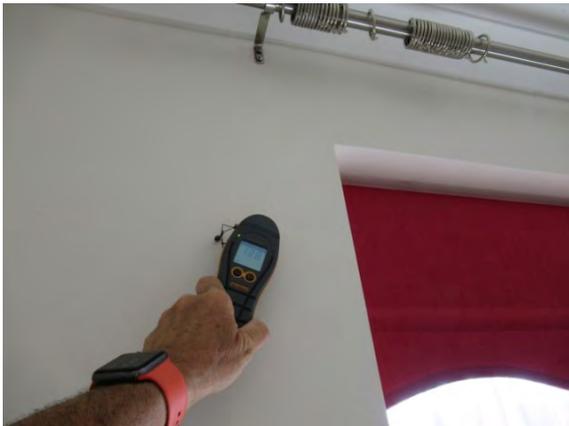
<p>Normal moisture reading on the wall of bedroom 1</p>

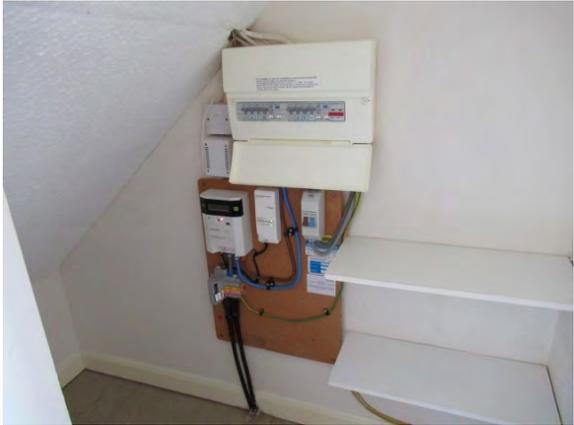
Consumer unit and meter

6.1 Electricity	Condition rating	HS
Construction & Type and Limitations	<p>There is a mains electrical supply and the meter and consumer unit [fuse box] are located in the cupboard under the stairs. A single rate smart meter is installed. The consumer unit is of a more modern style which includes micro circuit breakers and residual current device trip switches. The main fuse is rated at 100amps.</p> <p>It is not possible to fully assess the condition and safety of an electrical installation on the basis of a visual inspection only. Distribution wiring is largely concealed and therefore date and quality of installation cannot be verified within the scope of this inspection. The installation was inspected visually to the extent sufficient to form an overall opinion of the type of installation, the materials used, its apparent age, its visible condition and the need for further investigations. No testing of the installations or appliances was carried out other than operation in normal everyday use.</p>

Condition	<p>No evidence of broken, loose or damaged parts of the installation was seen, nor were any obvious amateur alterations or interventions noted. However, where furniture and other items are present many of the outlets can be hidden from view.</p> <p>As far as could be seen the visible wiring is of a modern PVC type, and the nature of the consumer unit indicates that the installation has been upgraded in more recent years, though it is not known whether this included wiring within the walls, floors and ceilings..</p> <p>NAPIT recommends that domestic electrical installations are inspected and tested every 10 years in line with IET (The Institution of Engineering & Technology) Guidance Note 3 covering Electrical Installation Condition Reports (EICR). This guidance also recommends that at any change of occupancy (such as a house sale, or change of tenant) an Electrical Installation Condition Report is carried out to prove the installation to be in a satisfactory or unsatisfactory condition. This report should cover all the fixed wiring and equipment within the property boundaries, including outbuildings.</p>

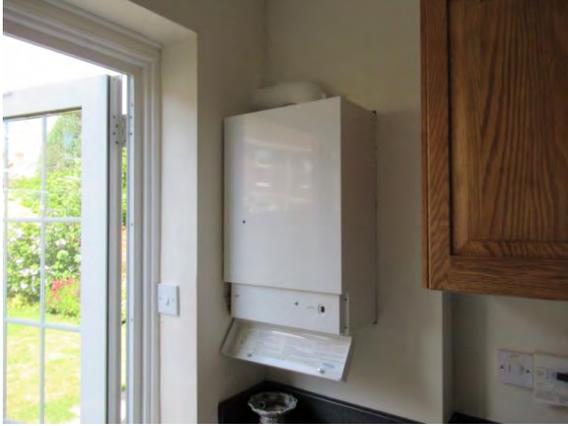
<p style="text-align: center;">Boiler</p>

<h2>6.4 Heating and Cooling</h2>	Condition rating	3
<p>Construction & Type and Limitations</p>	<p>The heating and hot water is provided by a gas-fired condensing boiler which is located in the kitchen.</p> <p>The boiler is a Main 15 HE A. On the SEDBUK seasonal efficiency database this boiler is shown as having a SAP 2009 annual efficiency rating of 89%. It is believed that this model was manufactured between 2010 and 2015.</p> <p>As a guide, most modern condensing boilers have an efficiency of around 85-90%. It is understood that the boiler was fitted by the current owners in around 2013.</p> <p>Heating is distributed by radiators in most rooms.</p> <p>The heating is controlled by a programmer located beside the boiler, a wall thermostat in the ground floor hall and thermostatic valves on some radiators.</p> <p>Repeated attempts by the owner to ignite the boiler were unsuccessful, preventing any checks of the installation or controls being conducted.</p> <p>It is not possible to fully assess the condition and safety of a gas installation on the basis of a visual inspection only. A visual inspection was carried out of the radiators, pipework and boiler to detect leaks, corrosion and other common defects.</p>

<p>Condition</p>	<p>The boiler is believed to be approximately 5 years old and, therefore, around one third of the way through its normal expected service life. Under normal circumstances a modern boiler will last for 15-20 years before requiring replacement.</p> <p>No evidence was seen to suggest that an inhibitor has been added to the heating system recently to prevent a build-up of sludge in the pipework and radiators, and it is therefore recommended that the system be flushed through and an inhibitor added.</p> <p>Gas Safe recommends that all gas appliances and boilers are inspected and serviced according to manufacturer's guidance, but at least once a year. A gas installation can look to be in a safe condition, but serious defects may be hidden, some of which can kill. It is therefore considered to be essential that you commission an inspection of the gas/heating installation prior to purchase of the property, unless you are provided with verifiable evidence that such an inspection has recently been carried out by a competent person. You can get more information, or find a Gas Safe registered engineer https://www.gasaferegister.co.uk/find-an-engineer/</p>

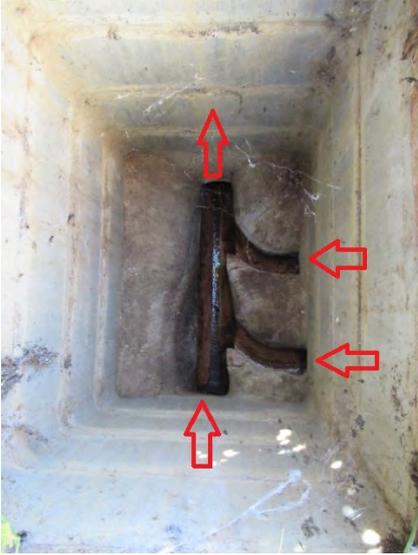
<p>Condition</p>	<p>Water was seen to run through the chamber with no blockages or undue levels of silt being apparent. The flow is from the house and forwards to the chamber at the front, whereupon it is directed to the left within a shared drain, presumably to a main sewer.</p> <p>Drains should be regularly inspected to ensure they remain free from blockages, tree root damage or other obstructions.</p>

<p>Inspection chamber in the front garden with the house to the right of the picture and the flow direction indicated</p>

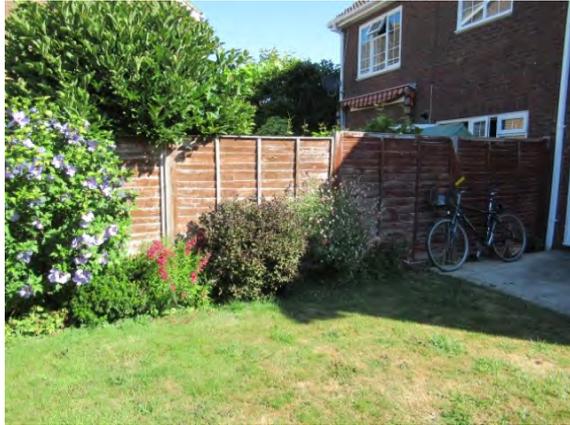
Boundary fence to the right side at the back is worn

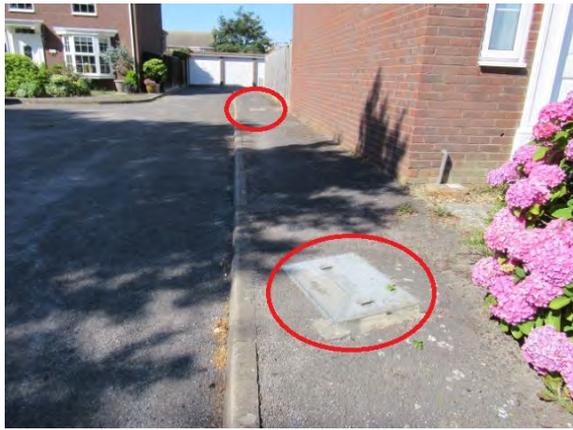
Raised manholes in the footpath to the left side
