BUILDING SURVEY REPORT

SURVEY DATE 25 Mar 2020

REF 7278

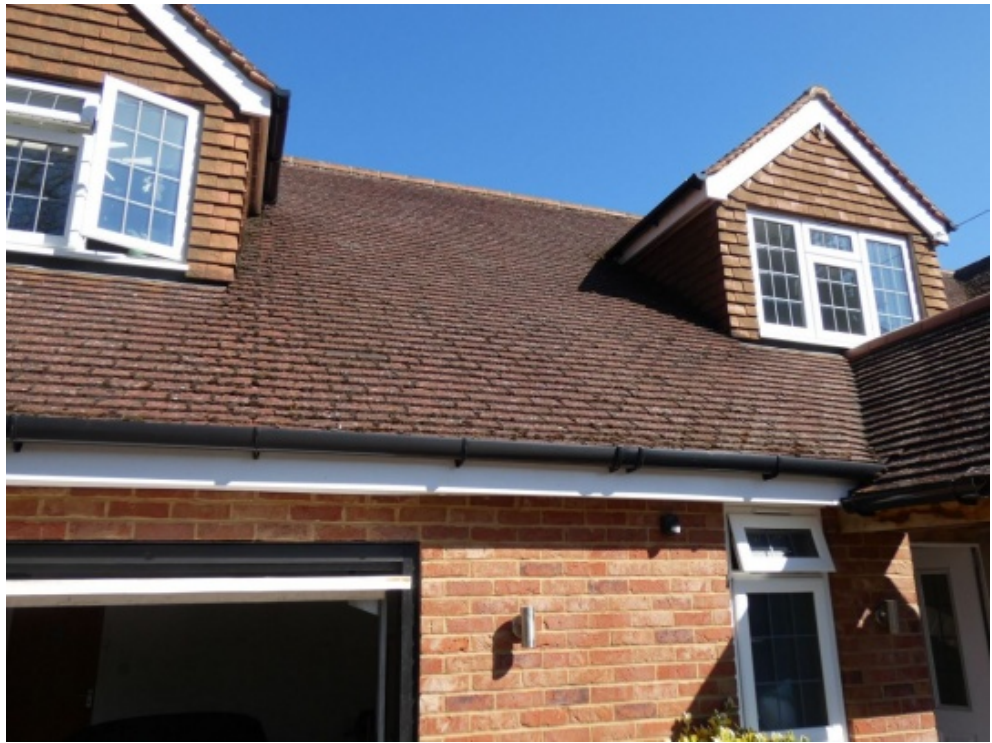
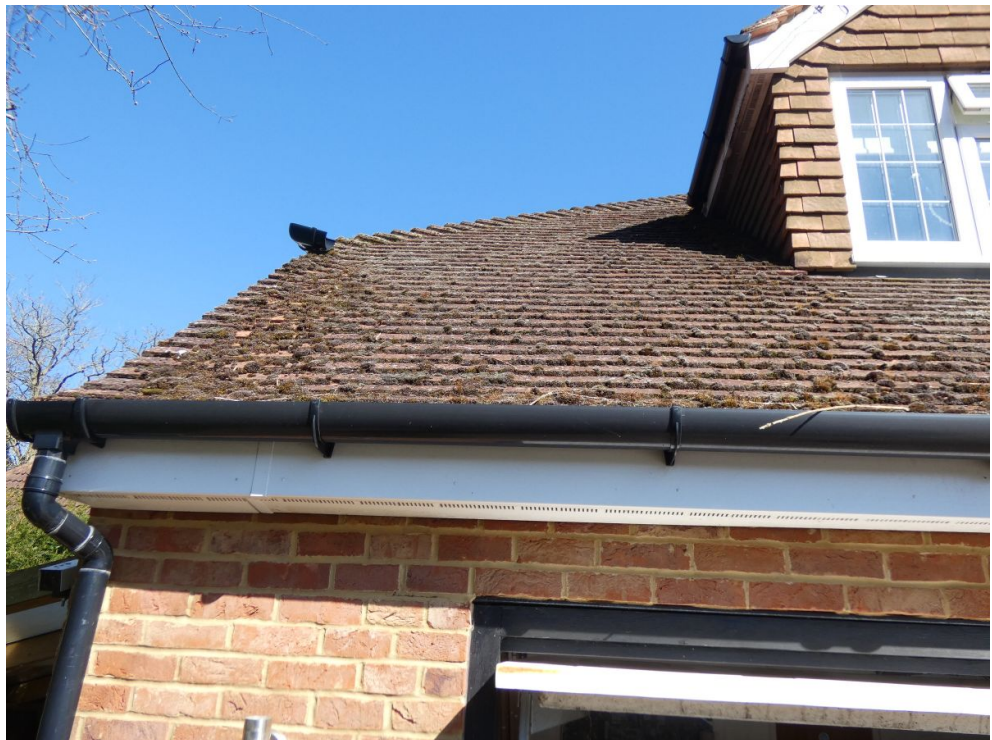
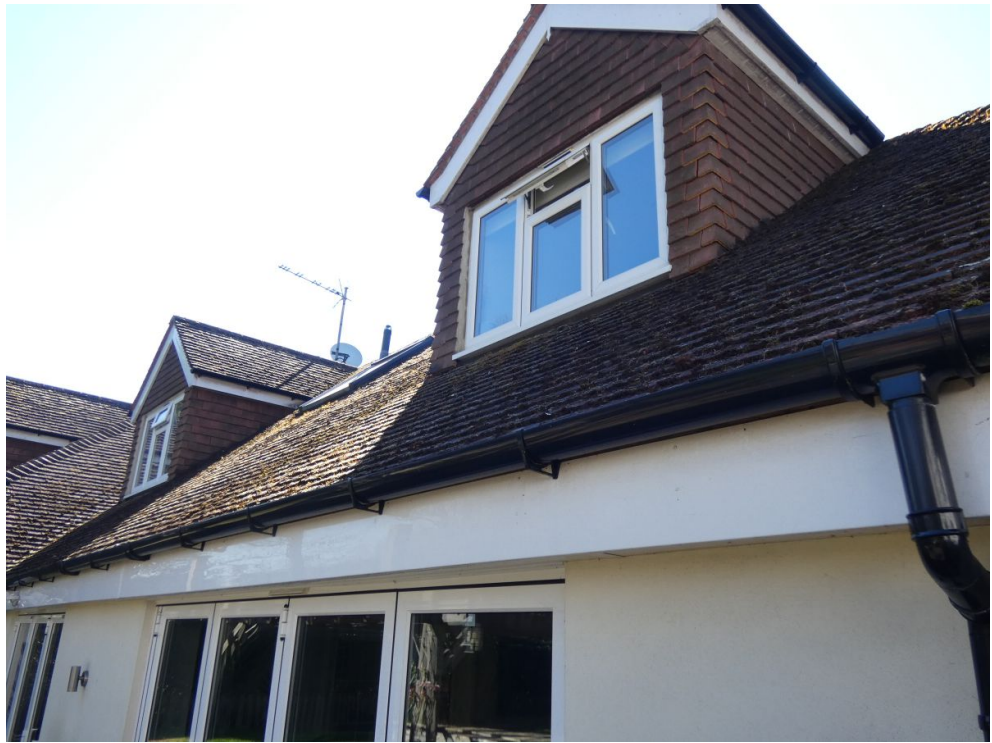
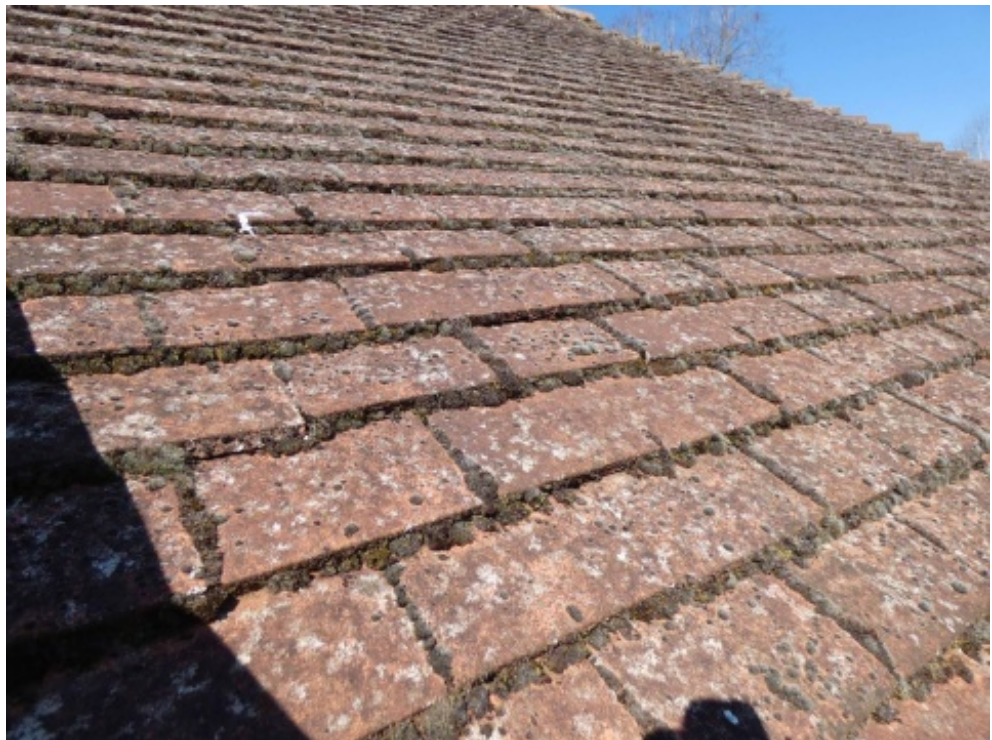
4.2 Roof Coverings	Condition rating	1
Construction & Type	<p>The main roof slopes are pitched and covered with plain concrete tiles.</p> <p>There is a flat roof section to the central part of the property.</p>		
Nature of inspection and Limitations	<p>The roof pitches were examined from ground level with the aid of binoculars where necessary for possible defects including sagging, collapse, broken/missing/damaged tiles, holes, and other evidence of failure.</p> <p>The flat roof could not be inspected as no part of it was visible from any external vantage point.</p>		
Condition	<p>Pitched roof section</p> <p>The roof and ridge tiles are in a generally good condition for their age and seem to be securely fixed.</p> <p>There is evidence of an excessive build up of moss and lichen on the surface of some of the roof tiles, which can reduce the effective flow of rainwater from the roof slope and which can also retain water and restrict the evaporation of humidity from the interior of the roof space. There is also a heightened risk of frost damage.</p> <p>Weathering and discolouration are both consistent with age and degree of exposure.</p> <p>Flat roof section</p> <p>This type of roof covering can last up to 20 years if the manufacturer's installation requirements have been strictly adhered to and if it is well maintained. The current roof was last recovered about 10 years ago.</p>

Front roof

Rear roof

Roof tiles

<p>Action Required</p>	<p>Pitched Sections: Carry out normal maintenance including removal of moss build-up.</p> <p>You should carry out a thorough visual inspection at least once a year, ideally in the Spring to identify and repair any damage that could have been caused by winter weather. Any missing mortar at the verges and beneath any hip or ridge tiles should be replaced. Any moss or other accumulated plant matter should be cleared</p> <p>Flat Sections: Ideally you should anticipate that it would require normal maintenance for the short to medium term but you should allow for recovering within 10 years. The most likely areas where deterioration will occur are the joints between the flat roof and the parapets or to other upstands. When any recovering is undertaken, the supporting structure may also need some attention.</p>
	  <p>Roof verges</p>

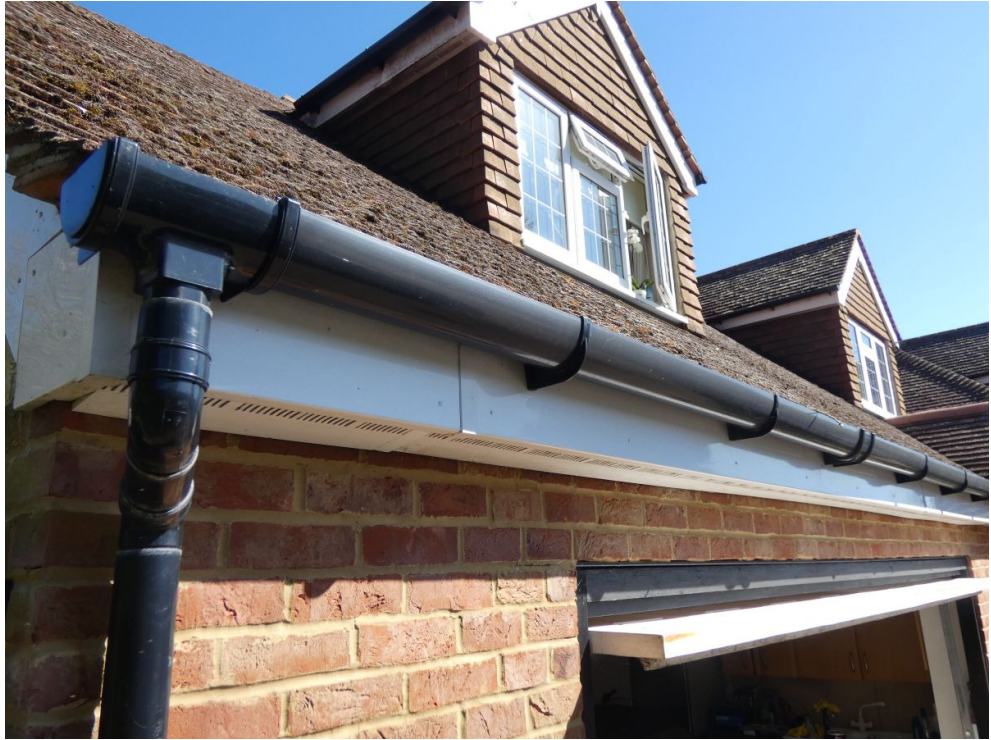
4.3 Rainwater and Above Ground Drainage Fittings	Condition rating	1
Construction & Type	The rainwater gutters and downpipes are uPVC throughout. The external soil stacks are also PVC.		
Nature of inspection and Limitations	<p>An inspection was carried out from ground level with the aid of binoculars where necessary to look for possible areas of leakage, misalignment, overflow and other defects. The soil stacks and gulley were examined for any signs of damage, leakage, correct supports, cracking and evidence of significant wear.</p> <p>As it was dry at the time of survey only a limited assessment could be made as to the effectiveness of the rainwater fittings.</p> <p>No tests have been carried out to either trace or establish the structure or condition of any underground soakaways.</p>		
Condition	<p>The gutters are currently in fair condition and alignment. There were no significant leaks noted but all gutters require examining periodically and clearing of moss, leaves and silt which will inevitably accumulate.</p> <p>The soil stack and associated plumbing is in a fair condition with no leakages noted.</p>

Rainwater fittings

Action Required	Gutters and downpipes should be cleaned and inspected regularly to ensure that they are free from blockages and leaks. If it is noted during any heavy rain, that gutters or downpipe joints are leaking, then these must be fixed as soon as possible to prevent water penetration to the property and damage to the foundations.

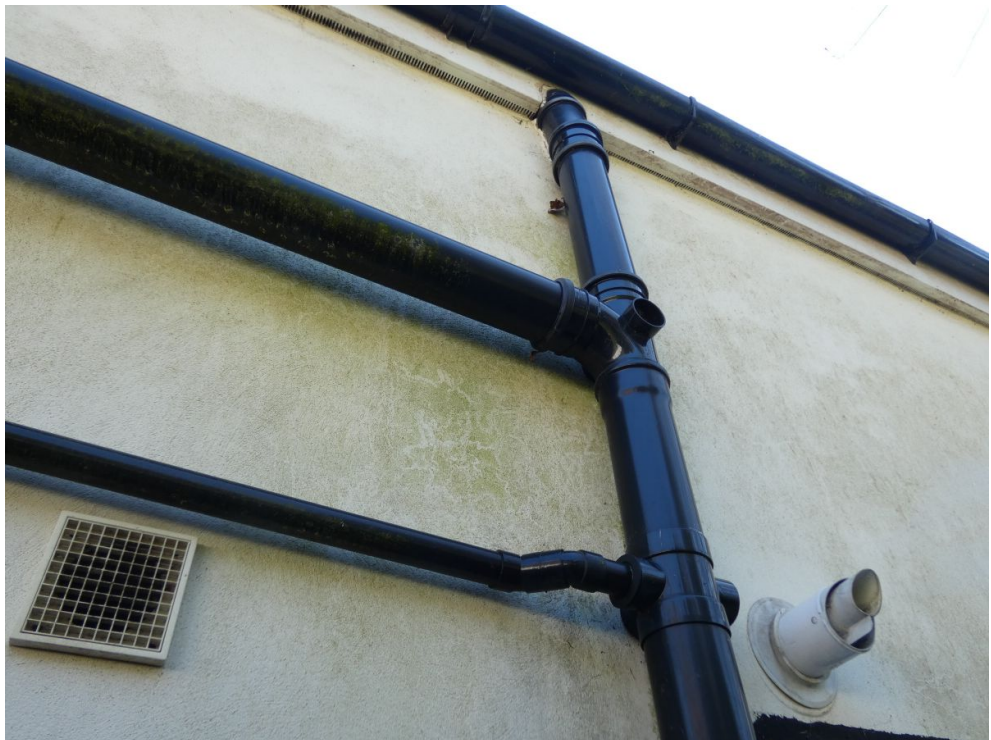
Soil pipe

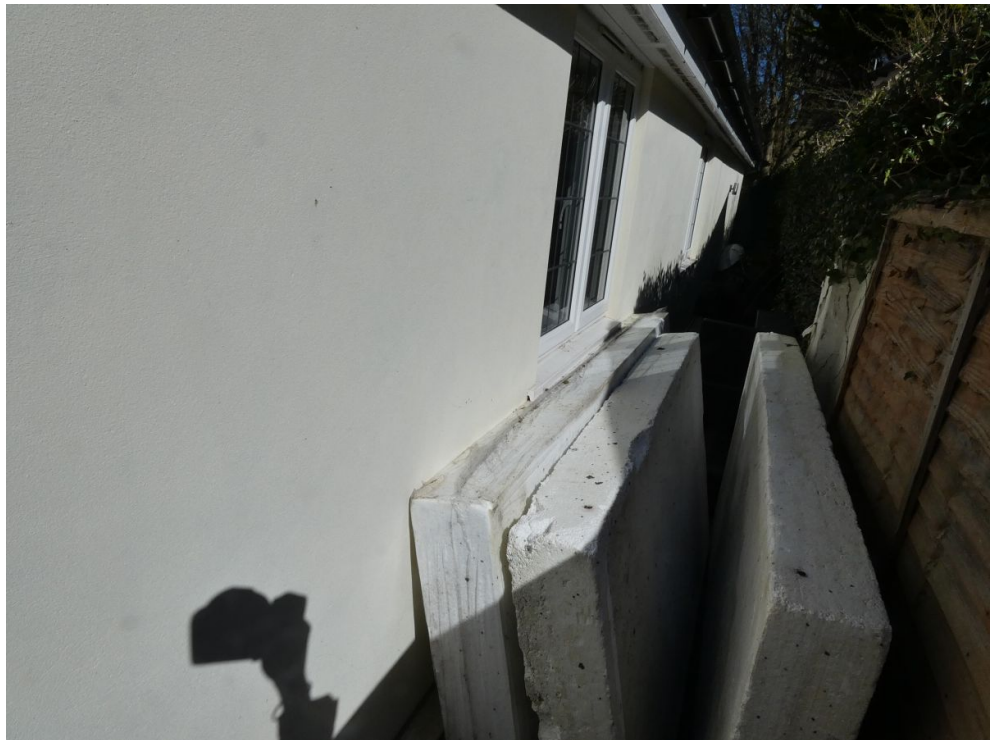
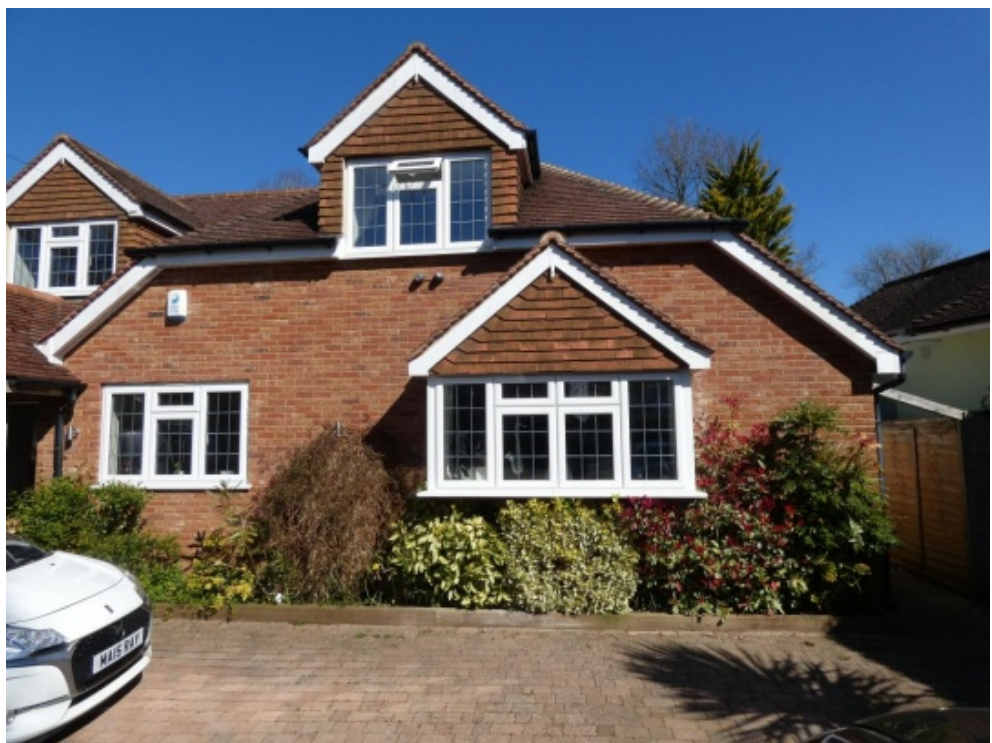
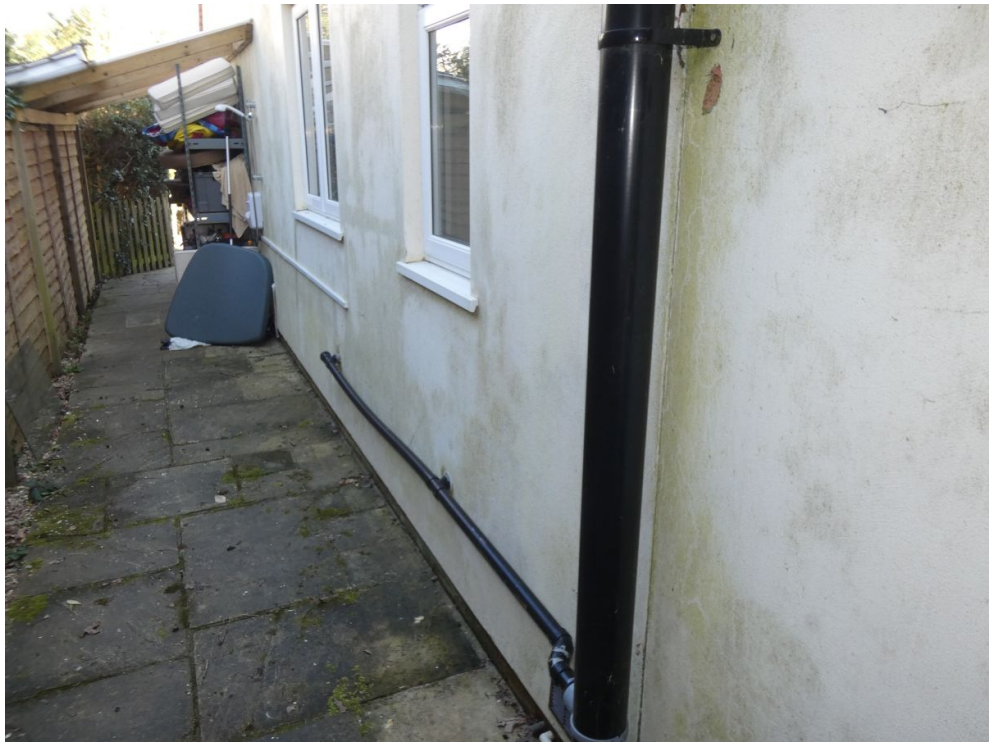
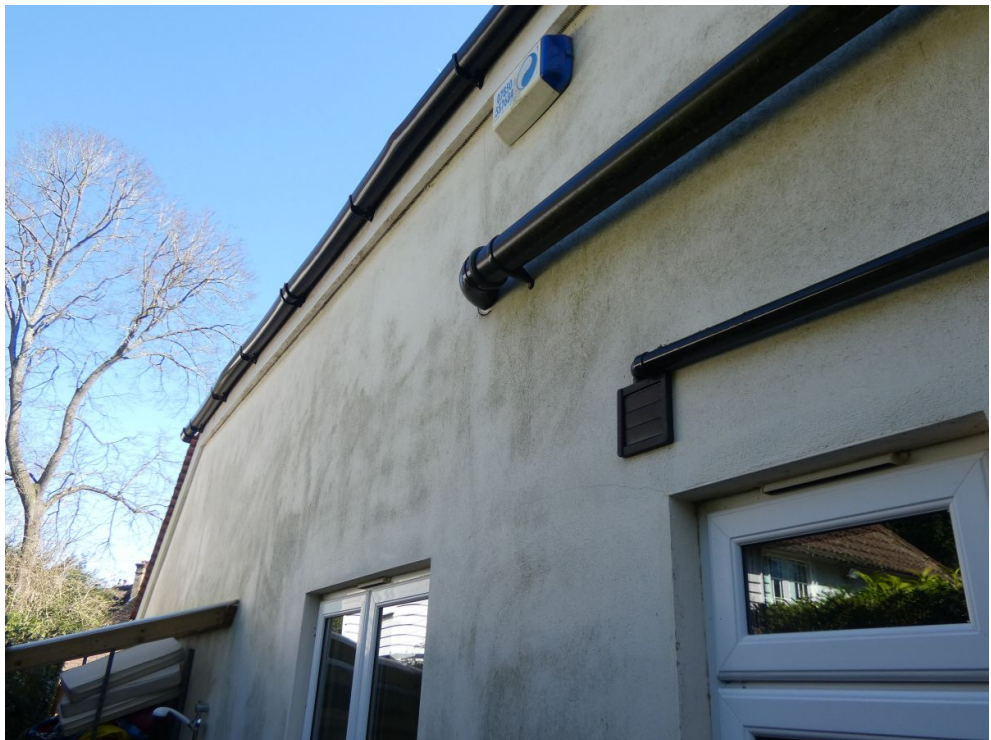
4.4 Walls	Condition rating	1
Construction & Type	<p>The outside walls are brick-faced and of cavity construction. The damp proof course at ground level [waterproofing to prevent rising damp] is PVC.</p> <p>The side and rear elevations are covered in a cement based render coat.</p>		
Nature of inspection and Limitations	<p>The outside walls were examined from ground level with the aid of binoculars from vantage points within the grounds of the property and suitable public areas around. The walls were examined for signs of bowing or leaning, damaged brickwork and pointing, cracking, indications of subsidence and land failure and other defects.</p>		
Condition	<p>Stability and vertical alignment is generally satisfactory. Condition and alignment of the brickwork is fair. There is no evidence of any significant bulges or major structural cracks. There is no evidence of foundation cracking at ground level.</p> <p>Most properties are subject to slight settling down over the years as sub-soil consolidates and adjusts to changes in ground condition. This will frequently result in limited differential movement, which is often expressed as minor cracking or distortion of window and door openings and is rarely of structural significance.</p> <p>Externally the brick window lintels and vertical mortar junctions are all complete with no evidence of any movement. These areas are mentioned specifically as any movement to the property would be noted at these points. The British Geological website indicates the ground is of chalk which is a solid base and hence not liable to move adversely.</p> <p>In all external walls there should be a damp proof course (DPC) just above ground level. This is an impervious layer present to prevent dampness rising up the walls from the ground. In modern properties this is often a plastic membrane but in older properties other materials such as bitumen felt or slate are often found. Houses built before 1880, or so, usually have no provision to prevent dampness rising up, or penetrating through, the walls. In this case the DPC can be seen at the base of the walls.</p> <p>The external render coat is in reasonable condition.</p> <p>No significant defects were noted during my inspection and the external walls were found to be structurally sound.</p>

Side wall

Front wall

Action Required	<p>Walls should be examined regularly to inspect for changes in the nature of any cracking or other defects that may become apparent.</p>

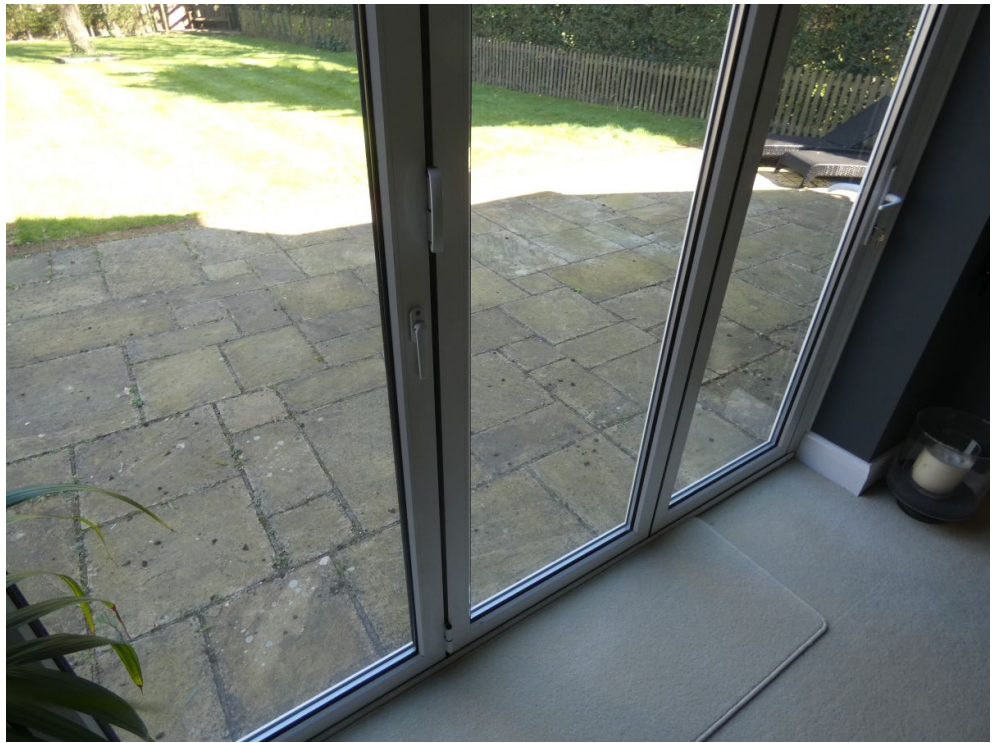
4.5 Windows and External Doors	Condition rating	1
Construction & Type	All of the windows and doors are double glazed with uPVC frames.		
Nature of inspection and Limitations	<p>All external doors were checked for normal operation and signs of failure or damage.</p> <p>Windows were examined for general signs of degradation and failure including blown double glazing units and worn seals. Opening was attempted to all windows and all checked for normal operation. The condensation levels in certain weather conditions can disguise evidence of blown double glazed units.</p>		
Condition	<p>uPVC frames can vary enormously in quality and an assessment of individual design is beyond the scope of this report. They are less suitable for piecemeal repairs whilst stay mechanisms and fixings can require occasional overhaul. The double-glazed units appear serviceable but will need routine maintenance.</p> <p>Double-glazing has a limited life and is prone to deterioration at edge seals. This can sometimes be recognised by moisture between the panes but its presence is dependent upon atmospheric conditions that are, of course variable. Such defects cannot always be diagnosed during a single inspection.</p> <p>Under normal circumstances sealed double glazed units can be expected to last around 20 years before the seals begin to fail. This can occur more quickly where windows are in exposed or vulnerable situations. It is estimated that most of the windows currently fitted are approximately 10 years old and there is no evidence of any imminent failures. The condensation levels in certain weather conditions can disguise evidence of blown double glazed units, but no issues were noted or suspected.</p>

Rear patio doors

Action Required	<p>Any future blown double glazing units require replacement. It should also be considered that, where some sealed units within a window have failed, others may also fail in due course.</p> <p>Normal maintenance of frames, hinges and locks is required.</p> <p>Be aware that previous owners may have distributed multiple sets of keys for the windows and doors to individuals not known to you. When purchasing a property, you should consider the cost of replacing all of the door and window locks as soon as possible after you take up occupation. When doing this you should consult your insurers to ensure that you meet their requirements for security, and obtain any discounts that may be available by improving the security of the property.</p>

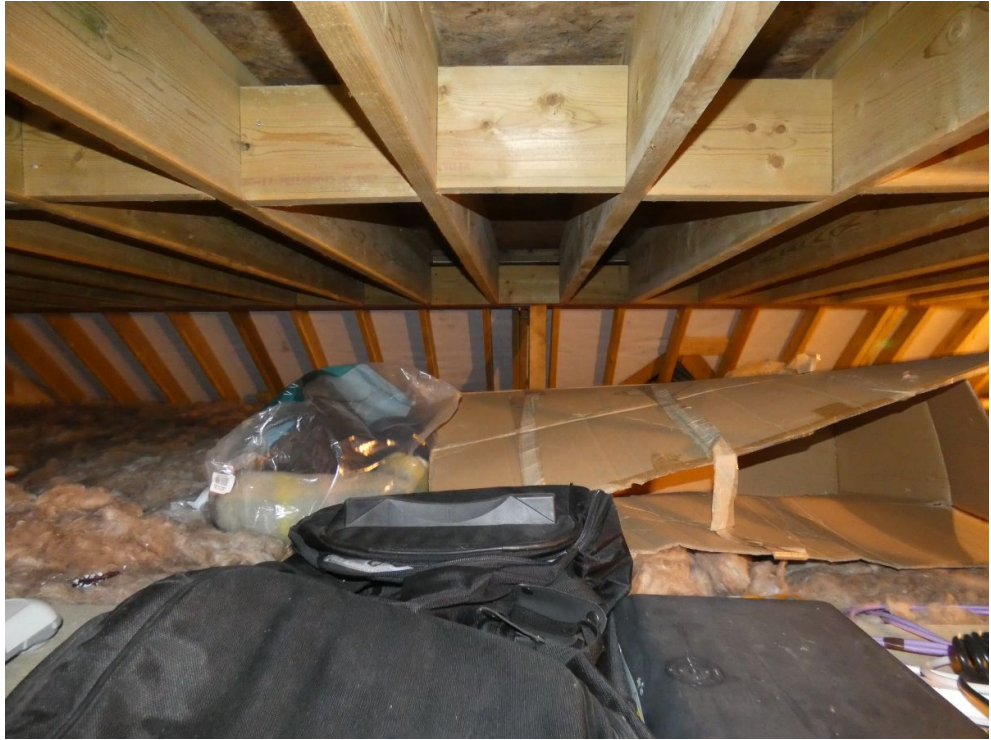
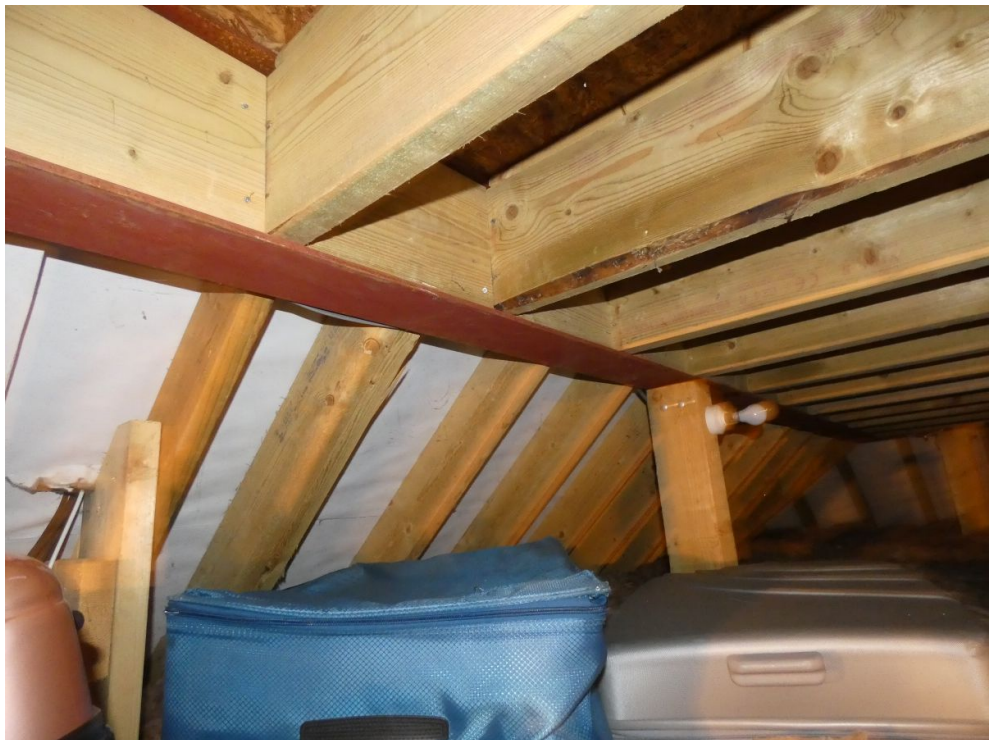
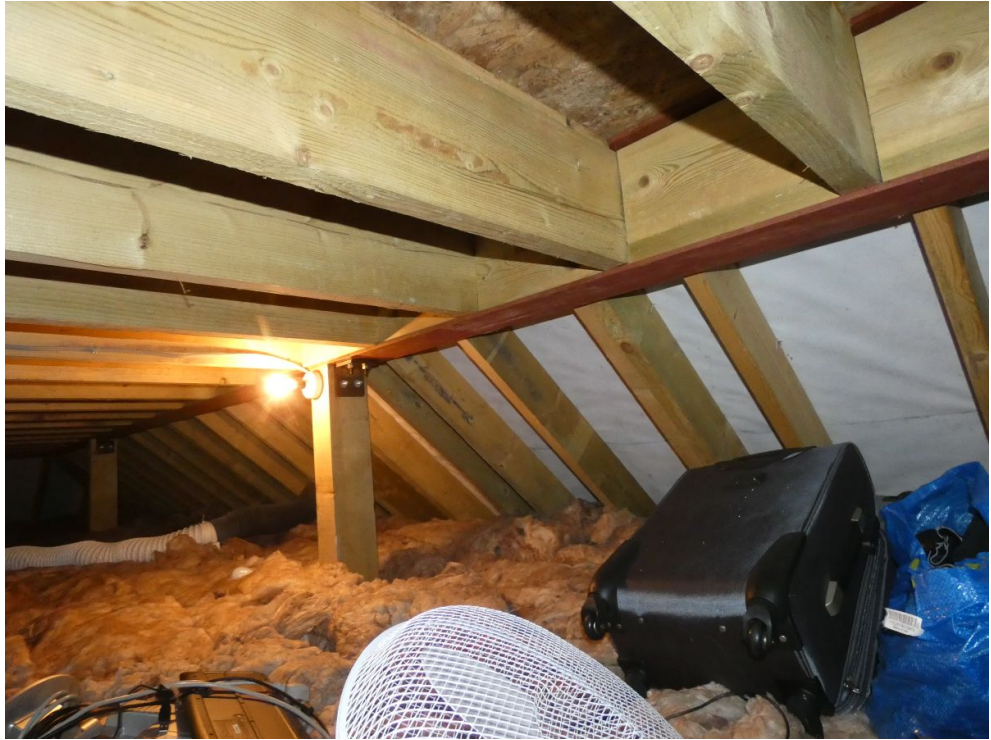
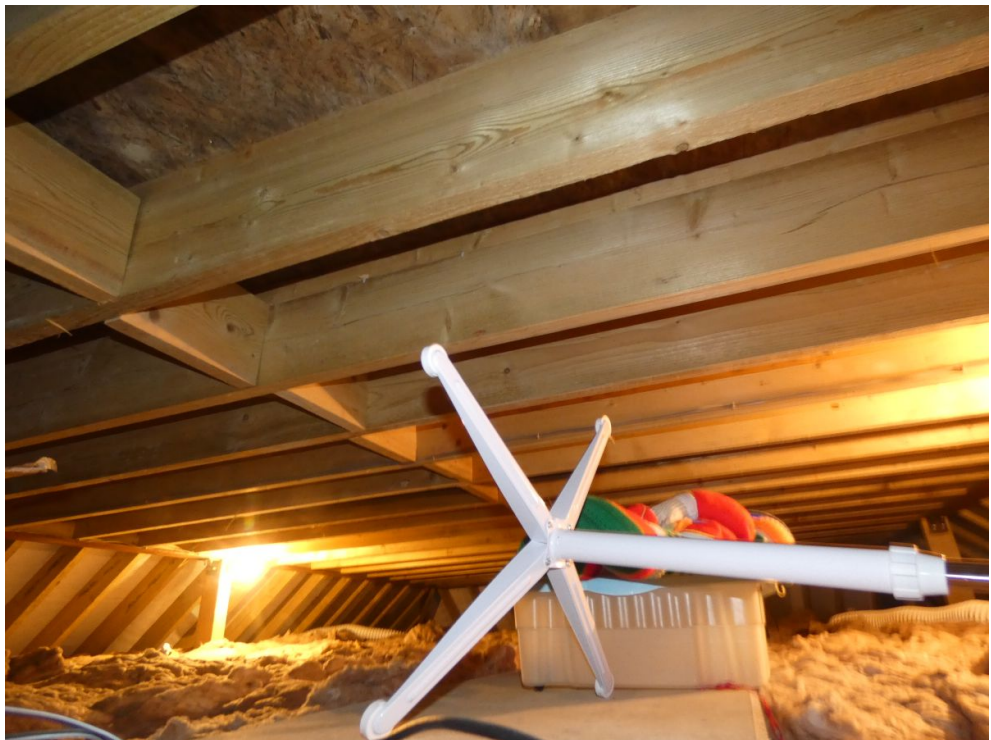
Condition	<p>The roof structure is in a good condition with reasonable quality timbers throughout.</p> <p>The roof space is laid with 200-300mm of wool type insulation at joist level. This close to the current recommendation of 270mm for maximum energy efficiency. It does, however, limit movement and storage within the roof space as any supporting joists are concealed.</p>		
Action Required	<p>Regularly monitor timbers for evidence of wood boring insects and other such infestations.</p> <p>Care should be taken when moving around, or storing heavy objects, in the roof space. The spaces between the floor joists will not support a persons weight, or that of large boxes etc. Where heavy items are to be stored it is important to distribute the weight evenly using fixed boards. Additional structural support may be required if you plan to store large quantities of heavy items in the roof space.</p>

Roof Structure

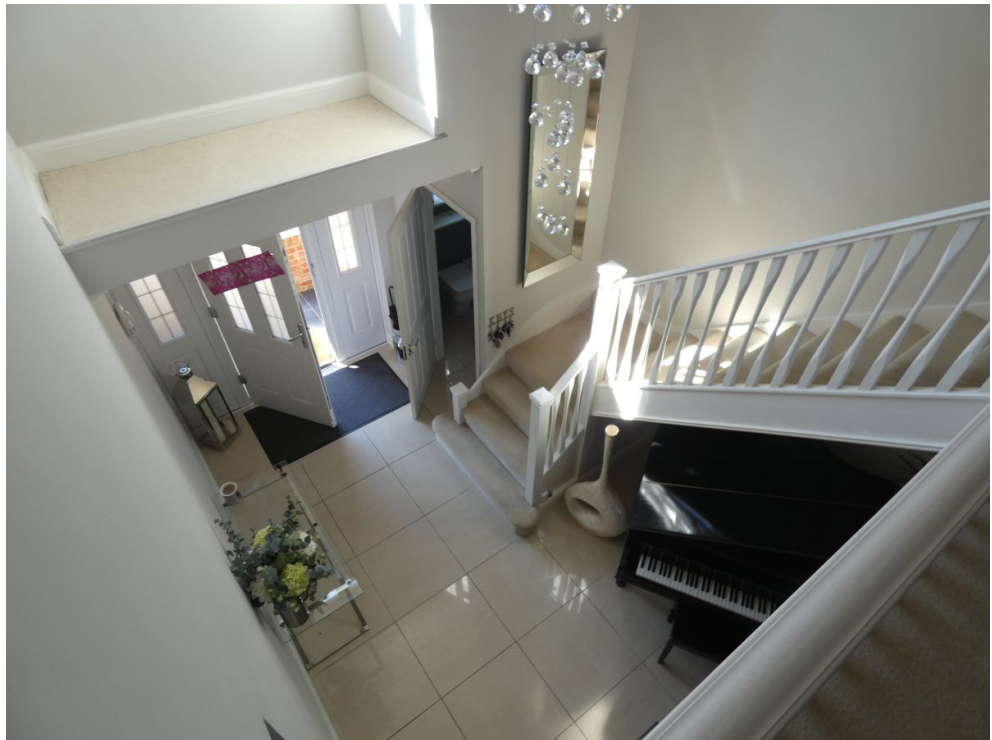
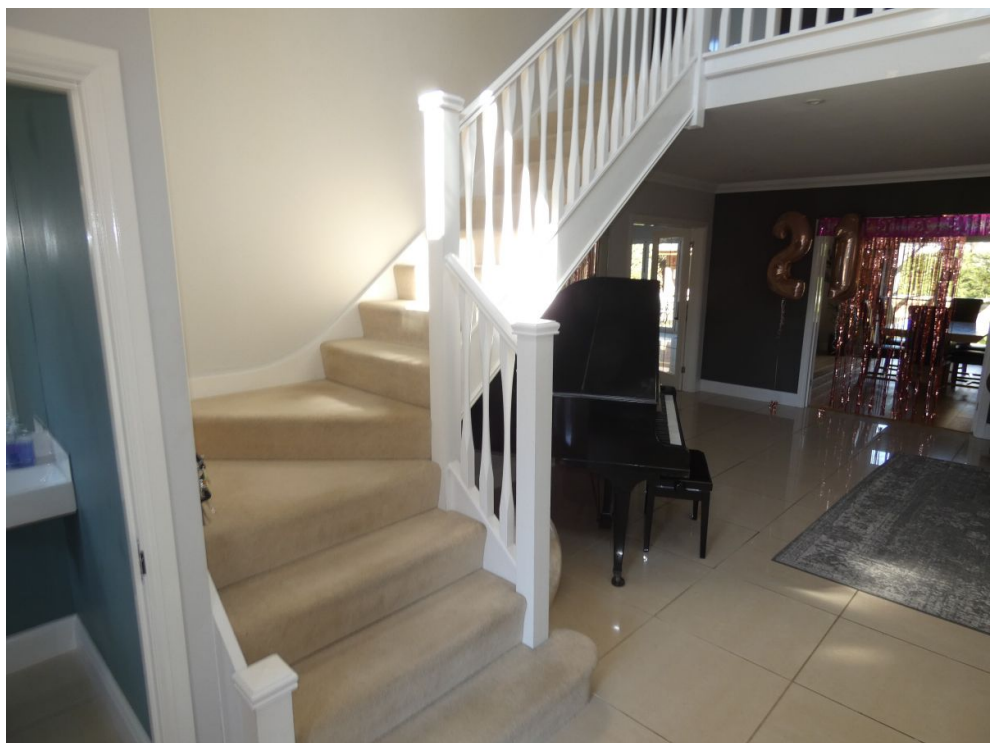
5.7 Internal Joinery	Condition rating	1
Construction & Type	The internal woodwork includes such items as: doors, frames, skirting's, banisters and staircases. All the internal doors are made from softwood.		
Nature of inspection and Limitations	<p>The internal doors were checked for normal operation and other woodwork examined for a range of defects.</p> <p>Woodwork was also examined for evidence associated with movement of the structure of the property, woodworm and other infestations, and general condition. Moisture meter readings were taken at regular intervals.</p>		
Condition	<p>The stair balustrades and hand rails are of softwood construction and of suitable quality. All parts were firm with no undue levels of movement during usage. The gaps between the balustrades, the pitch level and head heights are compliant with current regulations.</p> <p>As mentioned in 4.4 most properties are subject to slight settling down over the years as sub-soil consolidates and adjusts to changes in ground condition. This will frequently result in limited differential movement, which is often expressed as minor cracking or distortion of window and door openings and is rarely of structural significance. All internal doors were in fair alignment with no undue movement noticed to the frames. All doors operated effectively.</p> <p>No significant defects or damage was noted.</p>

Stairwell

Stairs

Action Required	Door hinges and locks should be regularly lubricated. Internal timbers should be inspected regularly for evidence of bowing or distortion, woodworm and other defects.

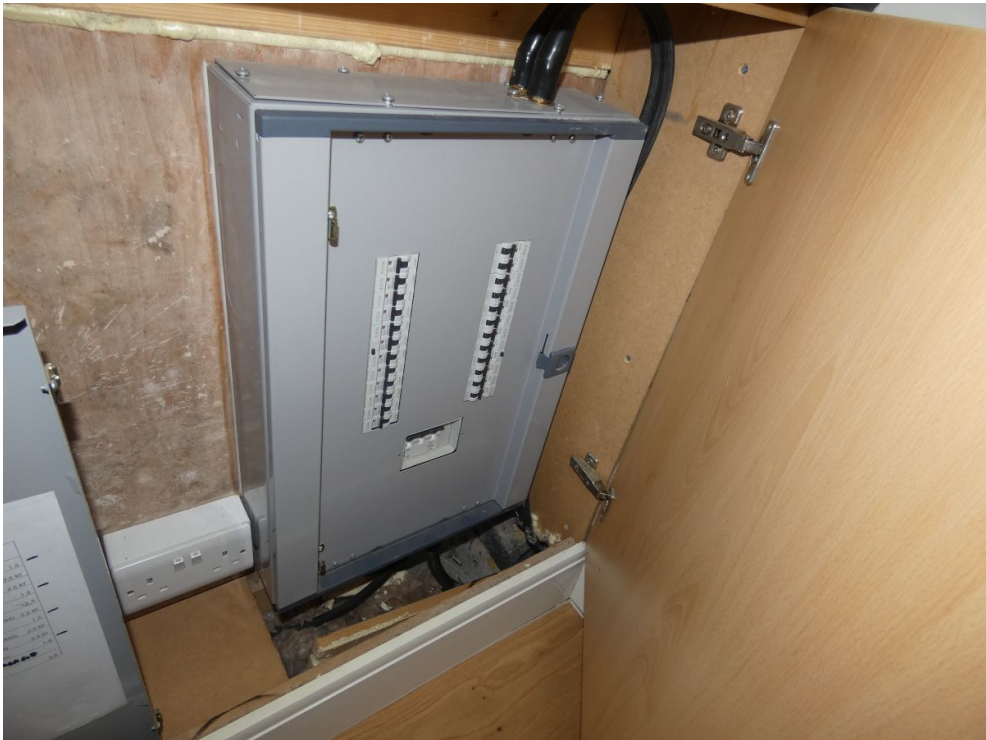
6.1 Electricity	Condition rating	HS
Construction & Type	<p>There is an underground electrical supply and the consumer unit [fuse box] is located in a cupboard in the games room.</p> <p>The consumer unit is a modern unit with MCB's (miniature circuit breakers) and also an RCD (Residual Current device).</p>		
Nature of inspection and Limitations	<p>It is not possible to fully assess the condition and safety of an electrical installation on the basis of a visual inspection only. Distribution wiring is largely concealed and therefore date and quality of installation cannot be verified within in the scope of this inspection.</p>		
Condition	<p>In general the electrical circuits seen are in a fair condition. PVC cabling was observed at the property and the socket face plates and switch plates are of a suitable modern quality.</p>		
Action Required	<p>Some services will be obscured by furniture and other objects at the time of the survey. Upon occupation it is strongly advisable to visually check all socket outlets and switch points for any broken housings or loose fascias. Any damage seen should be repaired accordingly.</p> <p>The NICEIC recommends that electrical installations are subjected to an Electrical Installation Condition Report (EICR) by a suitably qualified engineer at least every 10 years. They further recommend that a PIR be carried</p>

<p style="text-align: center;">Consumer Unit</p>

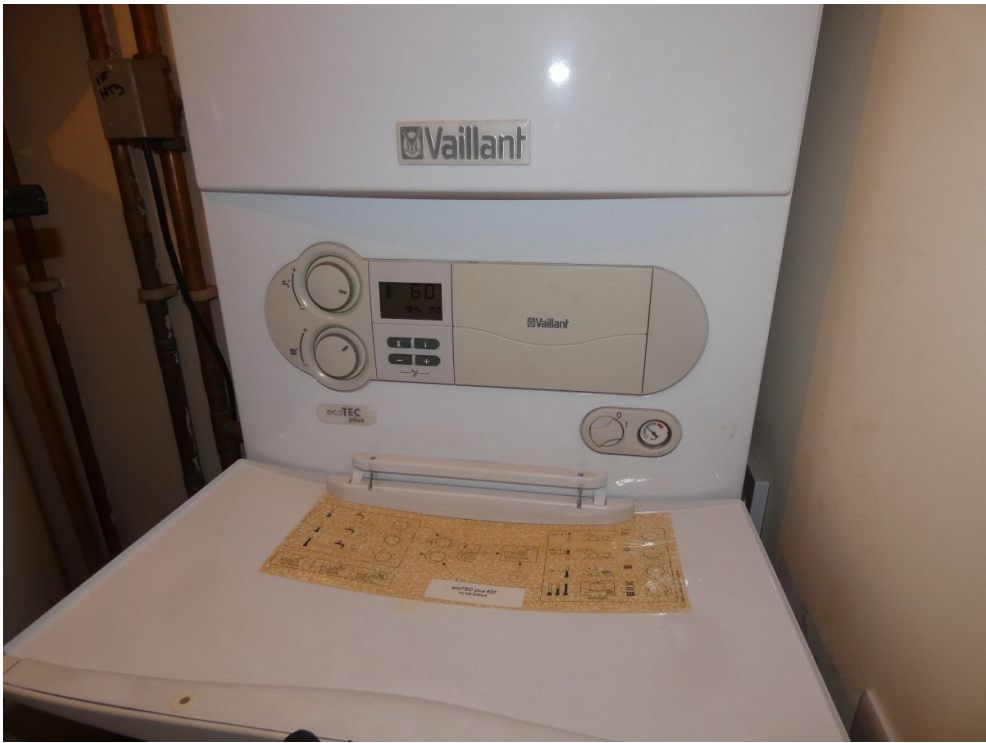
Boiler
