MI HOME BUYER SURVEY

# HOME BUYER SURVEY

SURVEY DATE 25 Aug 2020

REF 8629

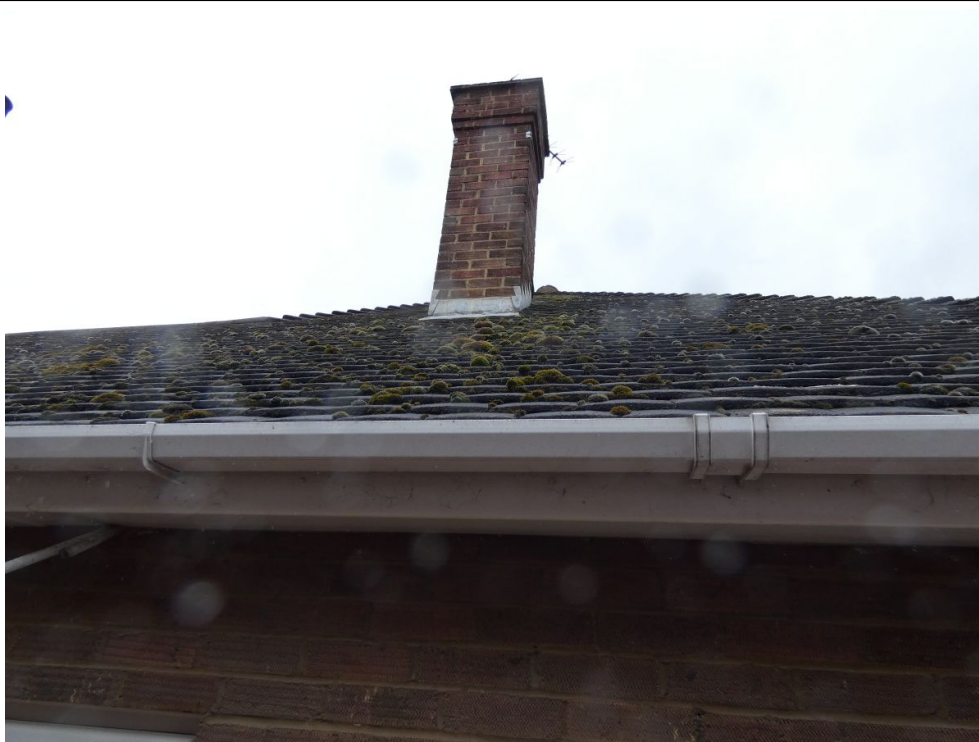
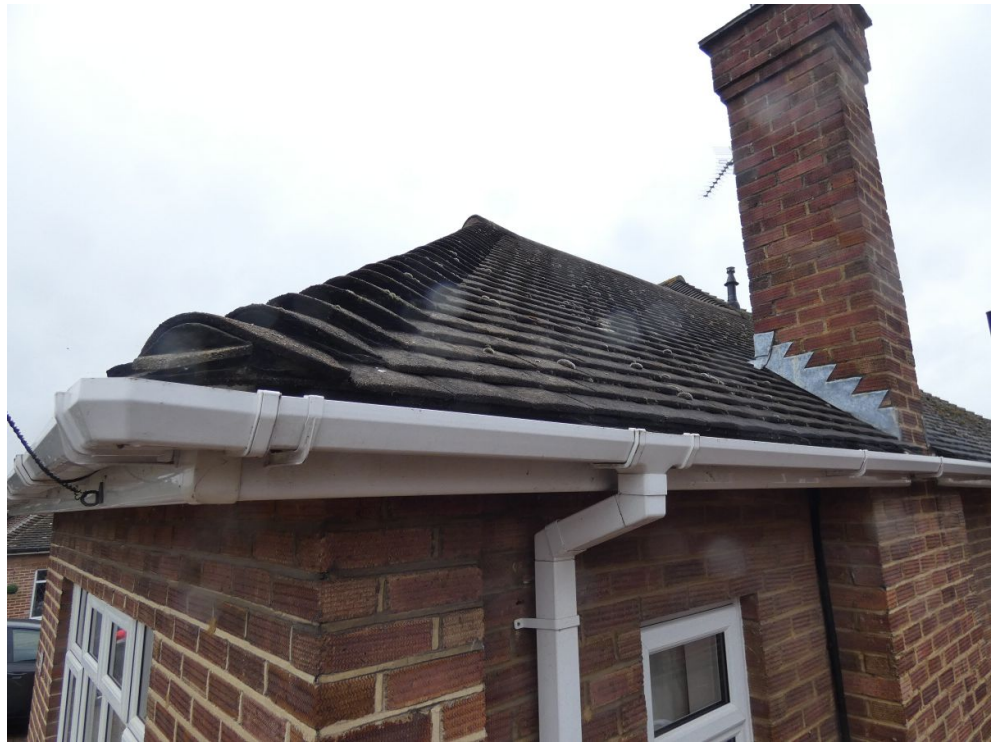
All flashings, brickwork and pointing seen were in a fair condition.

Chimney stack

Main chimney Stack

The chimney stacks should be regularly monitored for any indications of damage, instability or other defects. Missing, loose or defective mortar should be re-pointed as necessary.

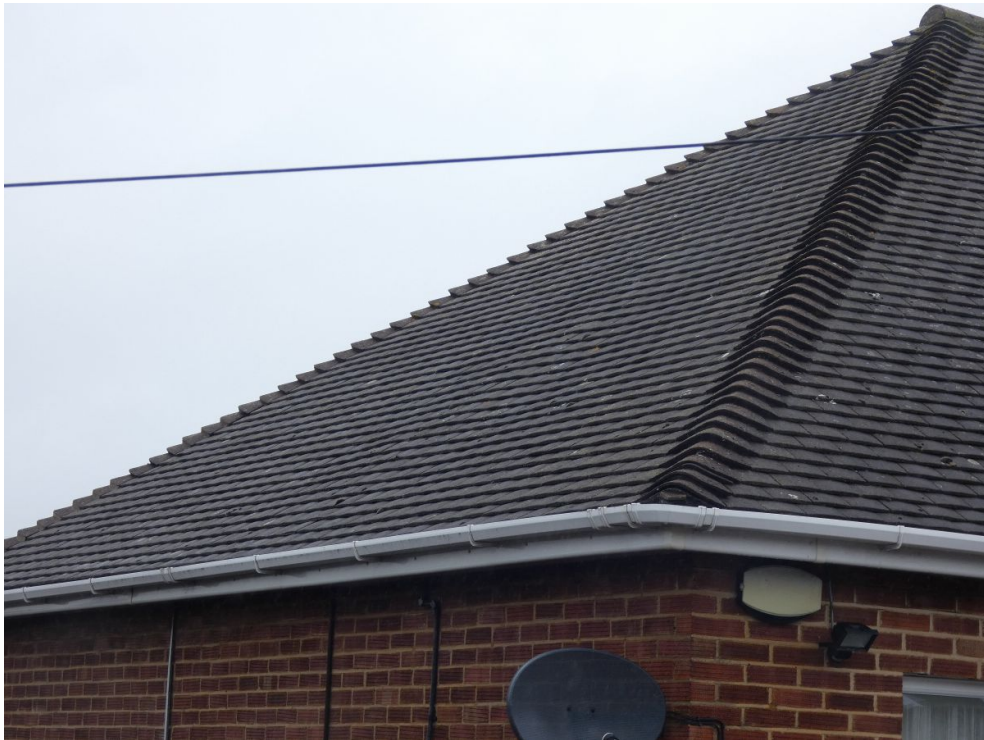
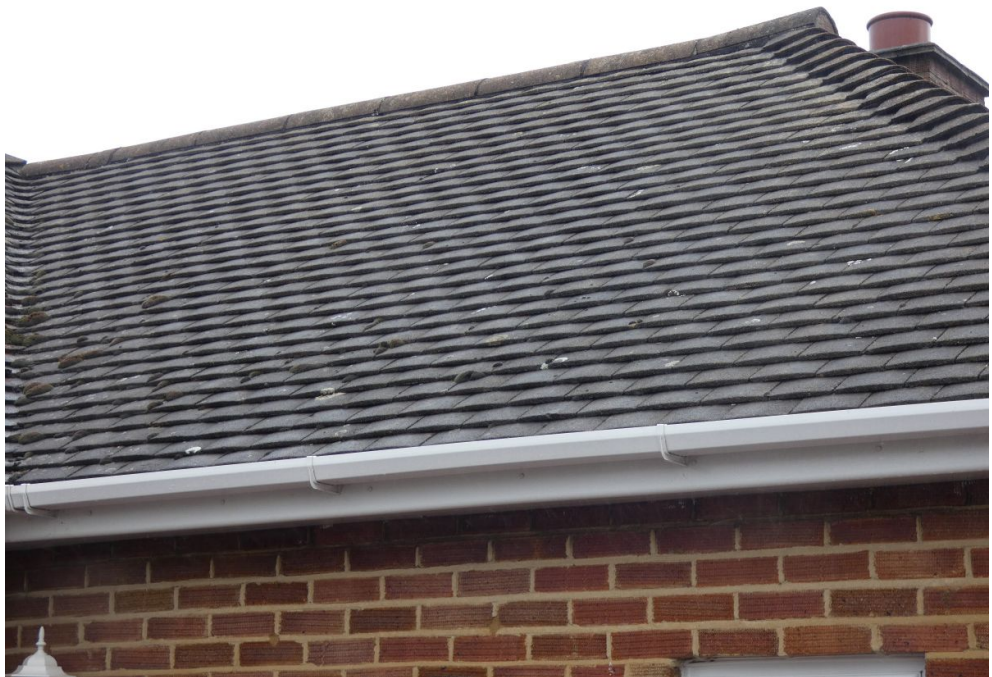
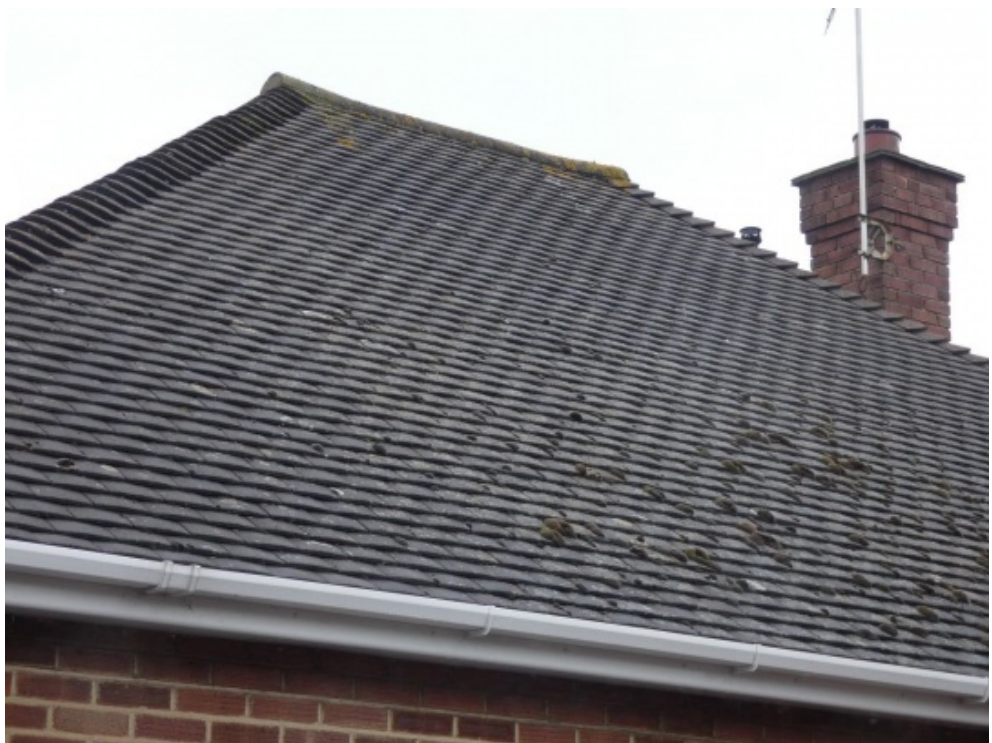
<p><b>Condition</b></p>	<p><b>Pitched Sections</b> All tiles seen were in a fair condition with no evidence of any major failures or defects. The top line of ridge tiles is even with no evidence of any undue levels of flexing or bowing.</p> <p><b>Flat Sections</b> The flat roof appeared to be in a serviceable condition.</p> <p>Built up bitumen and felt flat roofs have a limited life expectancy generally not more than 15/20 years, and they can fail within a shorter time span. It is essential to monitor and maintain this roof carefully repairing any sections that start to show signs of blistering.</p> <p>Pitched Sections: Carry out normal maintenance including removal of moss build-up.</p> <p>Any slipped, missing or broken tiles on the roof pitches should be repaired and replaced. You should carry out a thorough visual inspection at least once a year, ideally in the Spring to identify and repair any damage that could have been caused by winter weather. Any missing mortar at the verges and beneath any hip or ridge tiles should be replaced. Any moss or other accumulated plant matter should be cleared</p> <p>Flat Sections: Ideally you should anticipate that it would require normal maintenance for the short to medium term but you should allow for recovering within 10years, although, there is no evidence of failure at present. The most likely areas where deterioration will occur are the joints between the flat roof and the parapets or to other upstands. When any recovering is undertaken, the supporting structure may also need some attention.</p>

<p>Side roof</p>

Front roof

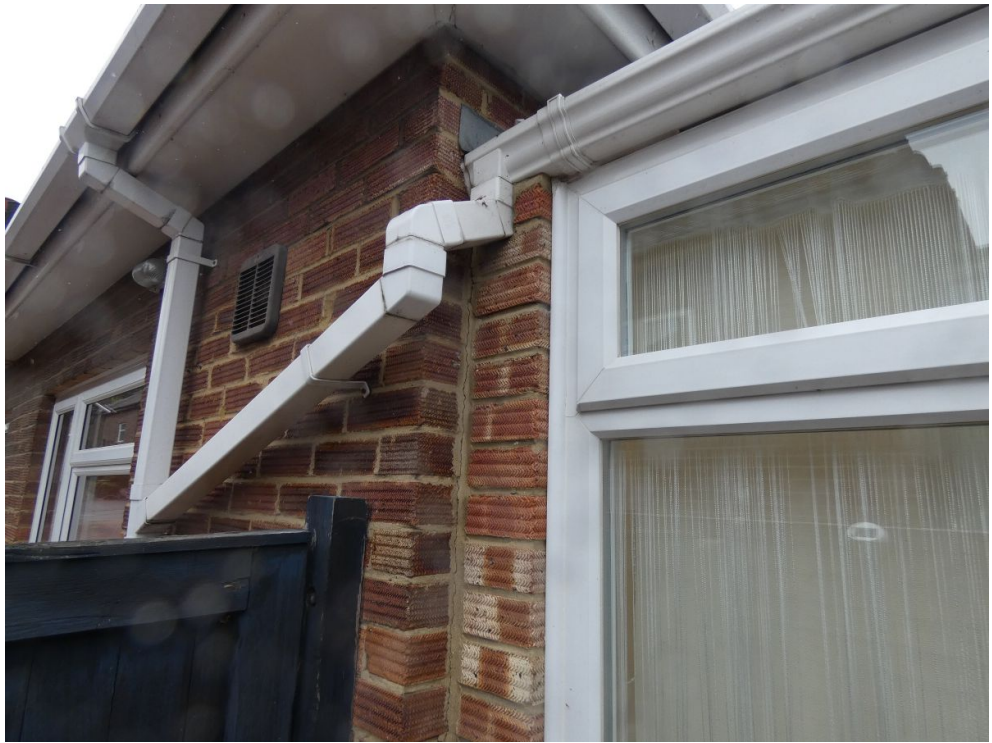
<p><b>Condition</b></p>	<p>Stability and vertical alignment is generally satisfactory. Condition and alignment of the brickwork is fair. There is no evidence of any significant bulges or major structural cracks, although there are some vertical cracks between the conservatory and rear extension/main house that will need to be monitored carefully</p> <p>Most properties are subject to slight settling down over the years as sub-soil consolidates and adjusts to changes in ground condition. This will frequently result in limited differential movement, which is often expressed as minor cracking or distortion of window and door openings and is rarely of structural significance.</p> <p>Externally the brick window lintels and vertical mortar junctions are all complete with no evidence of any movement. These areas are mentioned specifically as any movement to the property would be noted at these points.</p> <p>In all external walls there should be a damp proof course (DPC) just above ground level. This is an impervious layer present to prevent dampness rising up the walls from the ground. In modern properties this is often a plastic membrane but in older properties other materials such as bitumen felt or slate are often found. Houses built before 1880, or so, usually have no provision to prevent dampness rising up, or penetrating through, the walls. In this case the DPC can be seen at the base of the walls.</p> <p>Wall ties are metal linking plates built into the wall at intervals to hold the inner and outer leaves of the cavity wall together. In older properties these may have been of wrought iron that has since corroded and failed. In later properties they may be of galvanised steel, stainless steel or plastic. In the worst case their failure can allow the outer leaf to fall away from the inner leaf of brickwork. No evidence was seen to indicate any failure of the wall ties and it is therefore assumed that they are in a stable condition.</p> <p>There is evidence that the wall cavities have been filled with insulation (cavity wall insulation), though the exact nature, quality, and quantity of insulation inserted can only be determined by an invasive examination with the use of cameras. No issues are noted or suspected at this time.</p> <p>Walls should be examined regularly to inspect for changes in the nature of any cracking or other defects that may become apparent.</p>

Crack between conservatory and main property

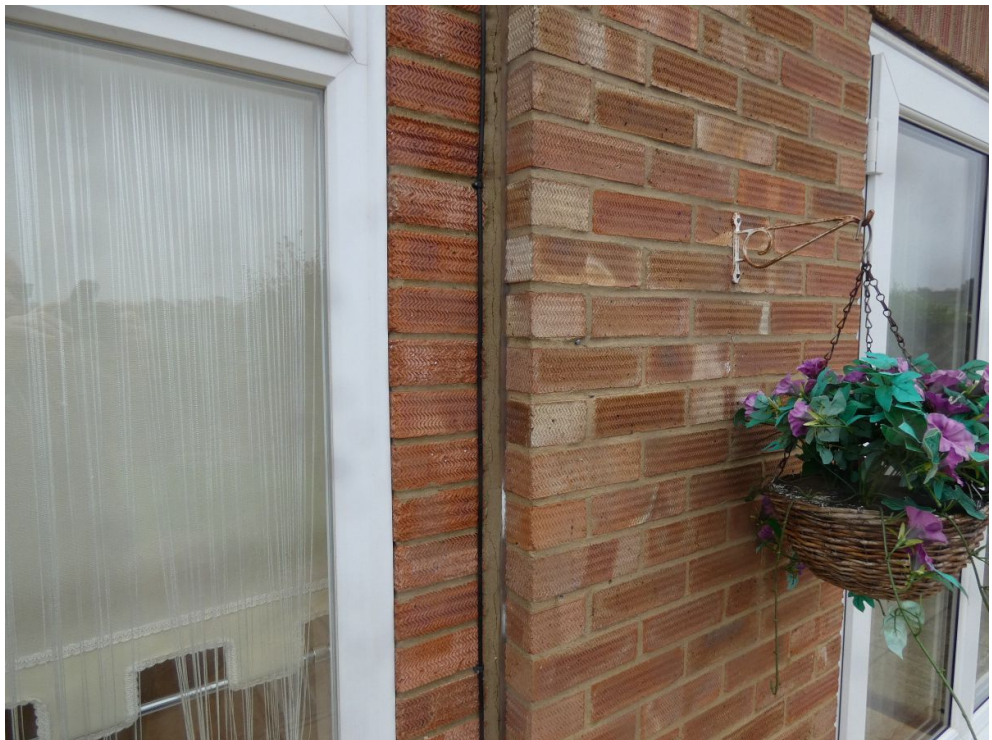
Crack between conservatory and rear extension

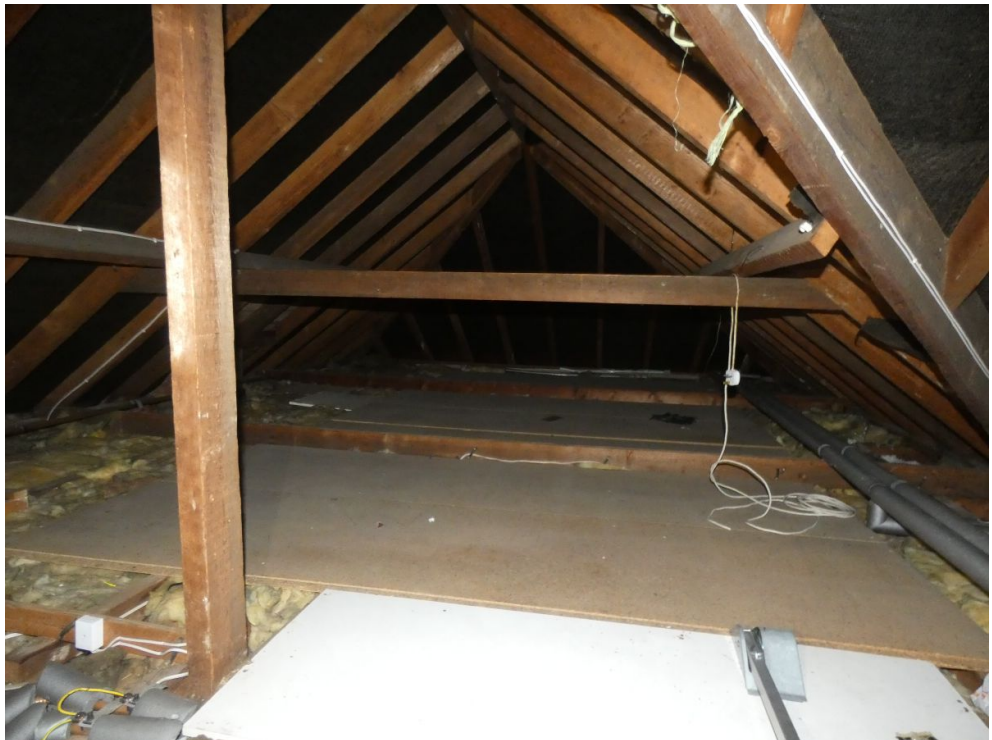
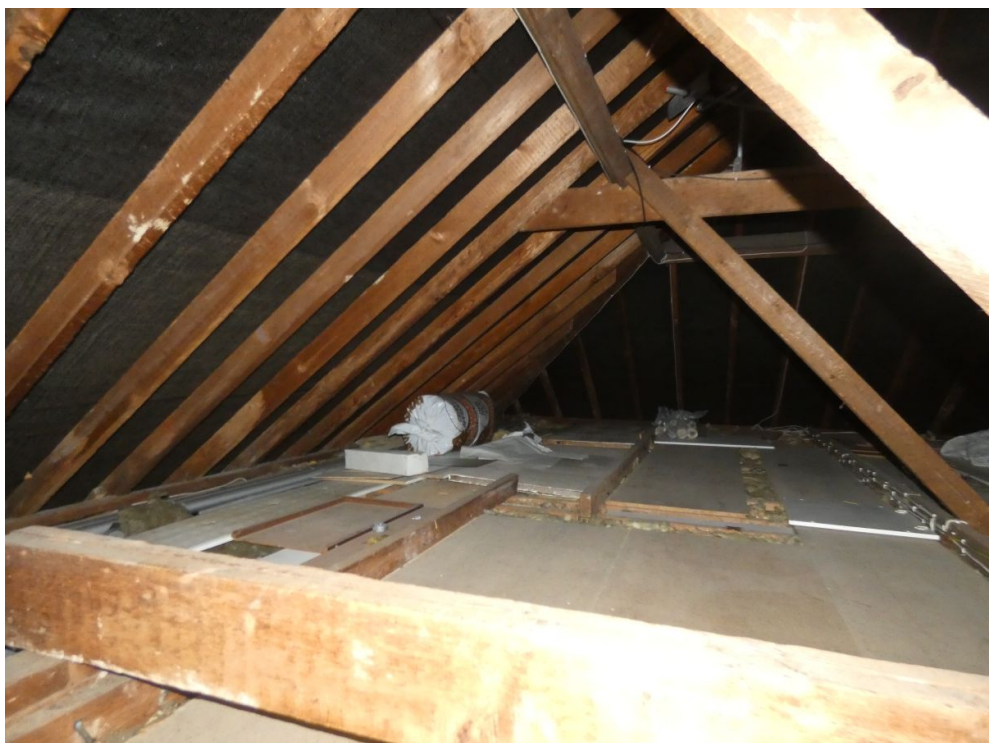
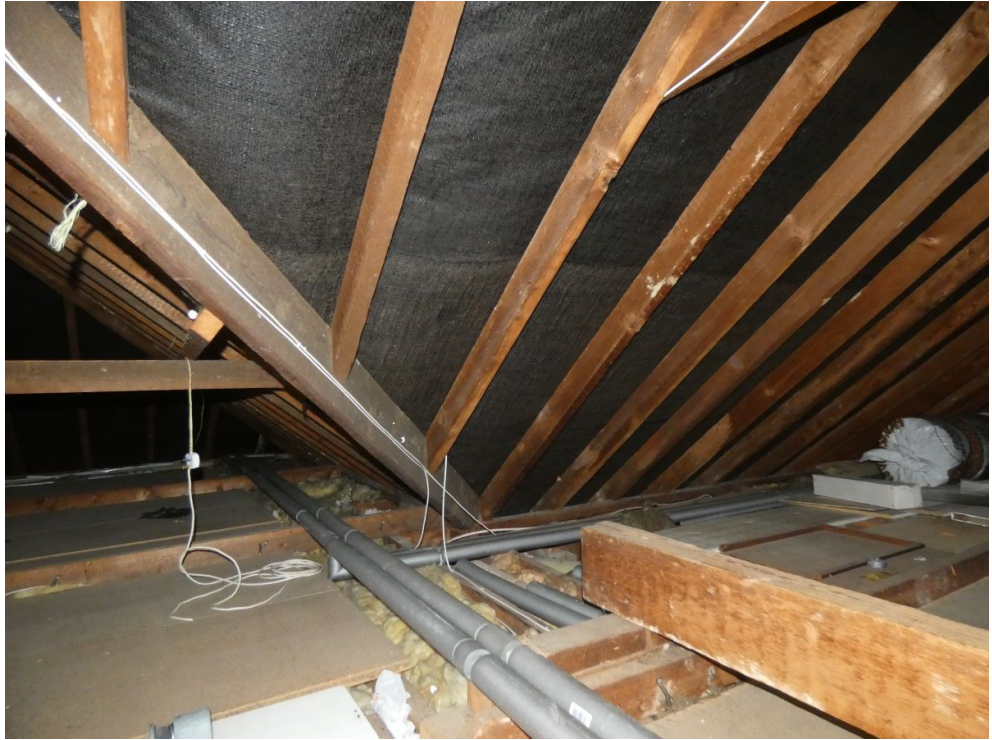
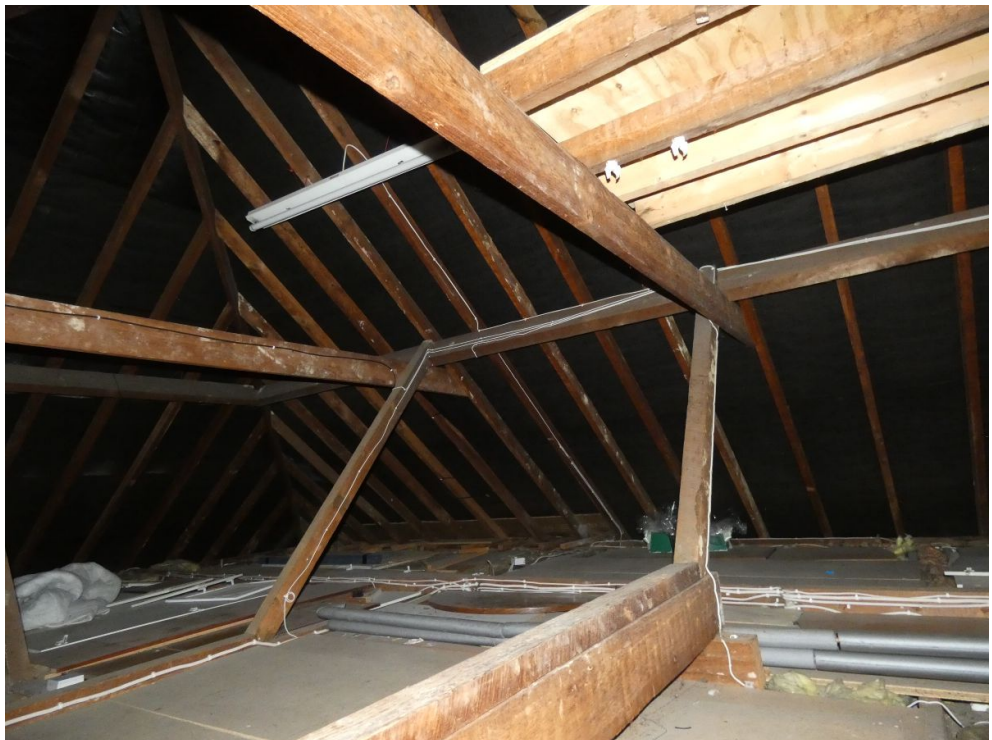
The roof structure is in a fair condition with reasonable quality timbers throughout. The rafters, purlins and strut timbers are complete with no evidence of any undue stress or cracking. The bitumen undercovering (secondary waterproof covering) is complete with no major tears or missing sections.

The roof space is laid with about 150mm of wool type insulation at joist level. Increasing the thickness to the current recommendation of 270mm is advised for maximum energy efficiency

Roof Structure

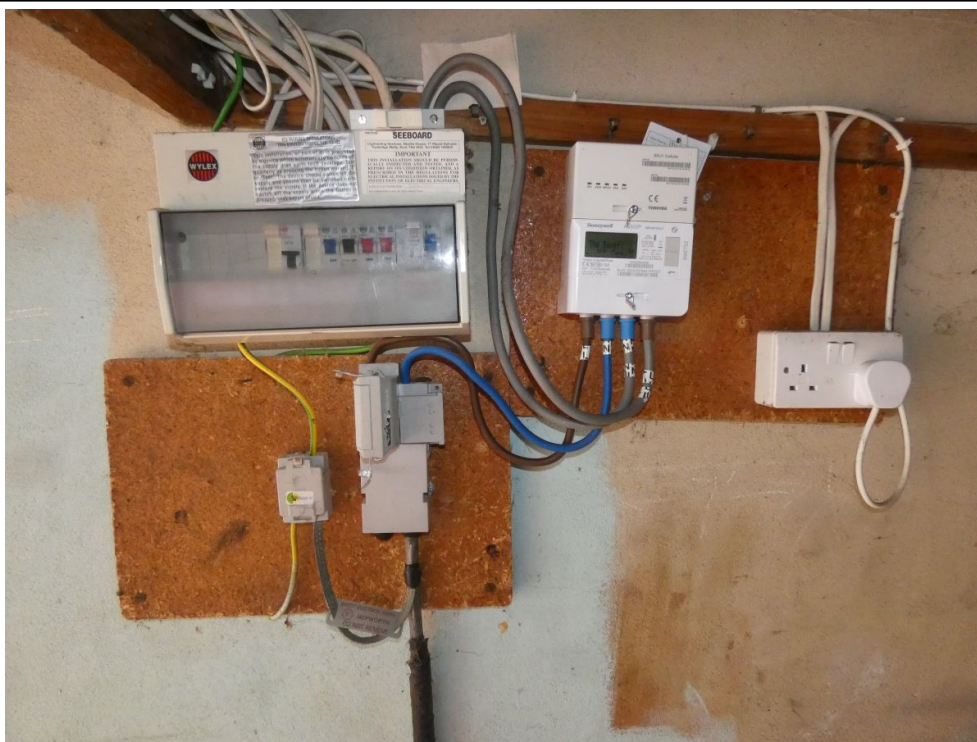
In general the electrical circuits seen are in a fair condition. PVC cabling was observed at the property and the socket face plates and switch plates are of a suitable modern quality. However to some rooms there are an insufficient number of sockets for modern living standards, this means a level of new circuitry or rewiring may be required.

Electric Meter and Consumer Unit

The NICEIC recommends that electrical installations are subjected to an Electrical Installation Condition Report (EICR) by a suitably qualified engineer at least every 10 years.

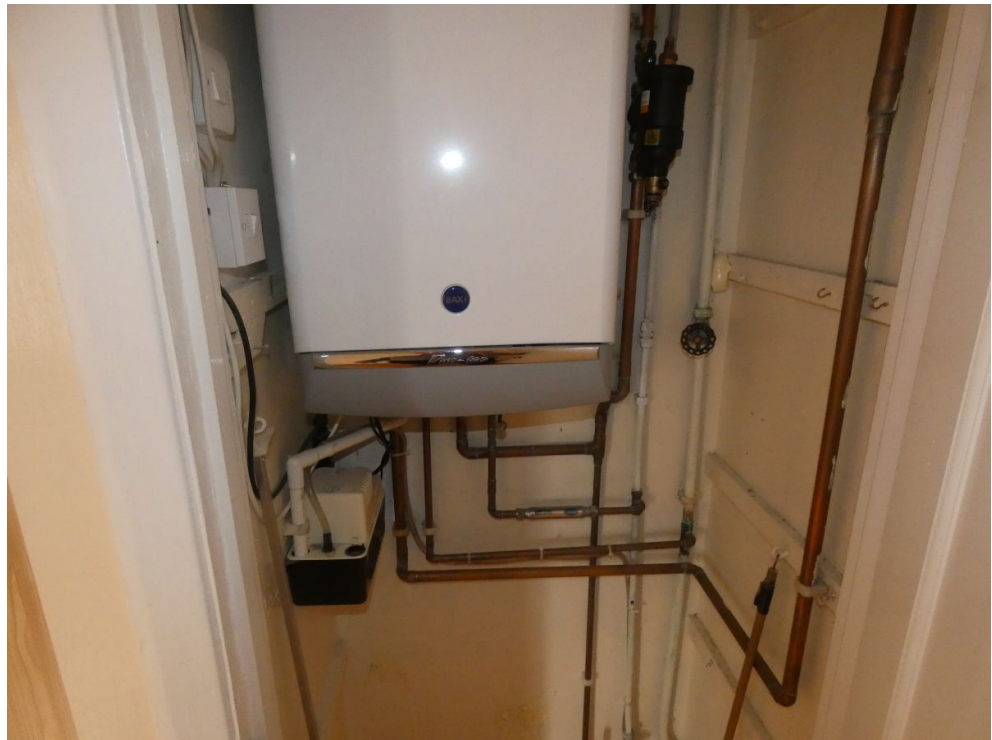
<b>Condition</b>	<p>It is recommended that you establish the service history of the gas boiler prior to commitment to purchase, as only regular servicing by a competent person can ensure efficiency and safety. If these enquiries suggest that previous maintenance has been inadequate you should instruct a competent person to check the whole system prior to purchase.</p>

Boiler

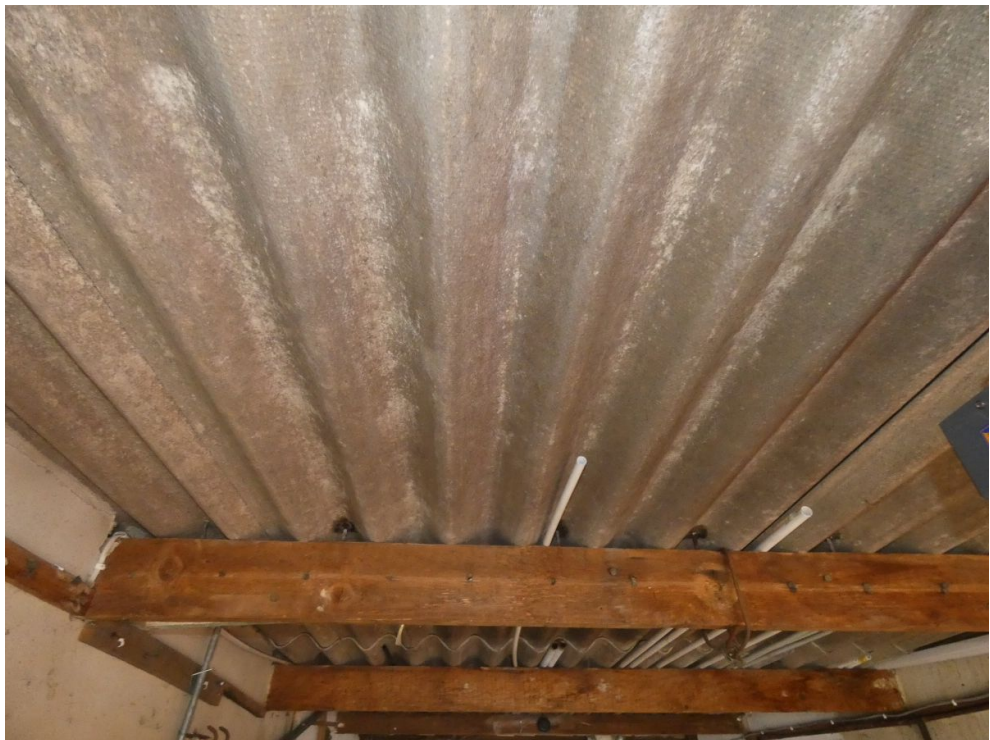
Some of the corrugated roof material contains asbestos.  
There are vertical cracks to the side of the internal walls which will need to be monitored carefully over time.

Asbestos sheet in garage

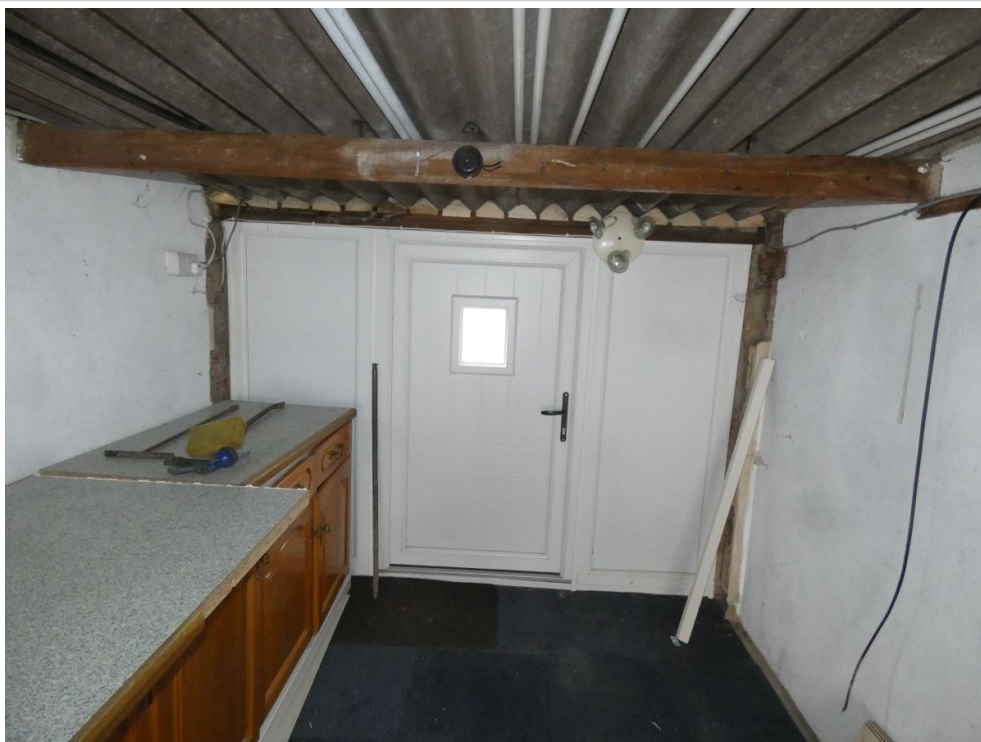
Garage interior
