HOME BUYER SURVEY

SURVEY DATE 23 Oct 2024

REF ME17 4QB

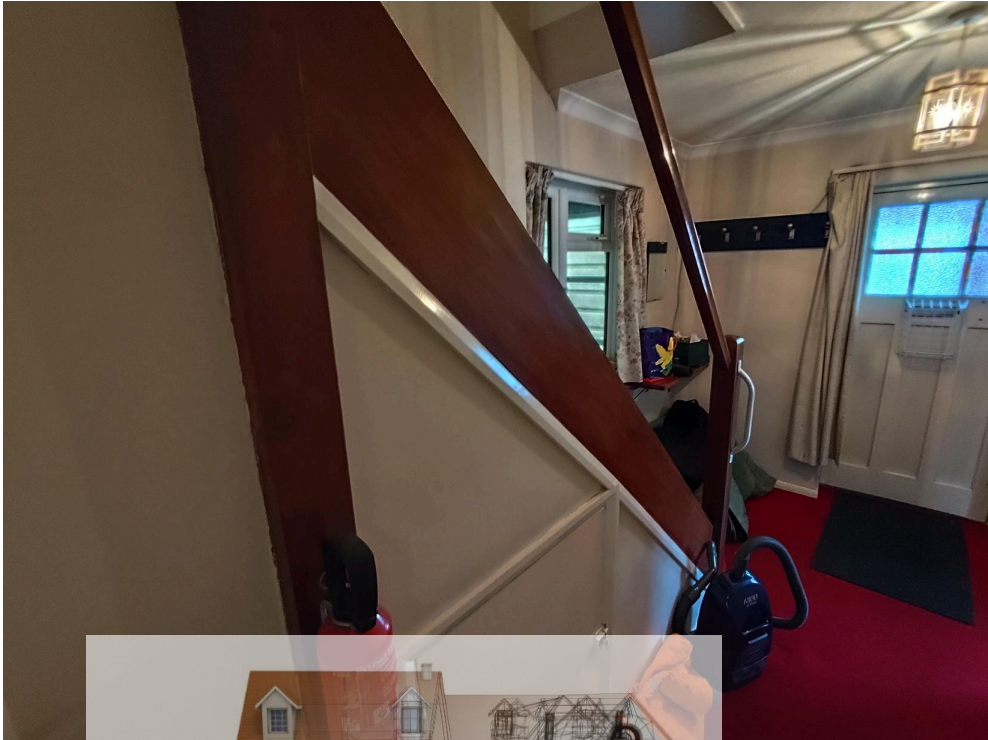
<p>Gap in staircase</p>

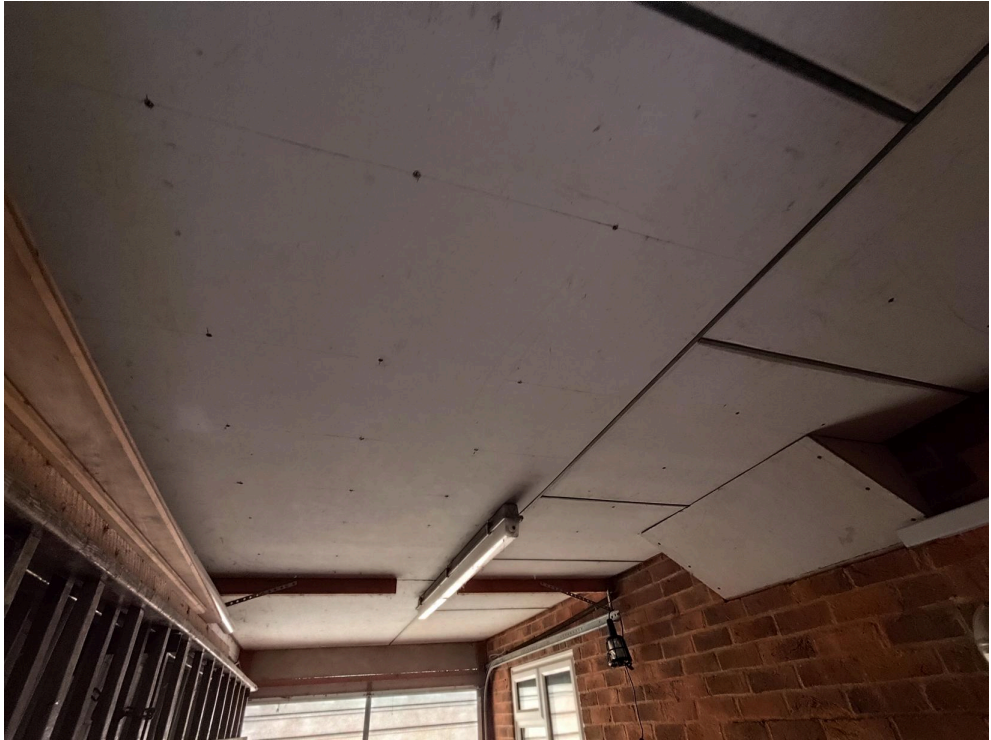
Asbestos sheeting in garage(2)

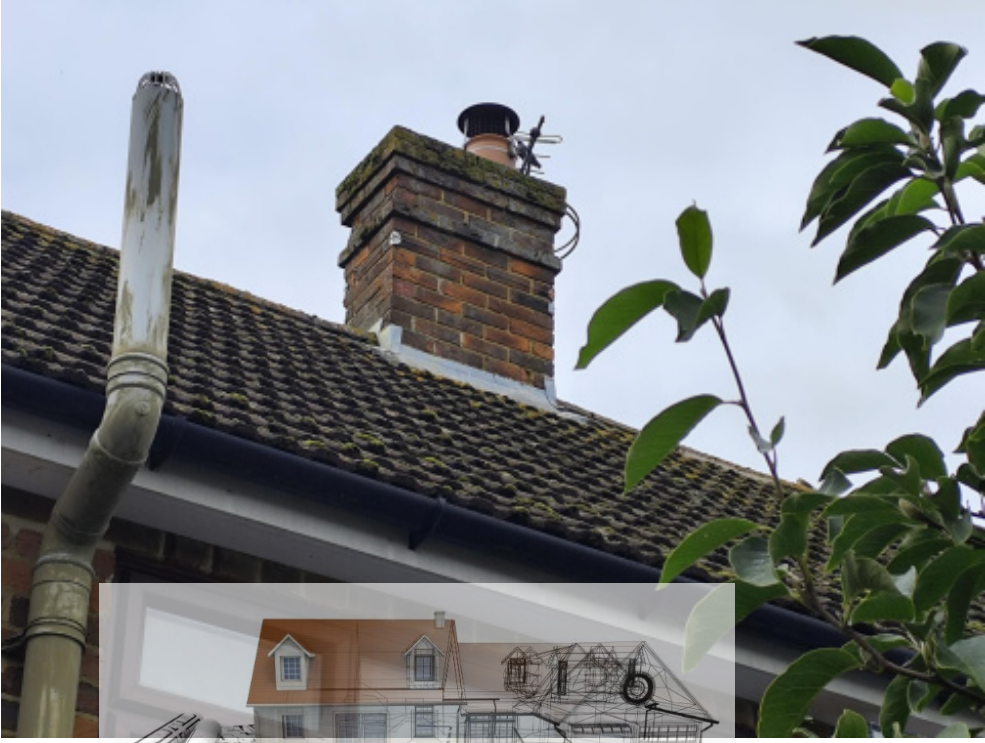
Condition	<p>All visible flashings, brickwork and pointing were in a fair condition.</p> <p>No Repair is currently needed. The property must be maintained in the normal way.</p> <p>The chimney stack should be regularly monitored for any indications of damage, instability or other defects. Missing, loose or defective mortar should be re-pointed as necessary.</p>

<p>Rear view of main stack</p>

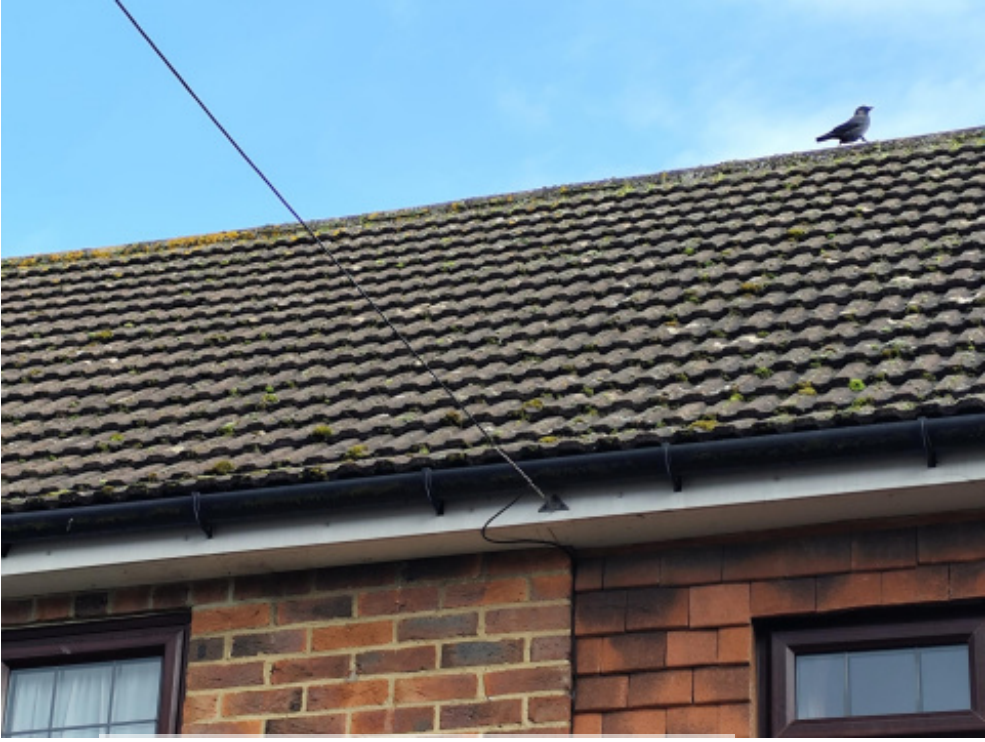
<p style="text-align: center;">Front roof</p>

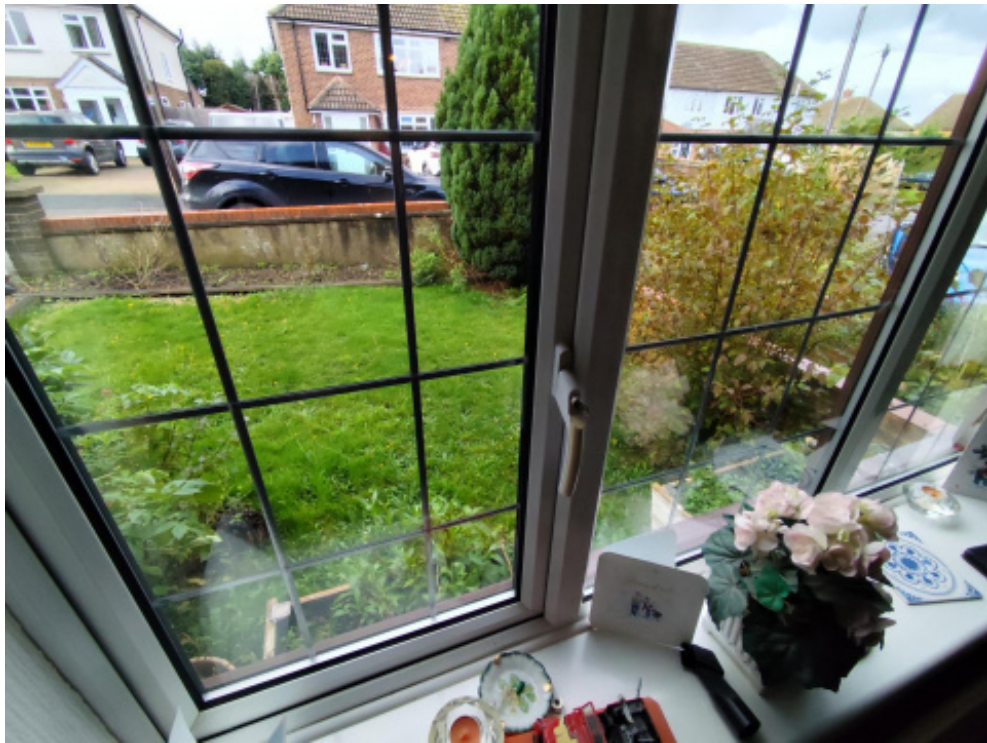
uPVC window

<p>Condition</p>	<p>Doors No significant defects were noted, all doors operated effectively on opening and closure. All locks functioned correctly.</p> <p>Windows WOOD FRAMES As expected the frames are affected by minor splitting and isolated softening. The frames are in overall serviceable condition although would benefit from future re-painting and attentive repair.</p> <p>uPVC frames can vary enormously in quality and an assessment of individual design is beyond the scope of this report. They are less suitable for piecemeal repairs whilst stay mechanisms and fixings can require an occasional overhaul. The double-glazed units appear serviceable but will need routine maintenance.</p> <p>Double-glazing has a limited life and is prone to deterioration at edge seals. This can sometimes be recognised by moisture between the panes but its presence is dependent upon atmospheric conditions that are, of course, variable. Such defects cannot always be diagnosed during a single inspection.</p> <p>According to records kept by FENSA (the Fenestration Self-Assessment Scheme, which was set up by the Glass and Glazing Federation (GGF) and other industry bodies in response to Building Regulations for double glazing companies in England and Wales), 3 new windows were installed in 2010. Each of these will carry a guarantee covering materials and labour.</p> <p>Under normal circumstances sealed double glazed units can be expected to last around 20 years before the seals begin to fail. This can occur more quickly where windows are in exposed or vulnerable situations. It is estimated that most of the windows currently fitted are approximately 10-15 years old and there is no evidence of any imminent failures. The condensation levels in certain weather conditions can disguise evidence of blown double glazed units, but no issues were noted or suspected.</p> <p>Any blown double glazing units will require replacement and it should also be considered that, where some sealed units within a window have failed, others may also fail in due course.</p> <p>Normal maintenance of frames, hinges and locks is required.</p> <p>Be aware that previous owners may have distributed multiple sets of keys for the windows and doors to individuals not known to you. When purchasing a property, you should consider the cost of replacing all of the door and window locks as soon as possible after you take up occupation. When doing this you should consult your insurers to ensure that you meet their requirements for security, and obtain any discounts that may be available by improving the security of the property.</p>

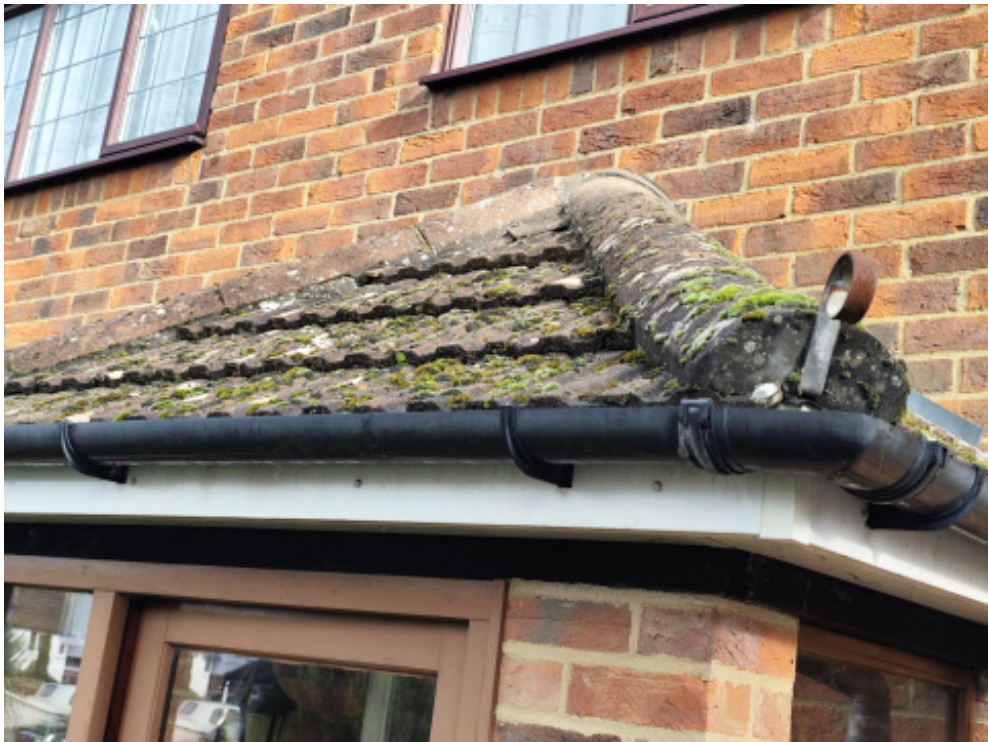
</div> <div data-bbox="767 1433 970 1464" data-label="Caption"> <p>Porch Structure</p> </div>

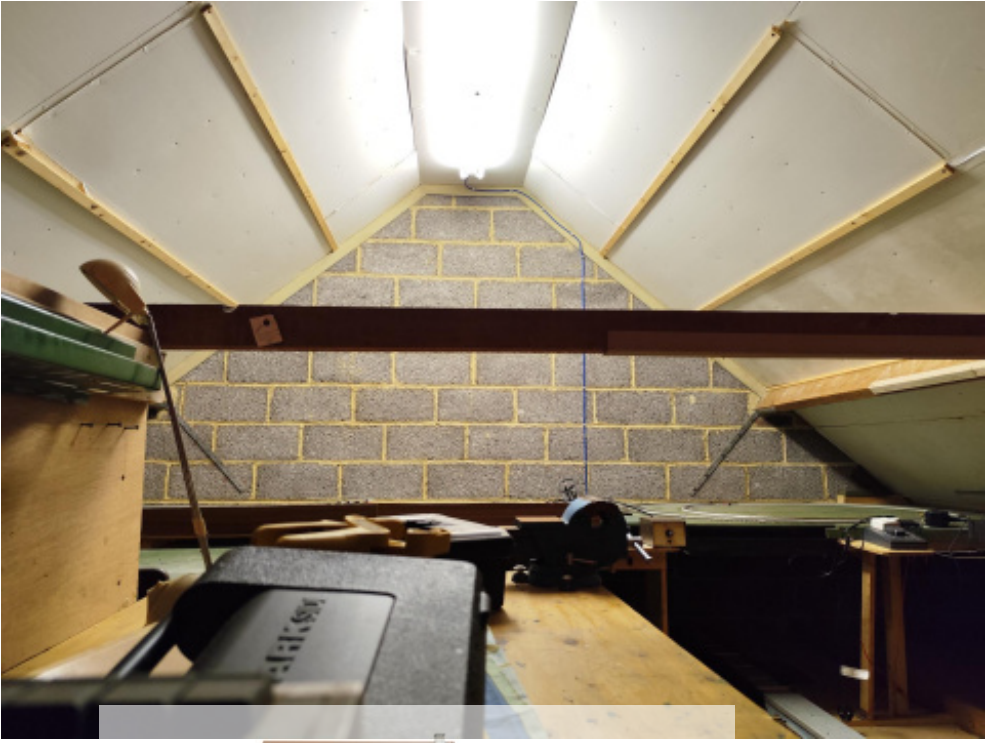
Roof Structure

5.1 Roof Spaces	Condition rating	2
Construction & Type	The main roof is a traditional cut timber structure comprising rafters spanning from ridge to eaves supported by struts. It has been completely boarded out.		
Nature of inspection and Limitations	The underside of the roof was covered by timber boarding.		
Condition	<p>The roof structure is in a fair condition with reasonable quality timbers throughout. The rafters, purlins and strut timbers are complete with no evidence of any undue stress or cracking.</p> <p>The roof space is laid with about 100mm of wool type insulation at joist level. Increasing the thickness to the current recommendation of 270mm is advised for maximum energy efficiency</p> <p>Care should be taken when moving around, or storing heavy objects, in the roof space. The spaces between the floor joists will not support a persons weight, or that of large boxes etc. Where heavy items are to be stored it is important to distribute the weight evenly using fixed boards. Additional structural support may be required if you plan to store large quantities of heavy items in the roof space.</p>

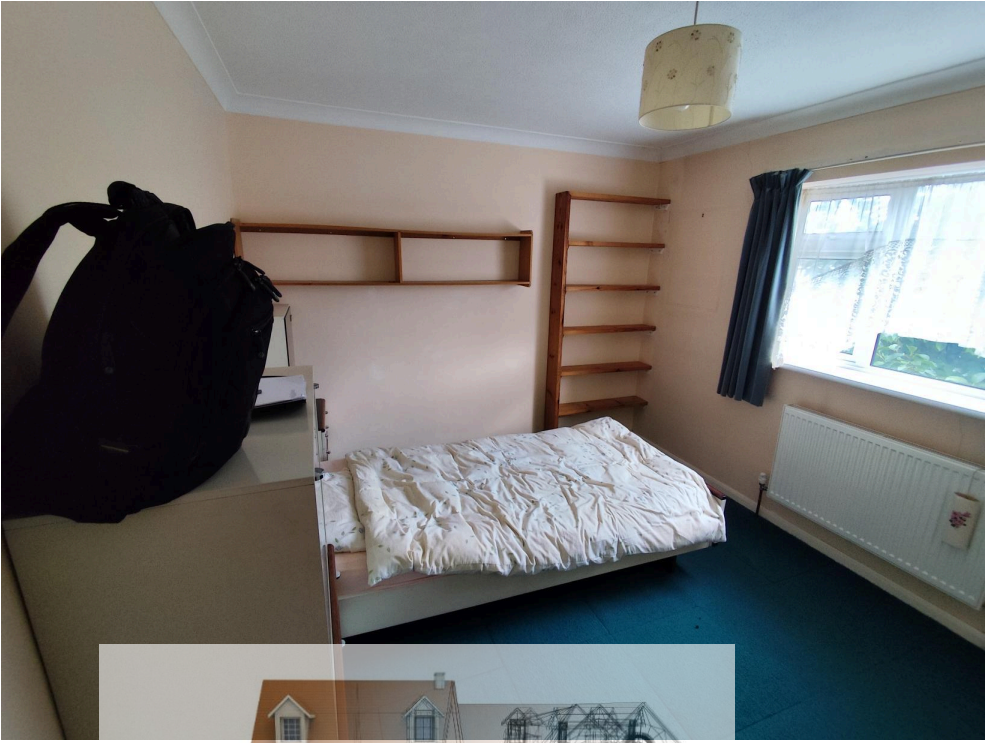
<p>Bedroom walls</p>

5.3 Walls	Condition rating	3
Construction & Type	The internal walls are of both solid and timber stud construction.		
Nature of inspection and Limitations	Internal walls were examined for indications of bowing, leaning, cracking and undue surface failure/damage. Moisture meter readings were taken at regular intervals where access and wall construction/location permitted.		
Condition	<p>There was no evidence of dampness to any of the internal walls or any of the internal faces of the external walls.</p> <p>Significant levels of cracking of the internal walls was noted on the first floor, particularly in the first floor extension. Further investigation is recommended as it could be symptomatic of settlement of the garage structure directly below the first floor extension.</p> <p>Supporting walls have been removed on the ground floor. Removal of internal load-bearing walls is a structural alteration and should be undertaken with Building Regulations consent. Your Legal Advisers should make further formal enquiries of The Local Authority to ascertain what paperwork is available to ensure compliance.</p> <p>It is possible that this has contributed to the cracking of the internal walls in the floor above.</p>

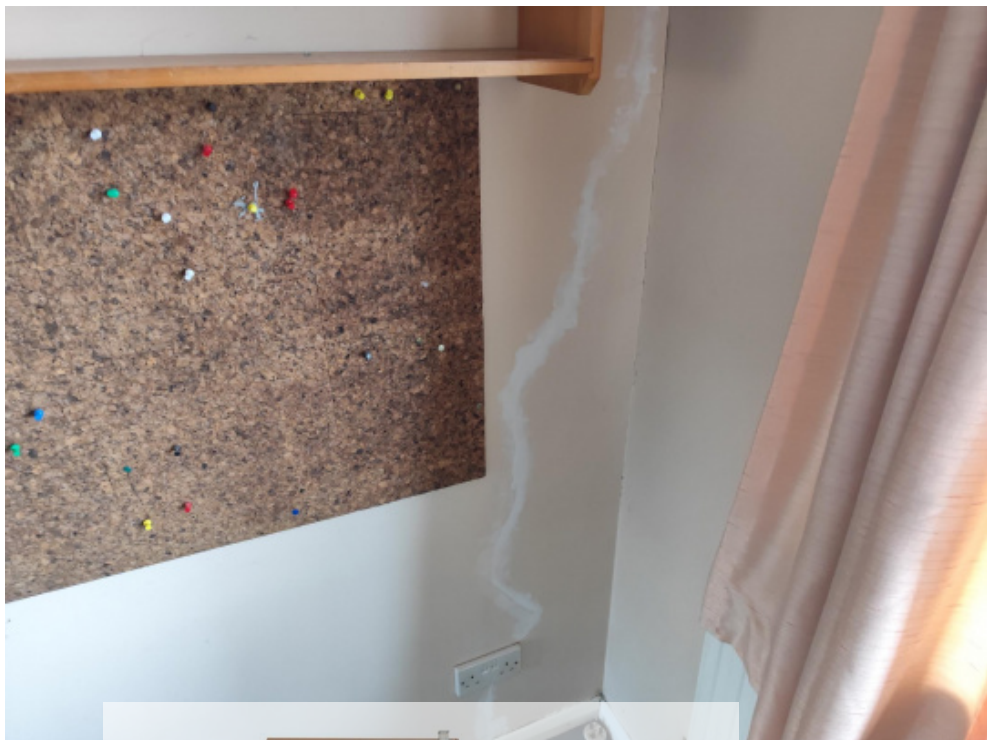
Repaired wall crack

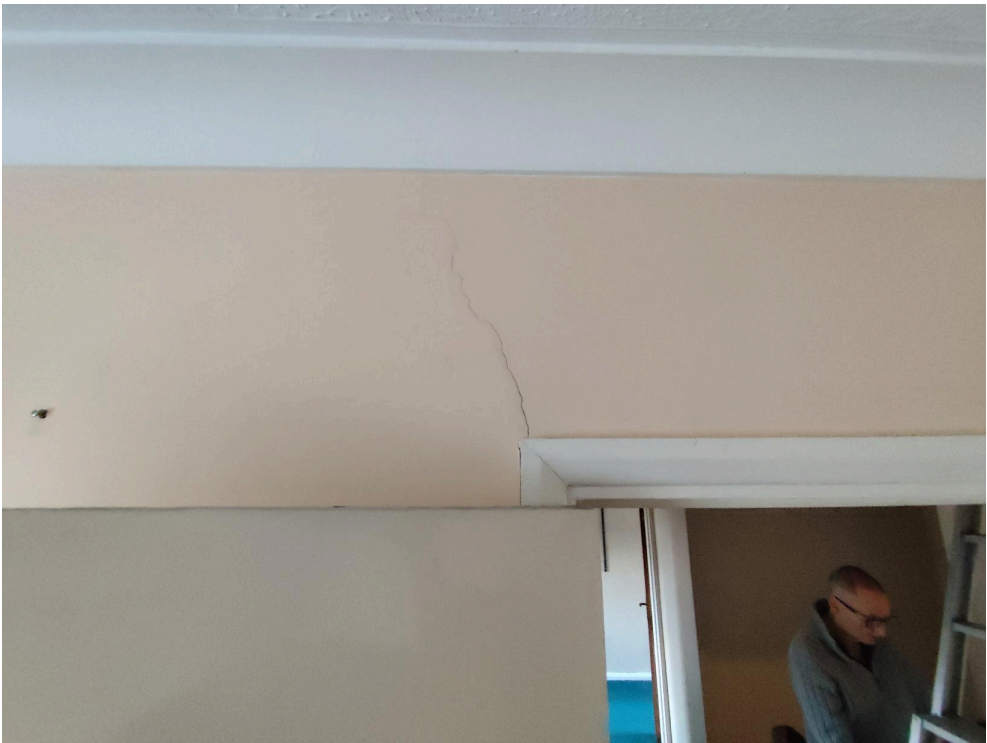
Hairline Wall Crack

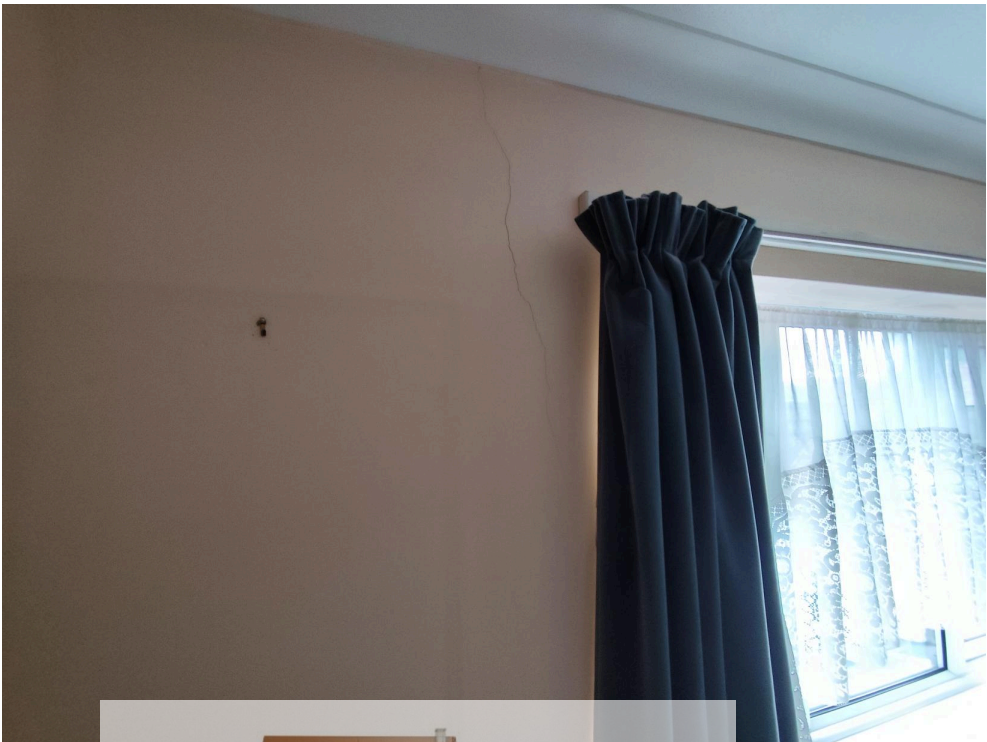
Hairline Wall Crack

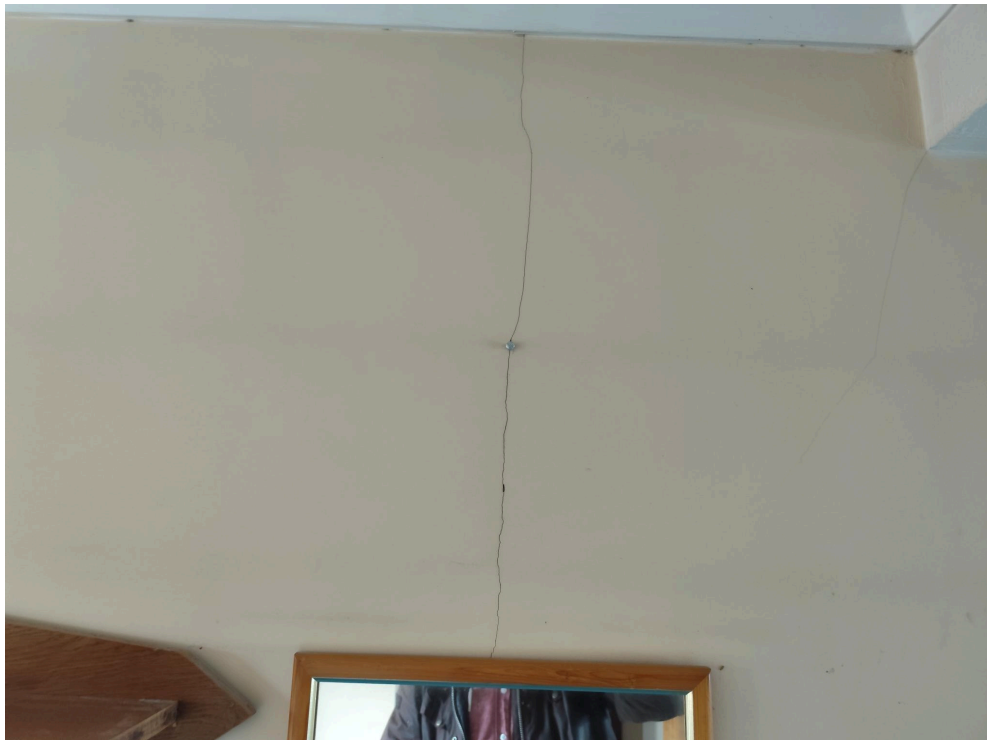
Hairline Wall Crack

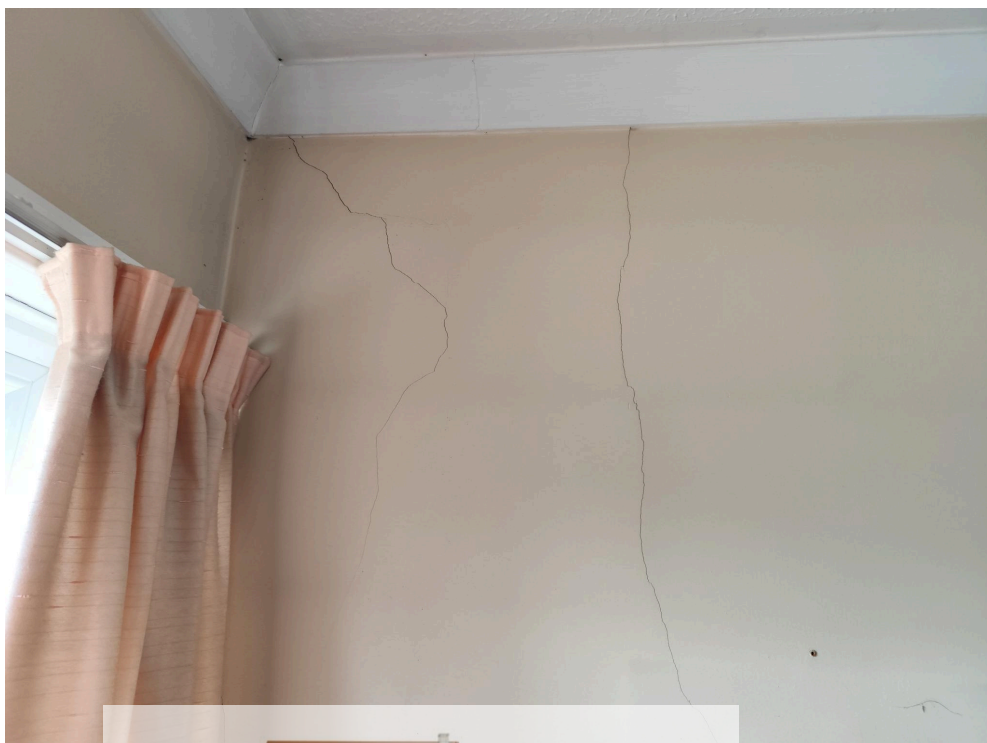
Hairline Wall Crack

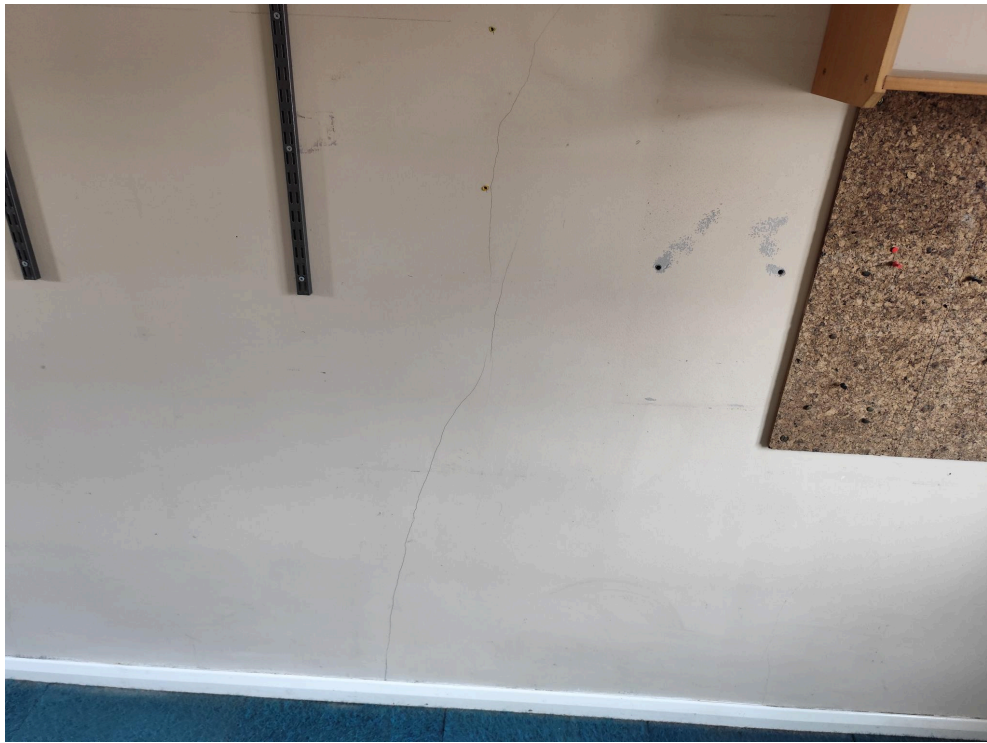
Hairline Wall Crack

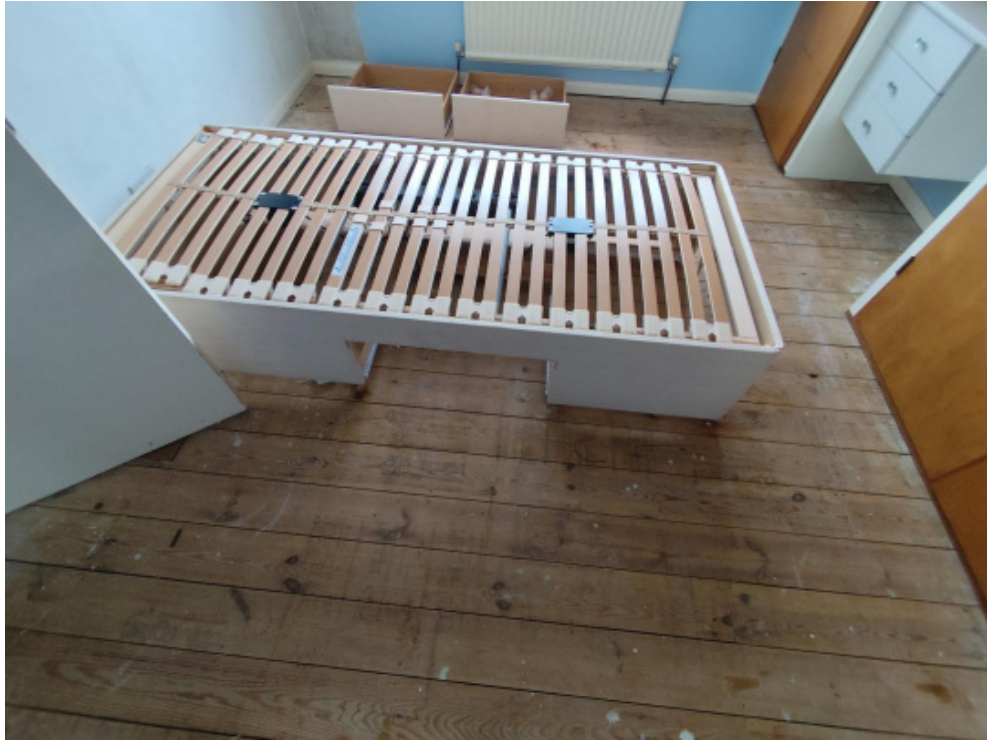
bedroom floor

5.4 Floors	Condition rating	2
Construction & Type	The floors to the ground floor are of solid construction and of suspended tongued and grooved timber decking on timber floor joists to the first floors.		
Nature of inspection and Limitations	Floors were examined for sagging, hogging, unevenness, undue springiness and other signs of failure or damage. Fixed floor coverings in most rooms prevented direct examination of the floor surfaces. Tiled floors were examined for any cracked tiles which could indicate movement of the structure.		
Condition	<p>Ground Floors Solid ground floors to older properties do not all incorporate satisfactory provision for damp proofing, which would help prevent rising dampness from affecting the floors. This is not uncommon in properties of this age, type and character. Rising dampness can cause rot(fungal decay)in timbers with direct contact with the floors, eg. door frames and skirting boards. Additionally, older concrete floors do not typically incorporate any insulation.</p> <p>Upper Floors Floors in properties of this age can be uneven and out of level. This type of unevenness is commonly found in properties of this age and type and usually reflects the settlement of the structure that has occurred over a long period of time. Where the significant movement of the floor structures has occurred recently, it is most commonly identified by separation of the joints of the skirting's, door frames and other associated finishes, exposure of undecorated areas where one surface has moved away from another, and unusual amounts of spring in the floor surfaces. No undue levels of movement were noted at the time of the survey.</p> <p>Isolated boards are slightly squeaky, due to being nailed rather than screwed in place. The timber floor construction is prone to misalignment or slight deflection over time, and this is not usually of significance. During the survey, I didn't observe any undue levels of movement.</p>

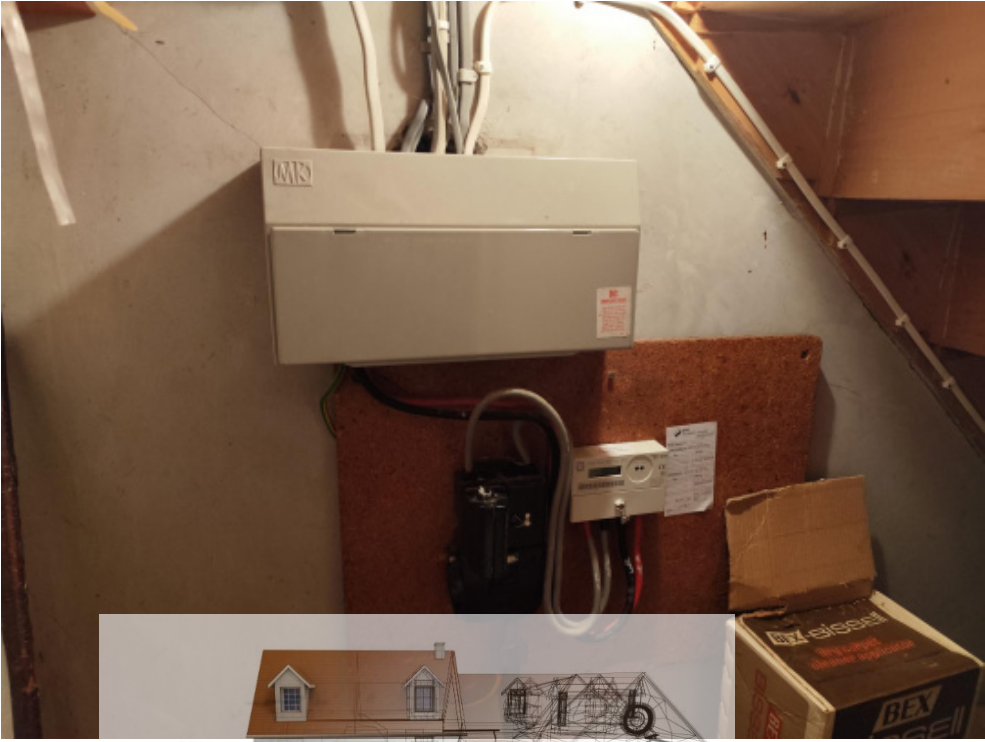
<p>Electric Meter and Consumer Unit</p>

6.1 Electricity	Condition rating	HS
Construction & Type	<p>There is an underground electrical supply and the meter and consumer unit [fuse box] are located in the cupboard under the stairs.</p> <p>The consumer unit is a modern unit with MCB's (miniature circuit breakers) and also an RCD (Residual Current device).</p>		
Nature of inspection and Limitations	<p>The installation was inspected visually to the extent sufficient to form an overall opinion of the type of installation, the materials used, its apparent age, its visible condition and the need for further investigations. No testing of the installations or appliances was carried out other than operation in normal everyday use.</p>		
Condition	<p>In general, the electrical circuits seen are in fair condition. PVC cabling was observed at the property and the socket faceplates and switch plates are of suitable modern quality. However in some rooms, there is an insufficient number of sockets for modern living standards, this means a level of new circuitry or rewiring may be required.</p> <p>Some services will be obscured by furniture and other objects at the time of the survey. Upon occupation, it is strongly advisable to visually check all socket outlets and switch points for any broken housings or loose fascias. Any damage seen should be repaired accordingly.</p> <p>The NICEIC recommends that electrical installations are subjected to an Electrical Installation Condition Report (EICR) by a suitably qualified engineer at least every 10 years.</p>

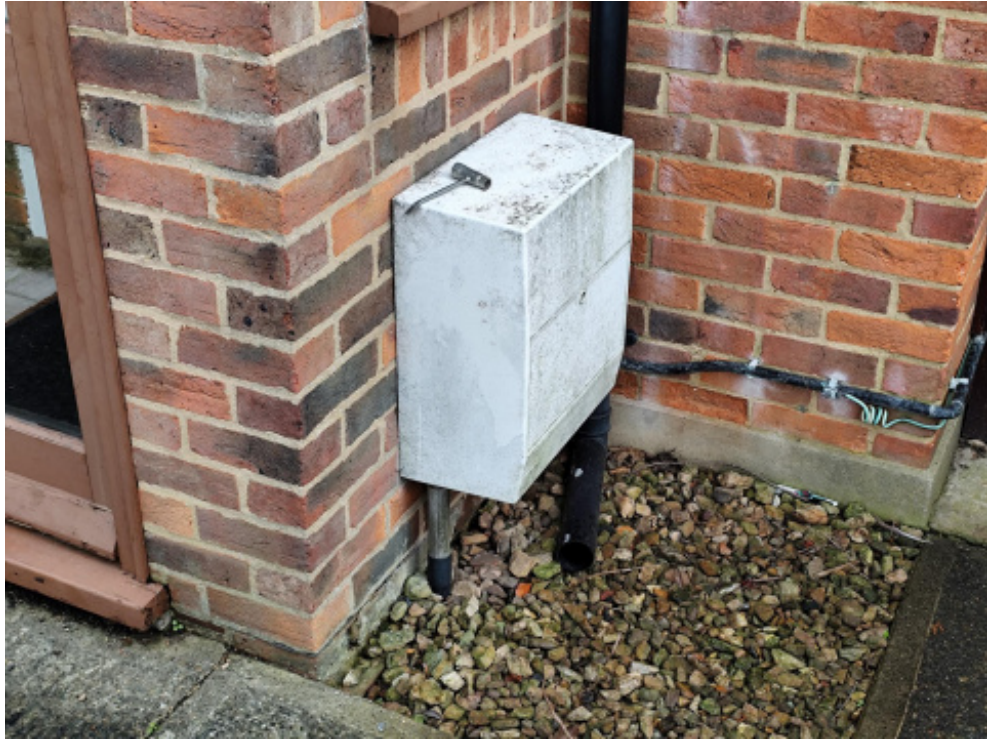
Gas Meter

6.2 Gas / Oil	Condition rating	HS
Construction & Type	There is a mains gas supply and the meter and valve are located in an external cabinet to the front of the property.		
Nature of inspection and Limitations	The system was inspected for any obvious signs of leakage and damage to the supply pipes where visible.		
Condition	<p>No significant defects were noted but see health and safety advice below.</p> <p>Advice: Gas Safe recommends that all gas appliances and boilers are inspected and serviced according to manufacturers' guidance, but at least once a year. At the time of the survey, no documentation was seen to verify that an inspection or servicing has been carried out within the last 12 months but the vendor advised that the boiler is on an annual service schedule. From a health and safety perspective, it is recommended that you validate any available certification, or commission an inspection and servicing of the gas installation and ALL appliances (including the boiler, gas fire and gas hob) prior to occupation of the property.</p> <p>As the property is empty, parts of the system may not have been in use for a while. These observations increase the risk of any hidden issues. Further advice should be obtained as to the operational safety of the complete system.</p> <p>The Gas Safe website called 'Buying a new home', it states: 'Homebuyers cannot always be sure when the gas appliances in their new home were last safety checked and serviced. Ask your vendor for an annual gas safety record that shows that a Gas Safe registered engineer has checked the gas appliances. If your vendor cannot supply an up to date annual gas safety record, you should get a Gas Safe registered engineer to check the gas appliances before you move in. This check should include the gas boiler, oven, and hob and gas fire. The registered engineer will give the vendor a gas safety record, which they should hand over to you before you move in. Better Gas Safe than sorry. Poorly maintained or badly fitted gas appliances can put you at risk from gas leaks, explosions, fires and carbon monoxide poisoning.'</p> <p>'Safety check' - As a minimum, this must check:</p> <ul style="list-style-type: none"> •Appliances are positioned in the right place; •Any flue or chimney serving appliances are safe and installed correctly; •There is a good supply of combustion air (ventilation) to appliances; •The appliances are on the right setting and are burning correctly; the appliances are operating correctly and are safe to use.

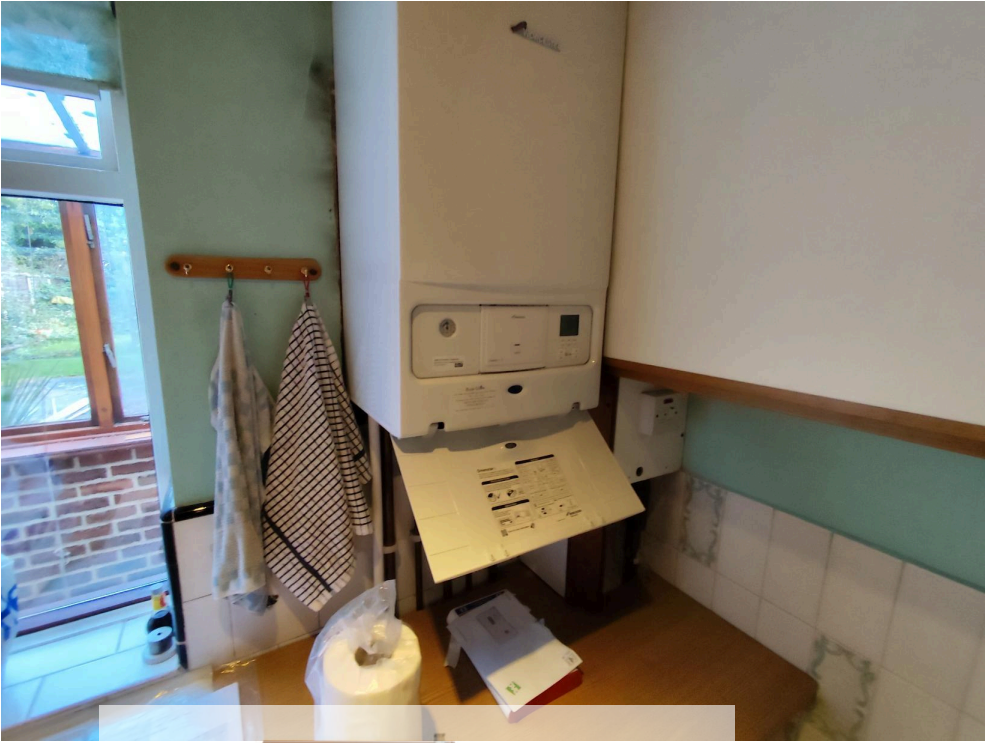
Condition	<p>It is recommended that you establish the service history of the gas boiler before you purchase, as only regular servicing by a competent person can ensure efficiency and safety. If these questions suggest that previous maintenance has been poor, you should instruct a competent person to check the whole system before you purchase.</p>

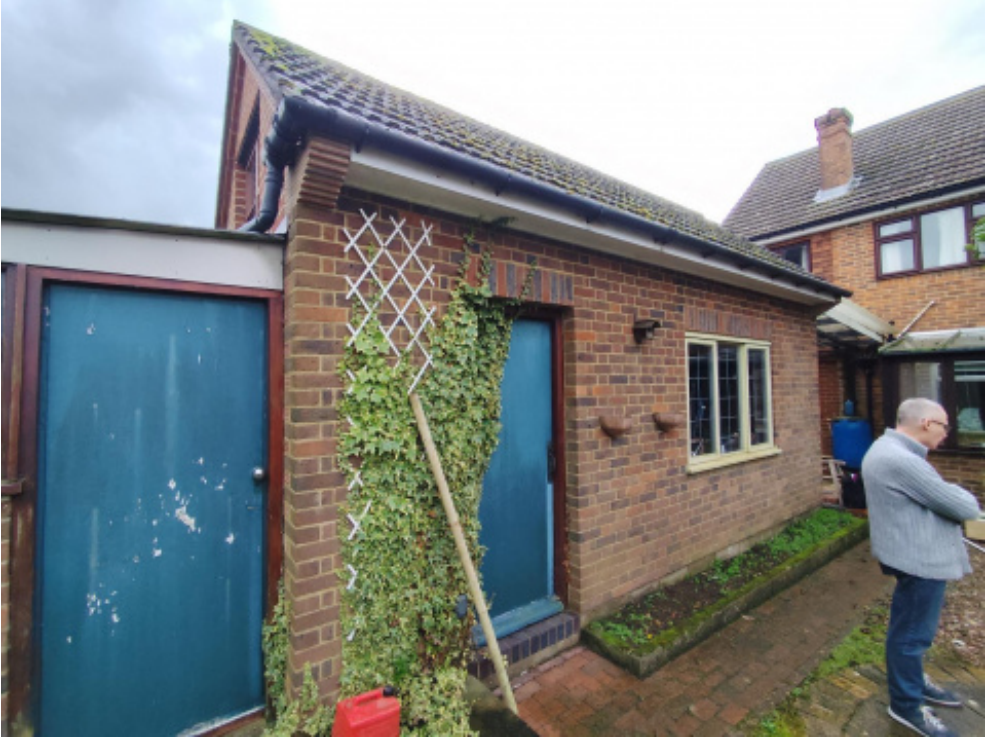
<p style="text-align: center;">Garage</p>

7.1 Garaging	Condition rating	2
Construction & Type	<p>One garage is integral to the main property and the external walls are brick and the floor is concrete. The ceiling is covered in material that may contain asbestos.</p> <p>The main garage is detached from the main property and the external walls are brick and the floor is concrete. The roof is pitched and is covered in tiles. The rainwater goods are plastic and the main doors are timber.</p>		
Nature of inspection and Limitations	<p>Both were examined from ground level for signs of bowing or leaning of walls, damaged brickwork, render and pointing, internal defects, and the condition of the roof both internally and externally.</p>		
Condition	<p>Normal maintenance is required.</p>

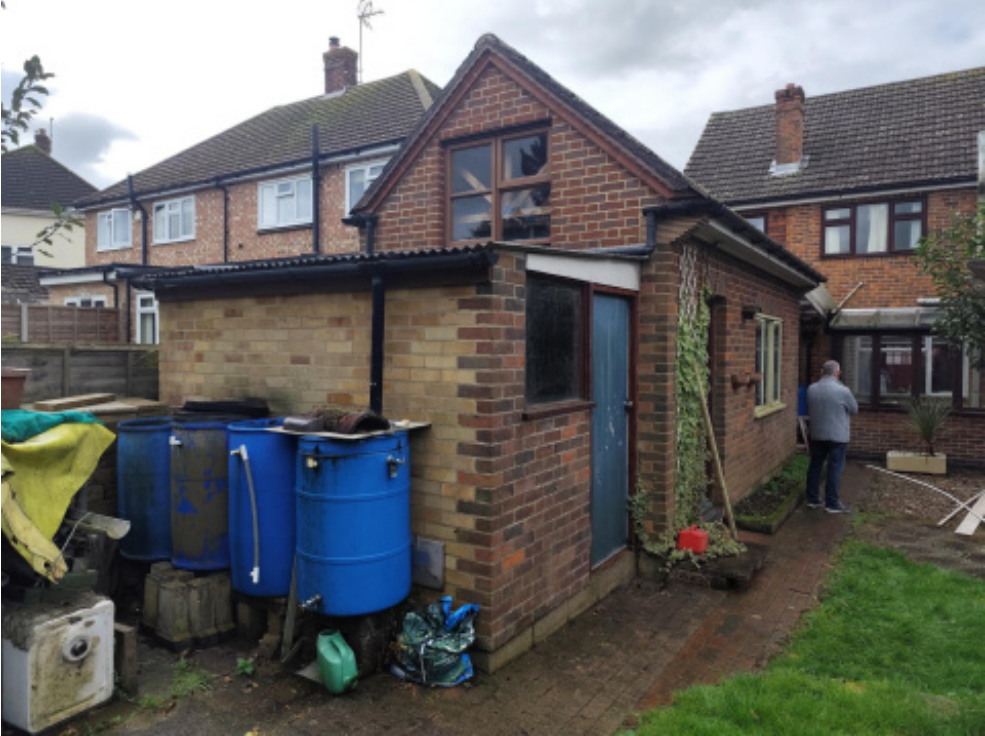
<p>Brick outbuilding</p>

7.2 Outbuildings and Sheds	Condition rating	2
Construction & Type	<p>There are two brick built outbuildings, one of which is attached to the main garage and whose roof is covered in corrugated material that may contain asbestos.</p> <p>The garden shed is timber.</p>		
Nature of inspection and Limitations	NA		
Condition	The shed is in a poor condition and the two brick outbuildings are in a reasonable condition for their age.

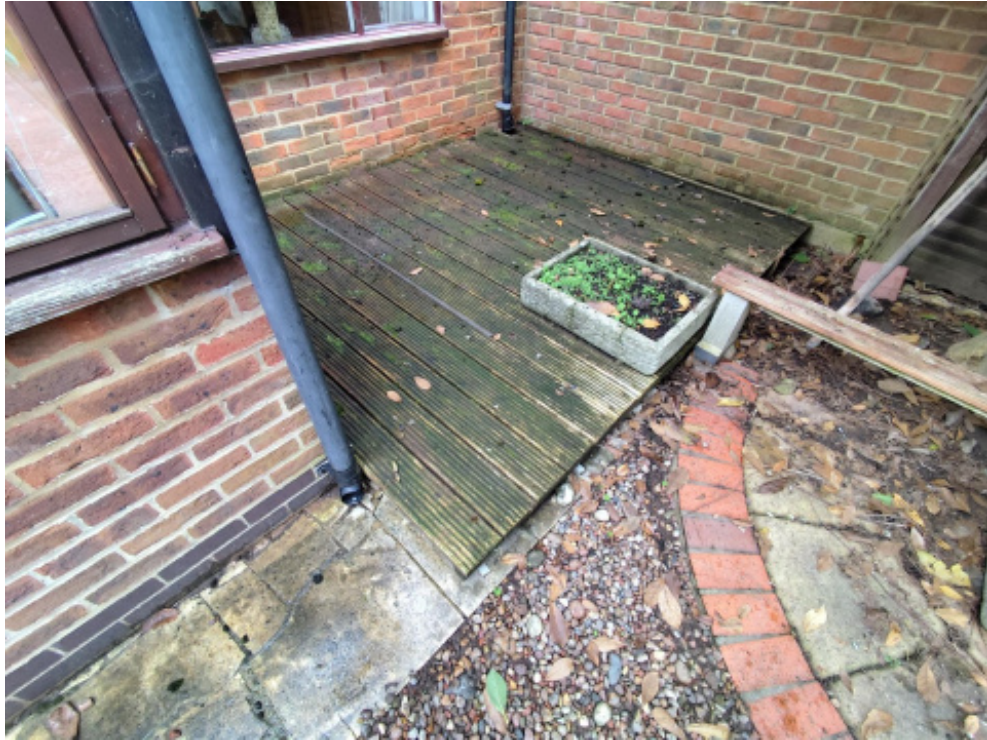
Timber decking in rear garden

7.3 Grounds	Condition rating	2
Construction & Type	<p>There are gardens to the front and rear which are mostly lawned with surrounding borders.</p> <p>The rear boundaries are defined by timber panel fencing and the front by brick walls.</p>		
Nature of inspection and Limitations	<p>The grounds around the house were inspected for any indications of land failure or movement, or other defects that would have a material effect on the property as a whole.</p> <p>It should be noted that a full and detailed inspection for the presence of Japanese Knotweed cannot be carried out especially where the gardens are well stocked or have been recently cut and maintained. No evidence of the presence of Japanese Knotweed was seen during my inspection but you are advised to seek further advice if you believe it may be present or are aware that it is present in premises nearby.</p>		
Condition	<p>There is no evidence of any damage from flooding.</p> <p>The gardens are presented in fair condition.</p> <p>The boundary fences are presented in fair condition but some minor repairs are required to some panels. (There is no indication of the ownership of any of the boundary walls, fences or hedges, and in most cases, this is not specified by the deeds or title documents. Often, responsibility for boundaries to one side or another has been assumed by subsequent owners. You should ask your conveyancer to advise on any indications of ownership included in the title documents.)</p> <p>Normal Maintenance is Required.</p>
