Domestic Property Surveys

BUILDING SURVEY REPORT

SURVEY DATE 30 Oct 2024

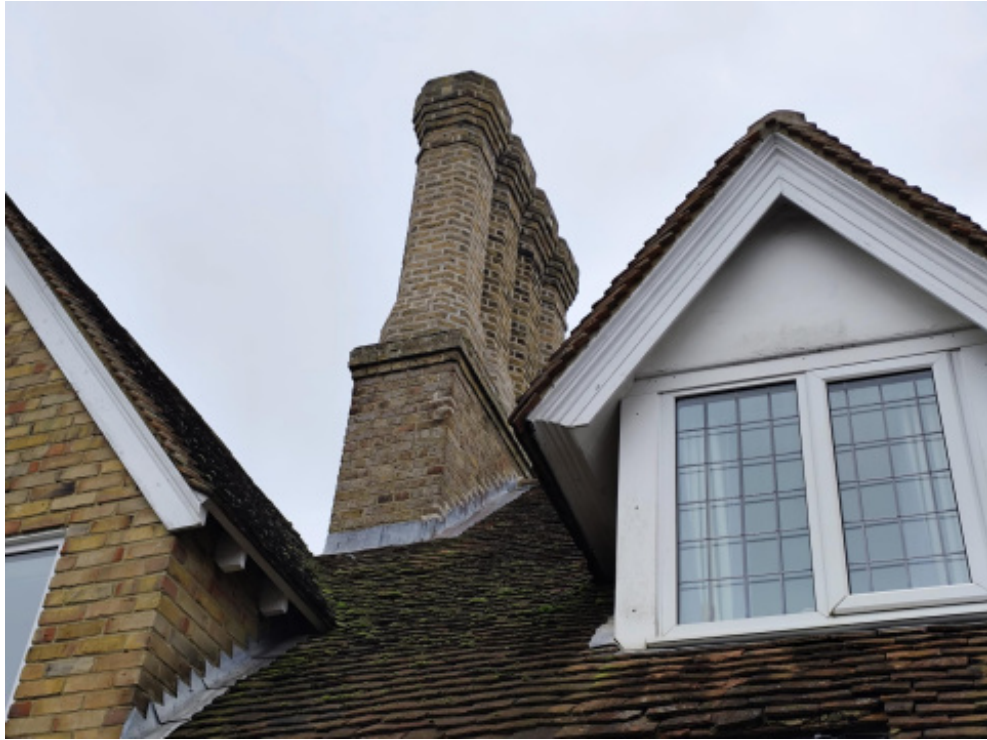
Rear stacks

Condition	<p>The visible brickwork is in a reasonable condition for its age and there is no evidence of significant spalling or sulphate attack. The mortar that joins the bricks together is in a fair condition and the lead flashing, which is located between the base of each stack and the slope of the roof, helping to prevent water penetration, is in a satisfactory condition.</p> <p>As the moisture levels of the upper section of the chimney breast directly below the rear stack in the rear bedroom are extremely high, it is reasonable to deduce that water is entering the stack and permeating to the area below and not being prevented from doing so by effective barriers.</p> <p>Repair works at high level would generally cost more than works at low level, as specialist access equipment such as scaffolds, long ladders or hydraulic platforms may be required. Other parts of the property close to the affected area may also have to be disturbed to carry out the repair, which would also increase the cost.</p>

Action Required	<p>The chimney stack should be regularly monitored for any indications of damage, instability or other defects. Missing, loose or defective mortar should be re-pointed as necessary.</p> <p>Further investigation will be required to determine the exact cause of water ingress into the chimney breast directly below the stacks and quotes should be obtained for providing satisfactory remedies.</p>

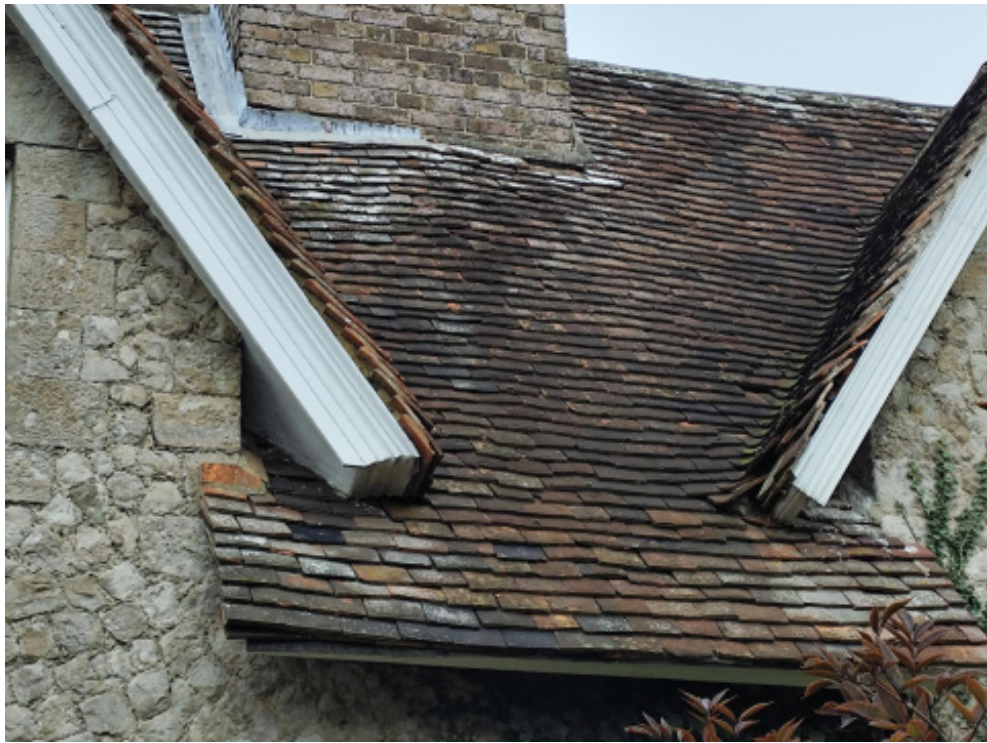
Front roof

4.2 Roof Coverings	Condition rating	2
Construction & Type	The main roof is of pitched design and is covered with Kent clay peg tiles and finished with half round ridge tiles bedded in mortar.		
Nature of inspection and Limitations	The roof pitches were examined from ground level for possible defects including sagging, collapse, broken/missing/damaged tiles, holes, and other evidence of failure.		
Condition	<p>The roof and ridge tiles are in a fair condition for their age but ongoing slippage seems to be in progress which is not unusual for a roof of this type.</p> <p>It is likely that the fixings for the tiles in the original roof are not as secure as they once were.</p> <p>The verges are in reasonable order and there is no evidence of movement.</p> <p>Weathering and discolouration are both consistent with age and degree of exposure.</p>		
Action Required	<p>Any slipped, missing or broken tiles on the roof pitches should be repaired and replaced. You should carry out a thorough visual inspection at least once a year, ideally in the Spring to identify and repair any damage that could have been caused by winter weather. Any missing mortar at the verges and beneath any hip or ridge tiles should be replaced. Any moss or other accumulated plant matter should be cleared.</p> <p>It is important to understand that a roof of this type, age and structure will require constant maintenance and repair and that an adequate budget should be set aside to address this.</p>

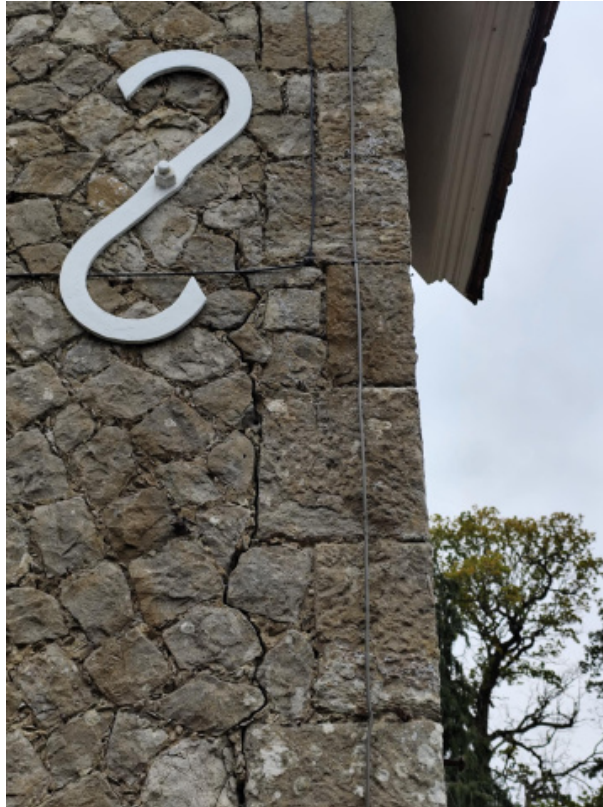
Crack to wall

<p>Action Required</p>	<p>Walls should be examined regularly to inspect for changes in the nature of any cracking or other defects that may become apparent.</p> <p>The keystones in both arches should be repositioned and the cracks to the front walls should be monitored and the cracks filled to prevent any water ingress.</p>

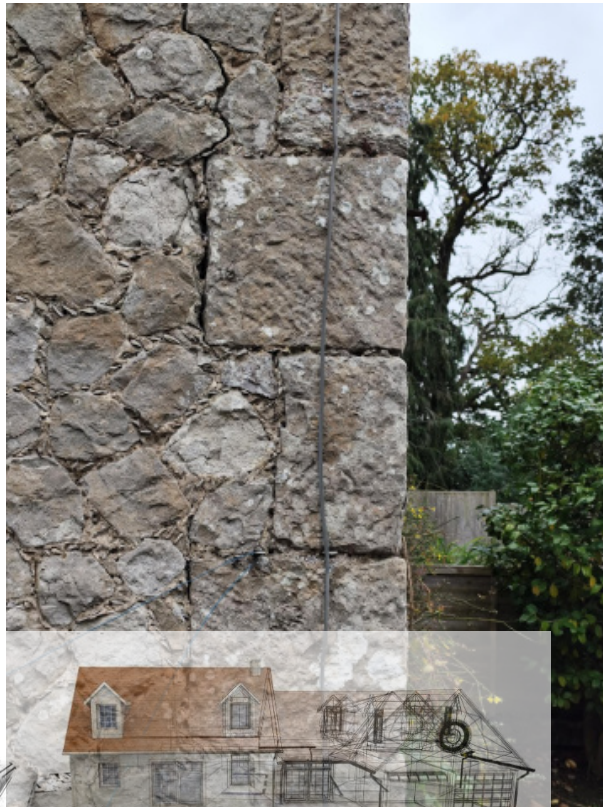
Crack to wall

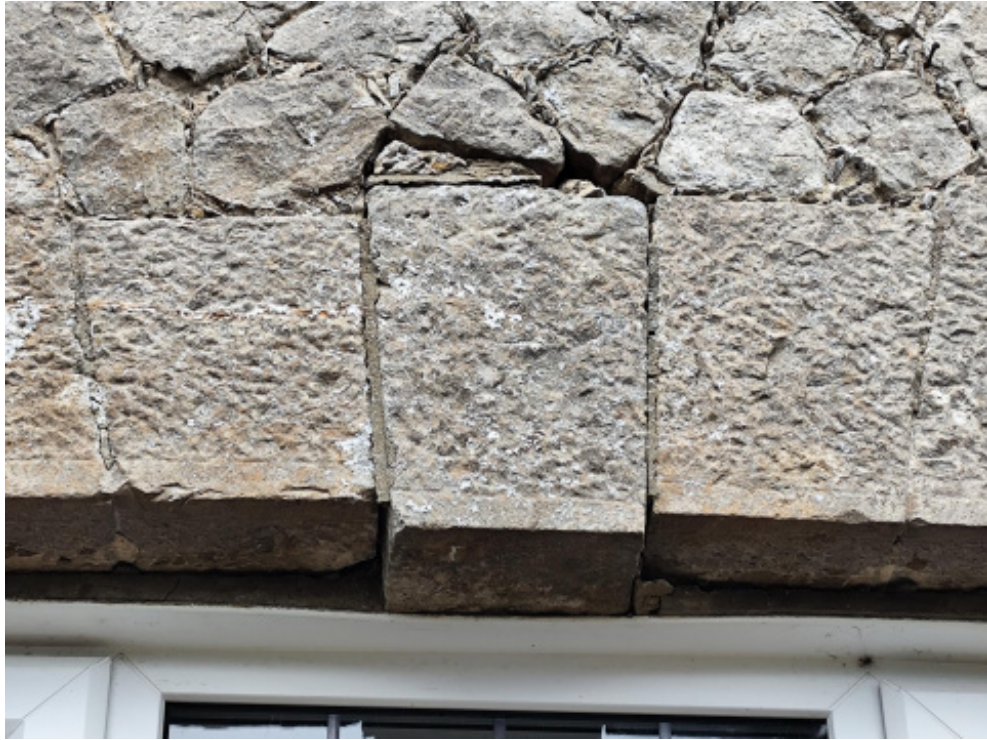
<p>Structural Summary</p>	<p>Two keystones that form the lintel above the front door and the front lounge window have slipped and there are cracks in the stonework at the front corner of the external wall.</p>
<p>Health & Safety related matters</p>	<p>There is no evidence of recent inspection of the electrical or heating systems, but certification may be available. See also 6.1 and 6.2.</p>

Slipped keystone at front

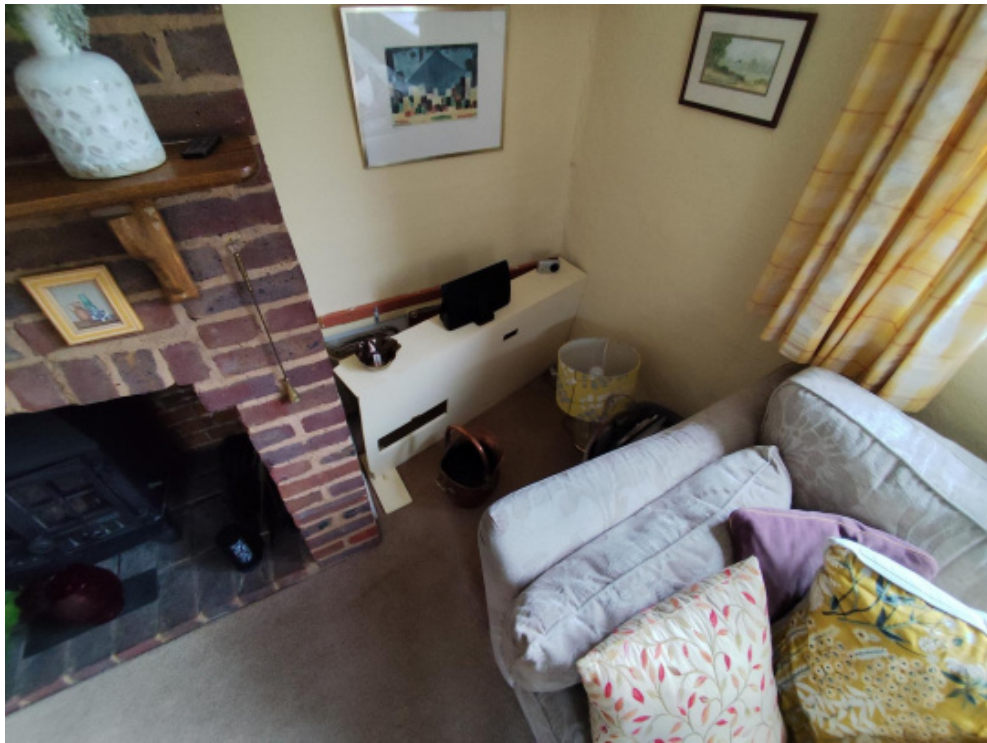
Damp wall

Action Required	<p>Remedies for the high level of moisture in some of the internal walls on the ground floor should be sought and quotes from local reputable damp proofing specialists obtained.</p> <p>Normal maintenance is required, including filling and redecorating cracks as necessary.</p>

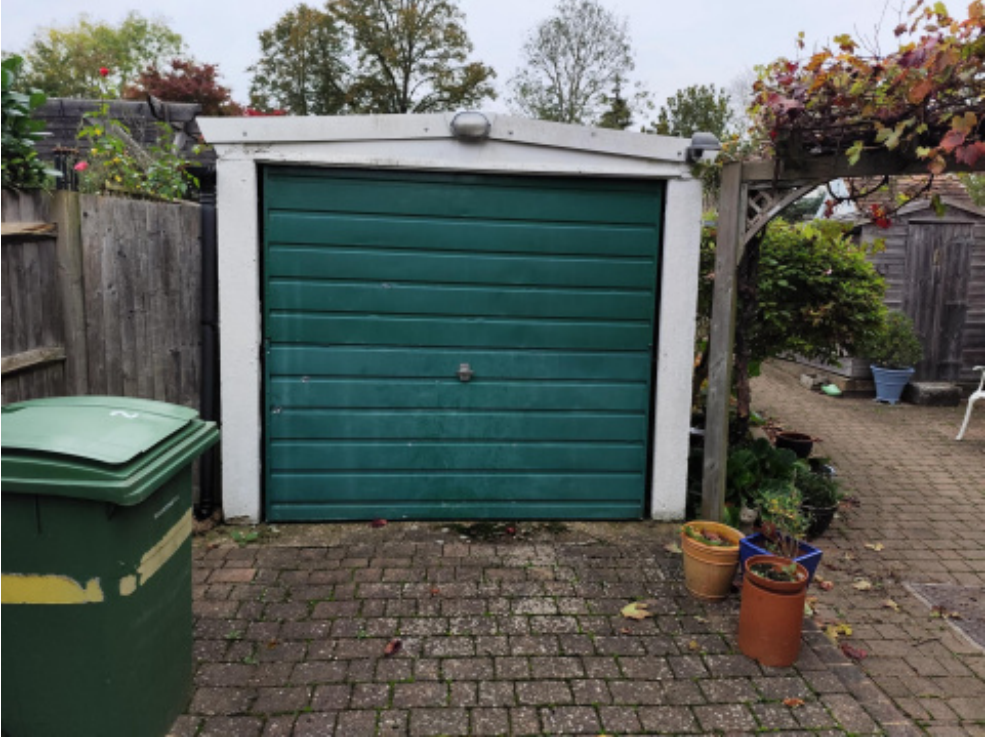
<p style="text-align: center;">Garage</p>

7.1 Garaging	Condition rating	2
Construction & Type	The garage is of block and concrete panel construction with a flat roof covered in a corrugated material that probably contains asbestos material. The garage is accessed via a vehicle metal up-and-over door to the front.		
Nature of inspection and Limitations	It was examined from ground level for signs of bowing or leaning of walls, damaged brickwork, render and pointing, internal defects, and the condition of the roof both internally and externally.		
Condition	<p>There is no evidence of moisture penetration and/or rot</p> <p>There is no cracking to the external walls</p>		
Action Required	Normal maintenance, including regular retreatment of the walls, is required.
