Domestic Property Surveys

# BUILDING SURVEY REPORT

SURVEY DATE 1 Mar 2024

REF 35785

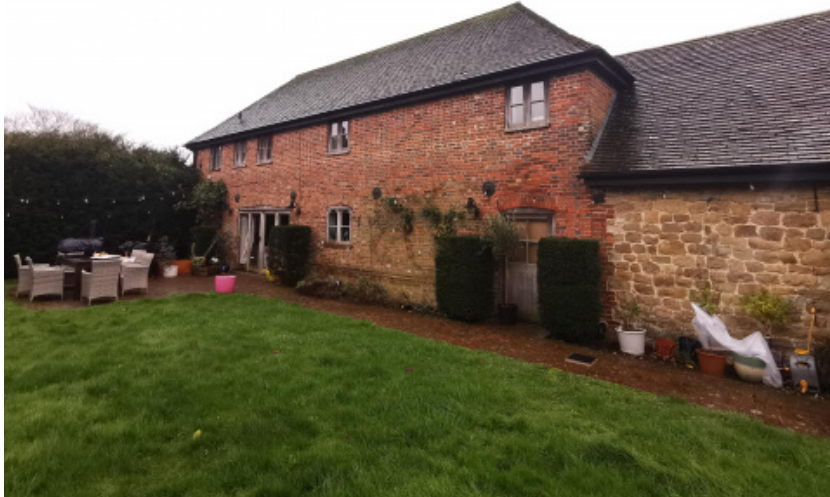
Front Elevation

- 1) There is a vertical crack that runs the length of the front external wall above and below the window in the reception room. This crack looks quite new.

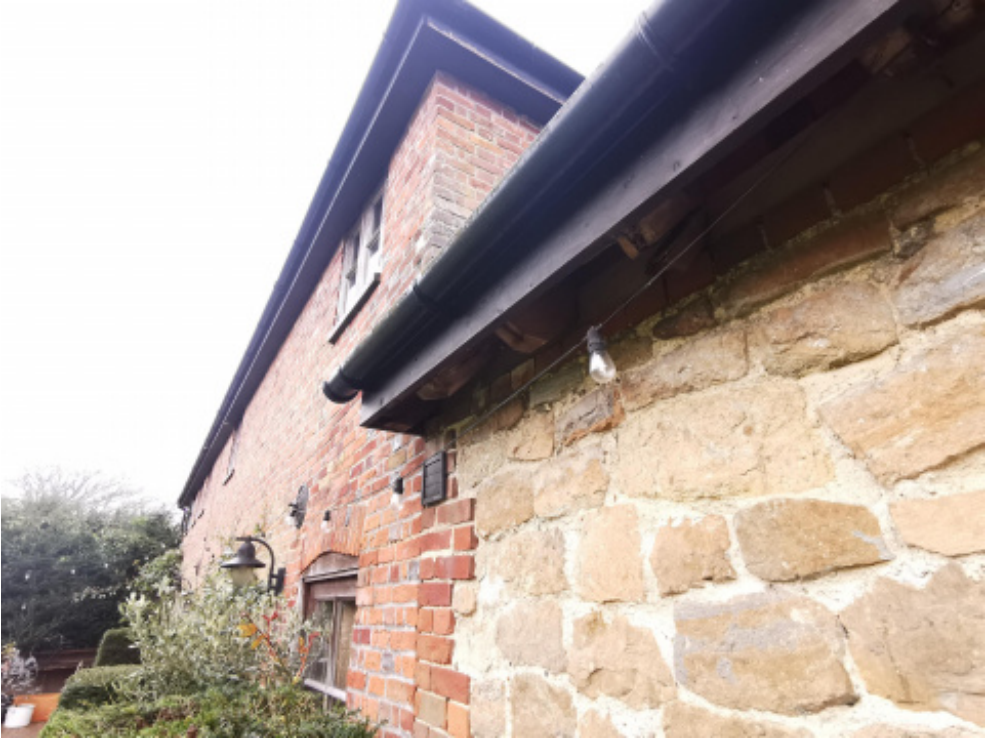
<p>Timber Soffit and Fascia Boards</p> </div>

<b>4.6 External Joinery and Finishes</b>	<b>Condition rating</b>	<b>1</b>
<b>Construction &amp; Type</b>	This includes such items as woodwork at the roof edges, fascias, and trim panels.		
<b>Nature of inspection and Limitations</b>	<p>Soffits are the horizontal timbers joining the fascia boards to the house walls. Fascia boards are the vertical timbers to which the gutters are normally fixed. Barge boards are the diagonal boards at the roof edge on the gable end of the house. All such materials were examined from ground level for indications of poor maintenance, rot and other damage.</p> <p>Decorations were examined from ground level with the aid of binoculars from vantage points within the grounds of the property and suitable public areas around. Decorations were examined for signs of wear and tear, peeling paint, lack of oiling where applicable and other defects.</p>		
<b>Condition</b>	All of these timbers are reasonably sound, have been maintained and appear to be in a serviceable condition. There is no immediate requirement for any redecoration.

<b>Action Required</b>	Regular maintenance will be required .		
	<div style="text-align: center;">

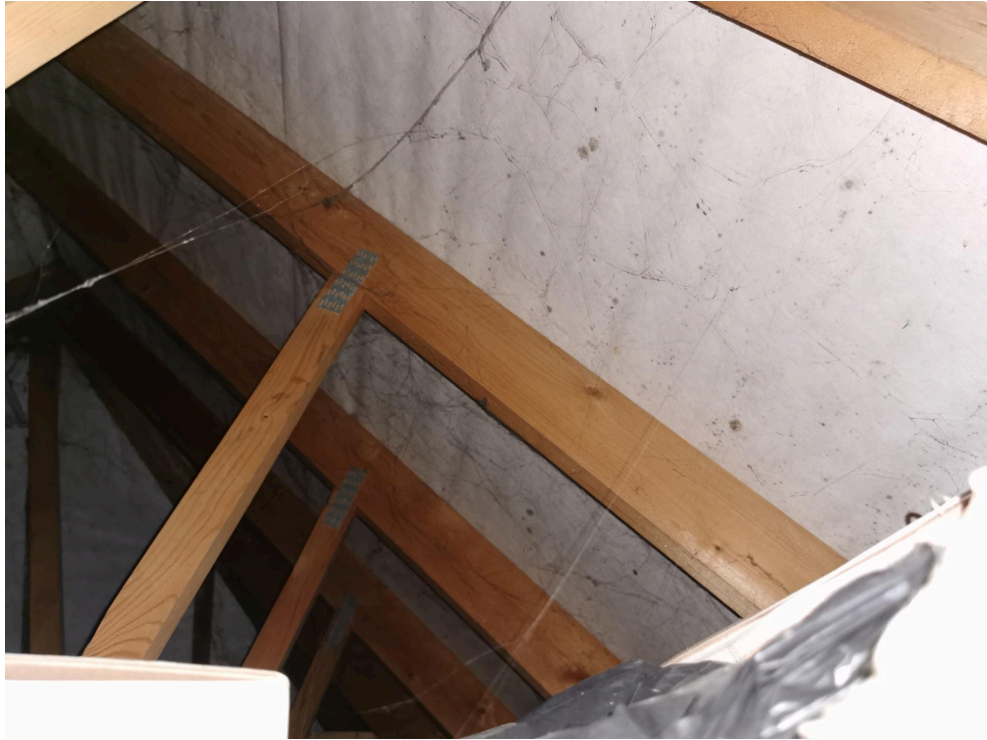
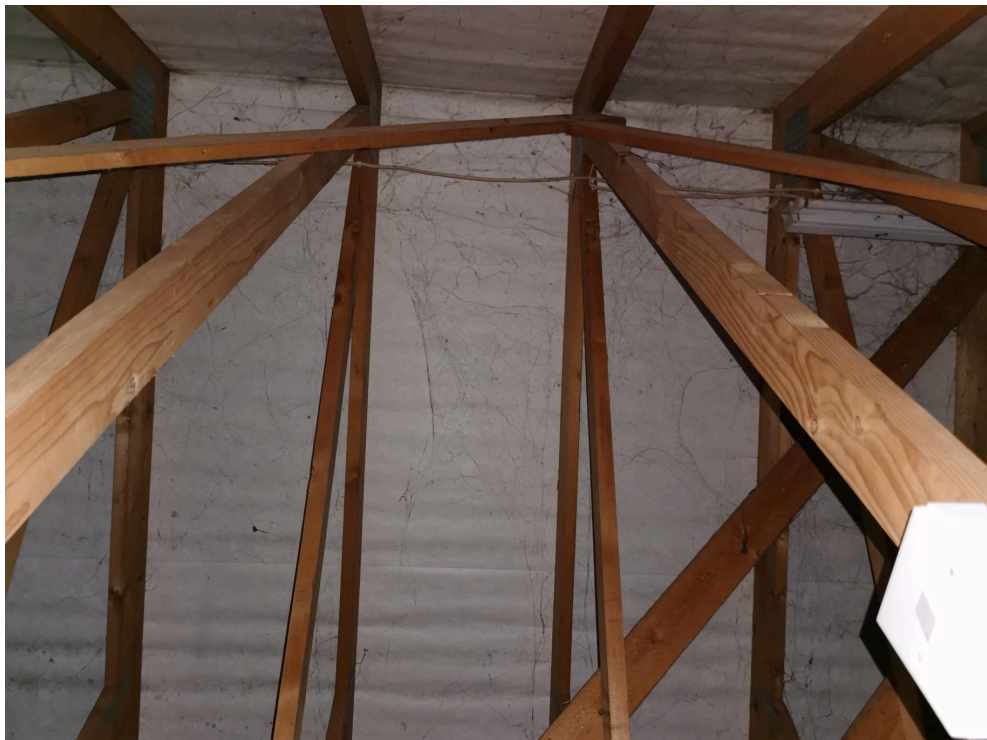
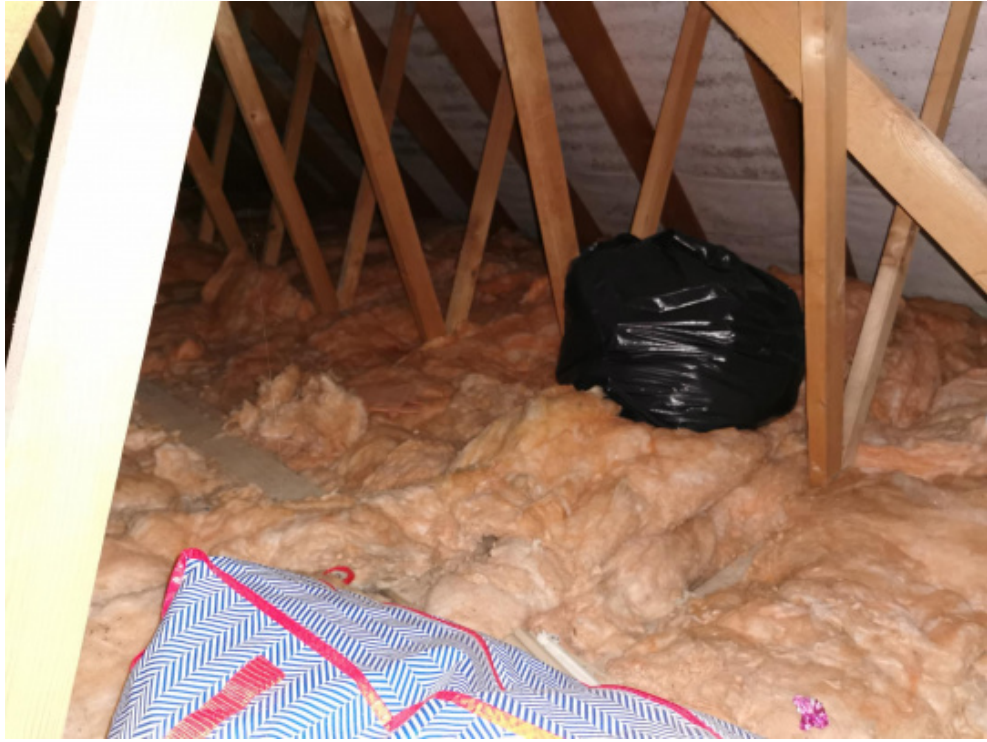
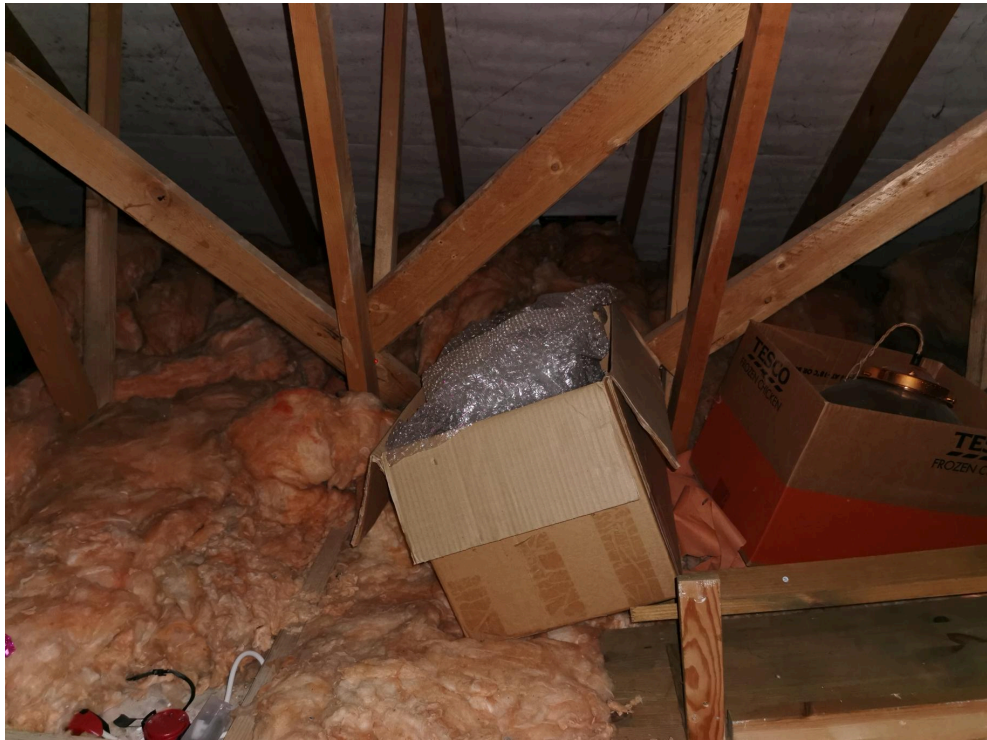
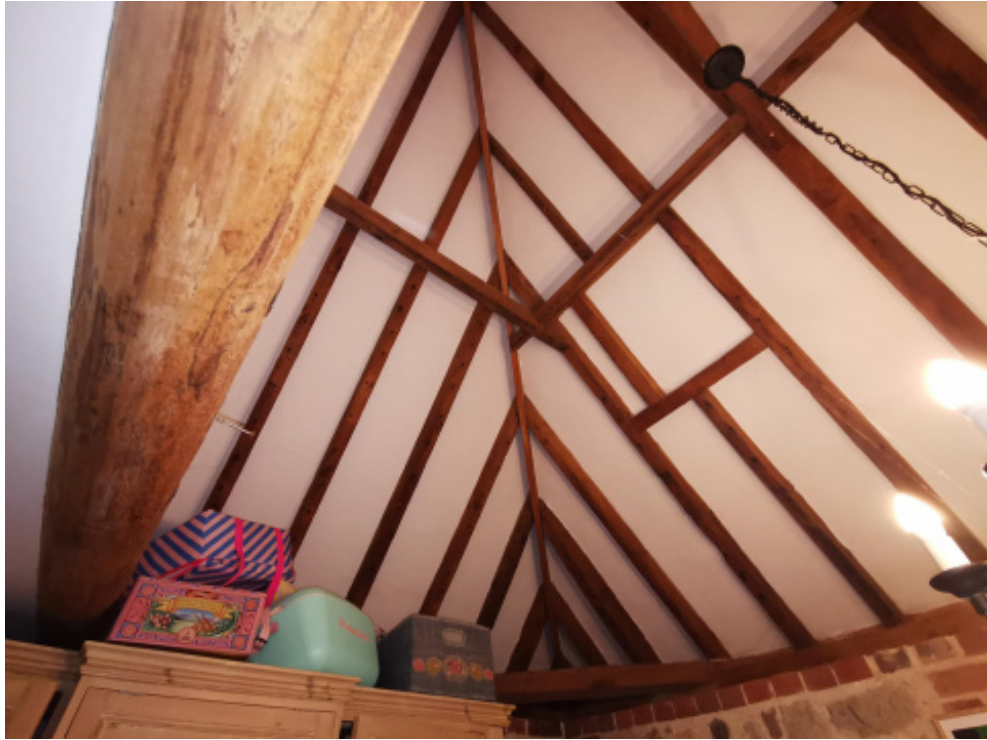
Roof Structure

<b>Condition</b>	<p>The roof structure is in a good condition with reasonable quality timbers throughout. The rafters, purlins and strut timbers are complete with no evidence of any undue stress or cracking.</p> <p>The roof space is laid with 200-300mm of wool type insulation at joist level. This close to the current recommendation of 270mm for maximum energy efficiency. It does, however, limit movement and storage within the roof space as any supporting joists are concealed.</p>		
<b>Action Required</b>	<p>Regularly monitor timbers for evidence of wood-boring insects and other such infestations.</p> <p>Care should be taken when moving around, or storing heavy objects, in the roof space. The spaces between the floor joists will not support a person's weight or that of large boxes etc. Where heavy items are to be stored it is important to distribute the weight evenly using fixed boards. Additional structural support may be required if you plan to store large quantities of heavy items in the roof space.</p>

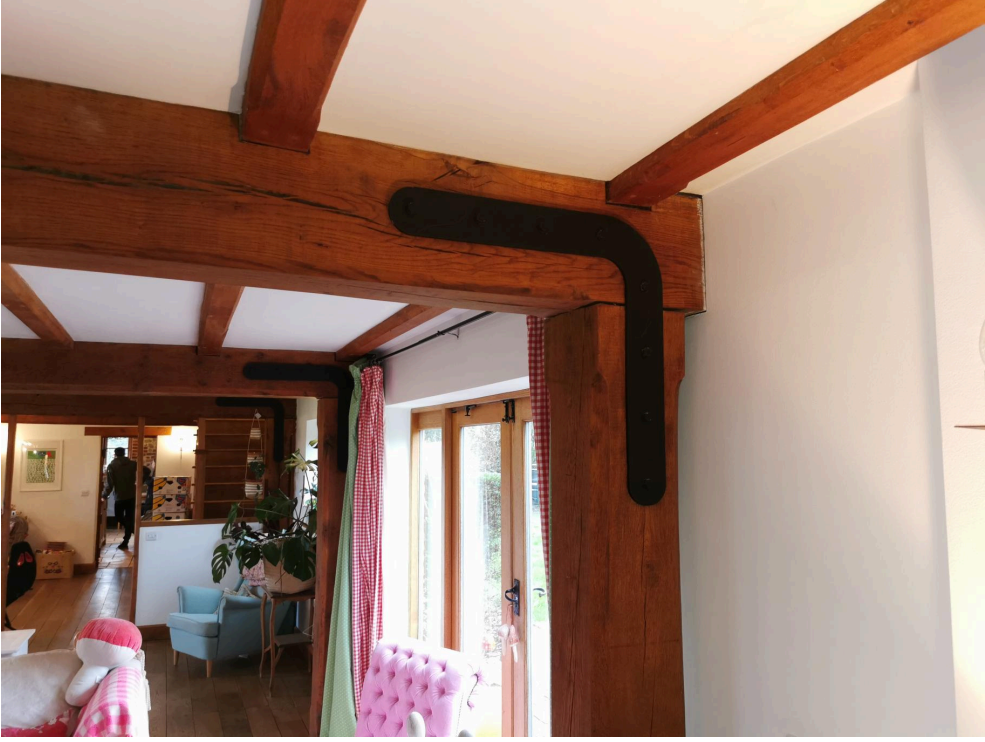
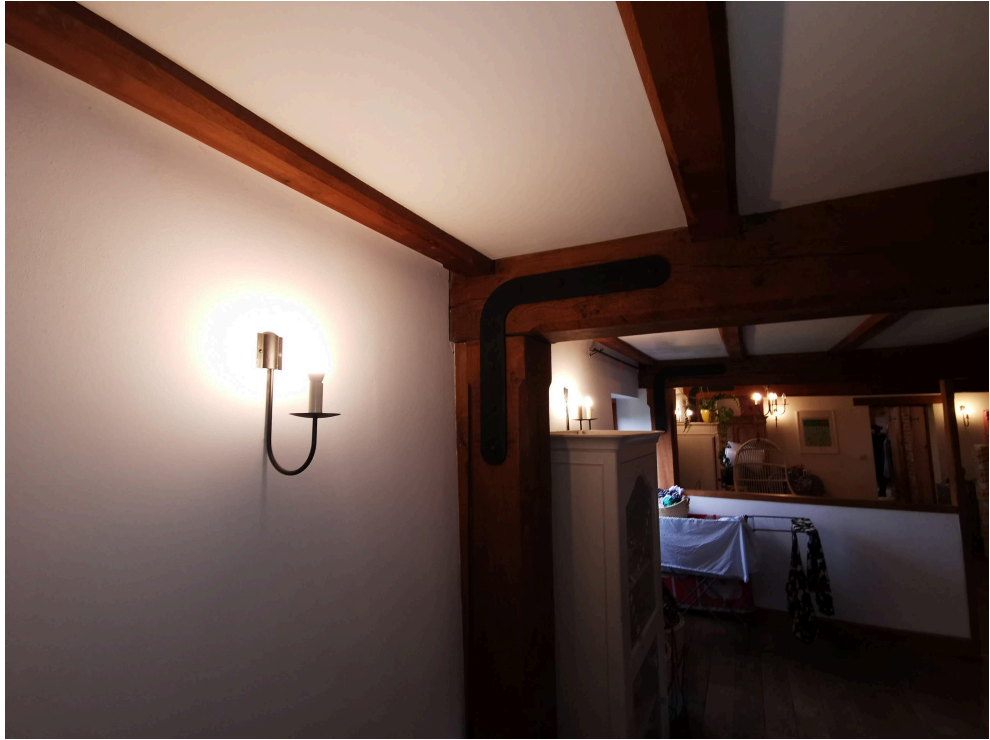
<p>Timber frame</p> </div>

<b>5.3 Walls</b>	<b>Condition rating</b>	<b>1</b>
<b>Construction &amp; Type</b>	<p>The internal walls and partitions are of mixed solid and lightweight construction with a mainly plastered finish.</p> <p>The inside faces of some of the external walls have been dry-lined.</p>		
<b>Nature of inspection and Limitations</b>	<p>Internal walls were examined for indications of bowing, leaning, cracking and undue surface failure/damage. Moisture meter readings were taken at regular intervals where access and wall construction/location permitted.</p>		
<b>Condition</b>	<p>All internal walls and ceilings have been maintained and all surfaces are presented in a fair decorative order. Some general unevenness was noted. This is due to normal disturbance of the surface by decorations, minor repairs and fittings having been attached in the past.</p> <p>There was no dampness recorded to the internal walls on the day of inspection . Condensation levels noted were within normal limits expected for a property of this type and age.</p> <p>No significant defects were noted during my inspection and the internal walls were found to be structurally sound.</p>

<b>Action Required</b>	<p>Normal maintenance is required, including filling and redecorating cracks as necessary.</p>		
	<div style="text-align: center;">

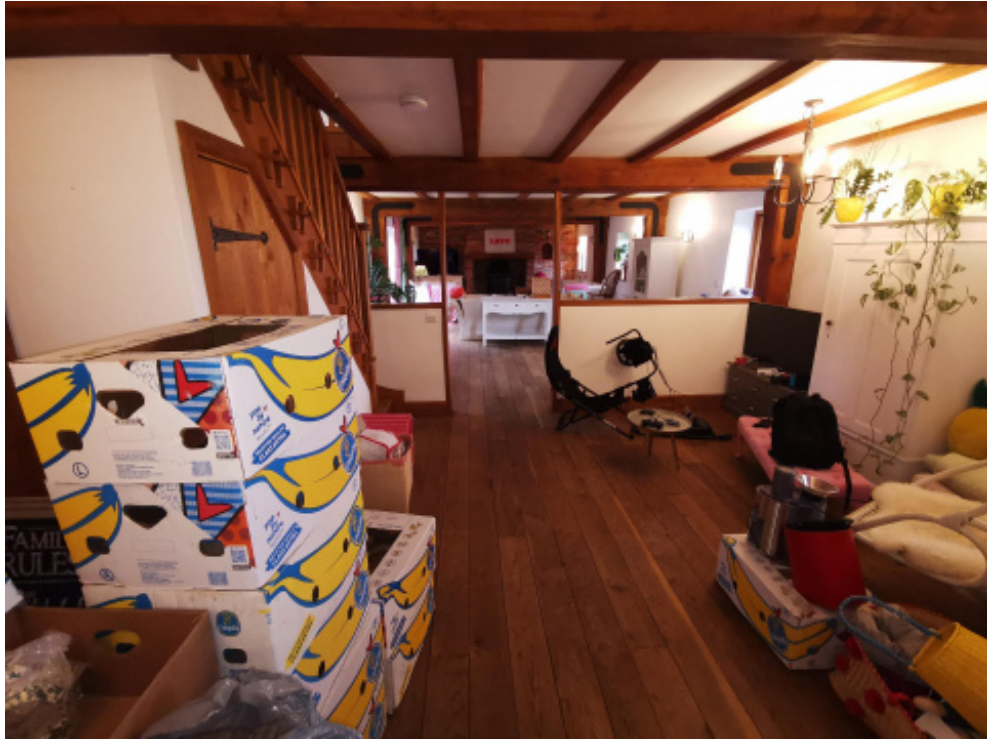
<b>5.4 Floors</b>	<b>Condition rating</b>	<b>1</b>
<b>Construction &amp; Type</b>	The floors to the ground floor are of solid beam and block construction and of suspended tongued and grooved timber decking on timber floor joists to the first floors.		
<b>Nature of inspection and Limitations</b>	Floors were examined for sagging, hogging, unevenness, undue springiness and other signs of failure or damage. Fixed floor coverings in most rooms prevented direct examination of the floor surfaces. Tiled floors were examined for any cracked tiles which could indicate movement of the structure.		
<b>Condition</b>	<p>The ground floor was of solid beam and block construction and the upper floor consisted of timber floorboards laid on timber floor joists supported in the main by the inner leaf of the external walls.</p> <p><b>Upper Floors</b>                      Floors in properties of this age can be uneven and out of level. This type of unevenness is commonly found in properties of this age and type and usually reflects settlement of the structure that has occurred over a long period of time. Where significant movement of the floor structures has occurred recently, it is most commonly identified by separation of the joints of the skirting's, door frames and other associated finishes, exposure of undecorated areas where one surface has moved away from another, and unusual amounts of spring in the floor surfaces. No undue levels of movement were noted at the time of the survey.</p> <p>Isolated boards are slightly squeaky, due to being nailed rather than screwed in place. Timber floor construction is prone to misalignment or slight deflection over time, and this is not usually of significance. During the survey I didn't observe any undue levels of movement.</p>

<b>Action Required</b>	Floors should be monitored for any changes that occur in their level or springiness.

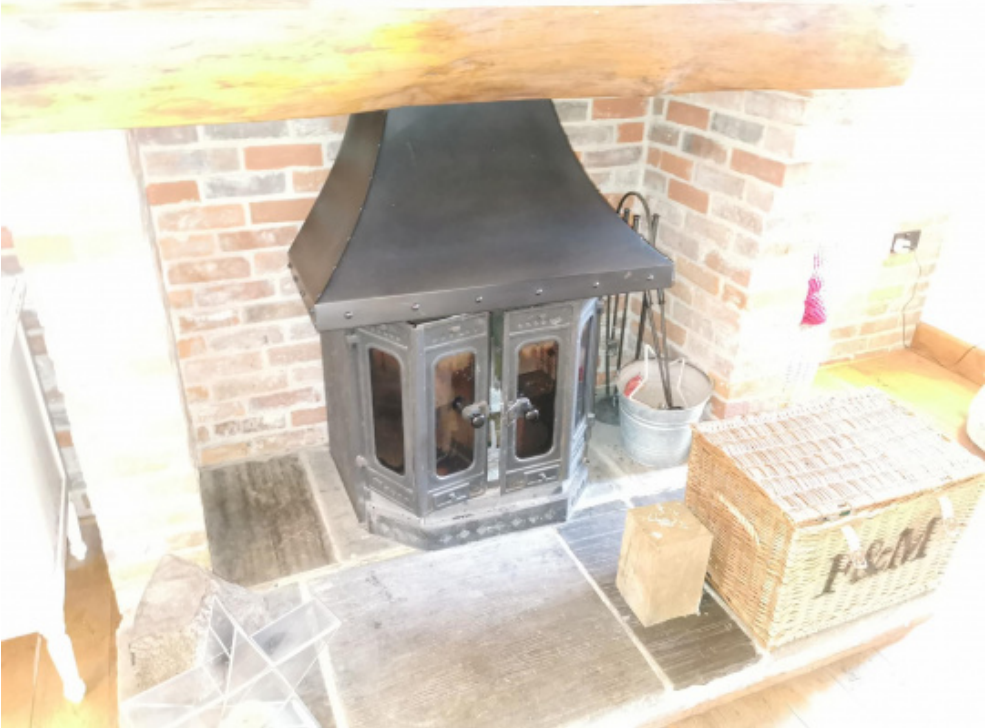
<p>Wood burning stove</p> </div>

<b>5.5 Chimney Breasts, Fireplaces and Flues</b>	<b>Condition rating</b>	<b>1</b>
<b>Construction &amp; Type</b>	The chimney breasts are of masonry construction.		
<b>Nature of inspection and Limitations</b>	The chimney breasts were examined for indications of dampness, lack of support, failed lining and other defects. It is not possible to investigate the condition or serviceability of chimney flues for use with fixed or open fires during a survey.  The active fireplaces were not tested during the survey. It is recommended that chimneys are swept and carefully checked before they are used in this way.		
<b>Condition</b>	Satisfactory.		
<b>Action Required</b>	All active flues should be checked by a reputable heating engineer specialising in flues and chimneys, prior to use. Flues should also be swept clean at this time.		
	<div style="text-align: center;">

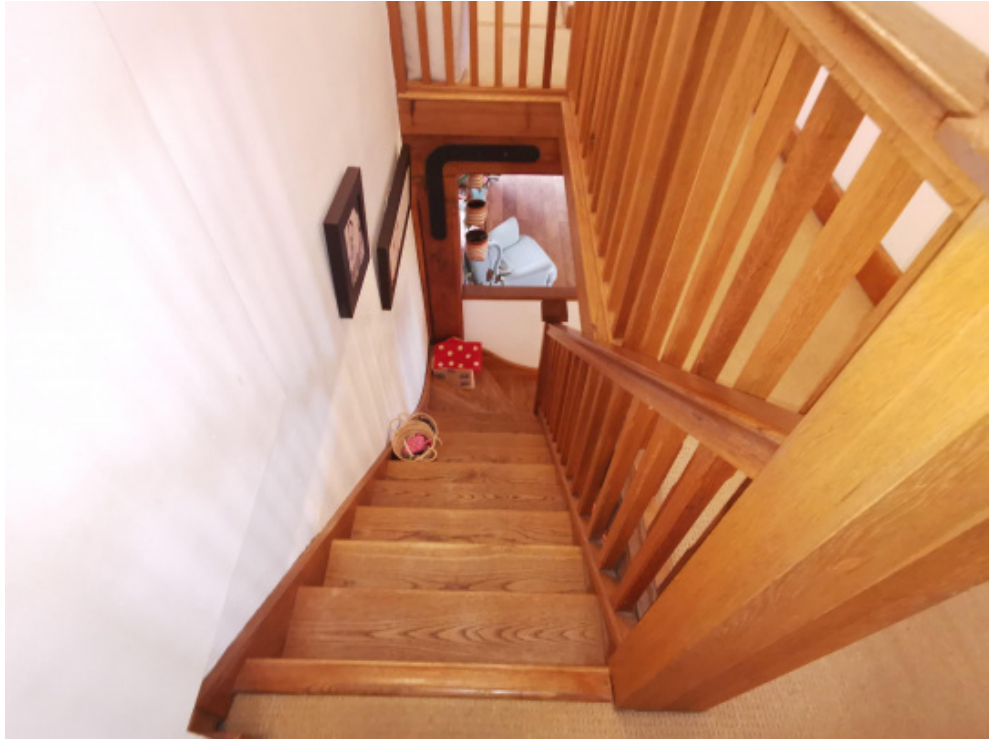
Staircase

<b>5.7 Internal Joinery</b>	<b>Condition rating</b>	<b>1</b>
<b>Construction &amp; Type</b>	The internal woodwork includes such items as: doors, frames, skirting boards, banisters and staircases.		
<b>Nature of inspection and Limitations</b>	<p>The internal doors were checked for normal operation and other woodwork examined for a range of defects.</p> <p>The woodwork was also examined for evidence associated with movement of the structure of the property, woodworm and other infestations, and general condition. Moisture meter readings were taken at regular intervals.</p>		
<b>Condition</b>	<p>As mentioned in 4.4 most properties are subject to slight settling down over the years as sub-soil consolidates and adjusts to changes in ground condition. This will frequently result in limited differential movement, which is often expressed as minor cracking or distortion of window and door openings and is rarely of structural significance. All internal doors were in fair alignment with no undue movement noticed to the frames. All doors operated effectively.</p> <p>Slight misalignment was noted to some of the door frames. As mentioned in 4.4 most properties are subject to slight settling down over the years as sub-soil consolidates and adjusts to changes in ground condition. This will frequently result in limited differential movement, which is often expressed as minor cracking or distortion of window and door openings and is rarely of structural significance.</p> <p>The observed movement is within normal acceptable limits, but you will need to verify that this is aesthetically acceptable to you.</p> <p>No significant defects or damage was noted.</p>

<b>Action Required</b>	Door hinges and locks should be regularly lubricated. Internal timbers should be inspected regularly for evidence of bowing or distortion, woodworm and other defects.

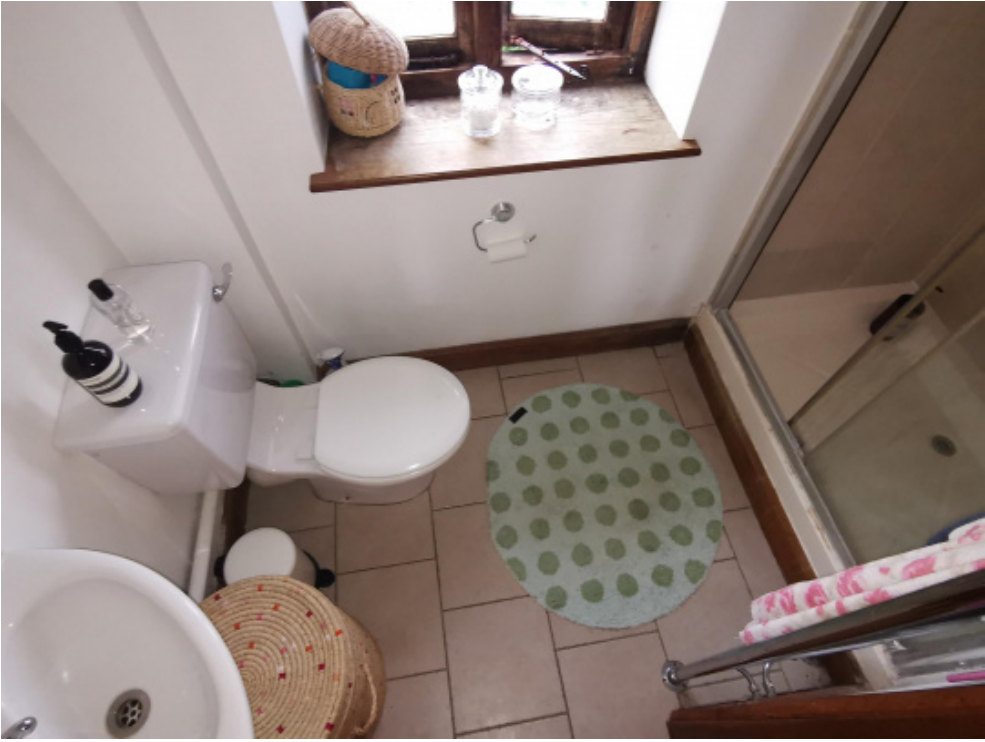
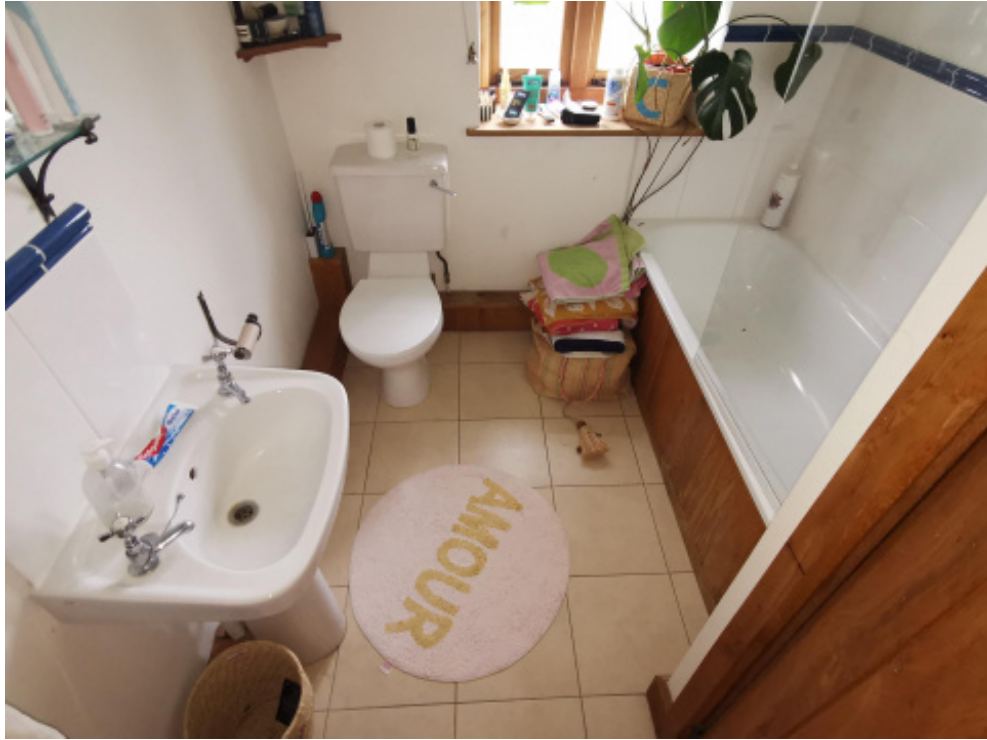
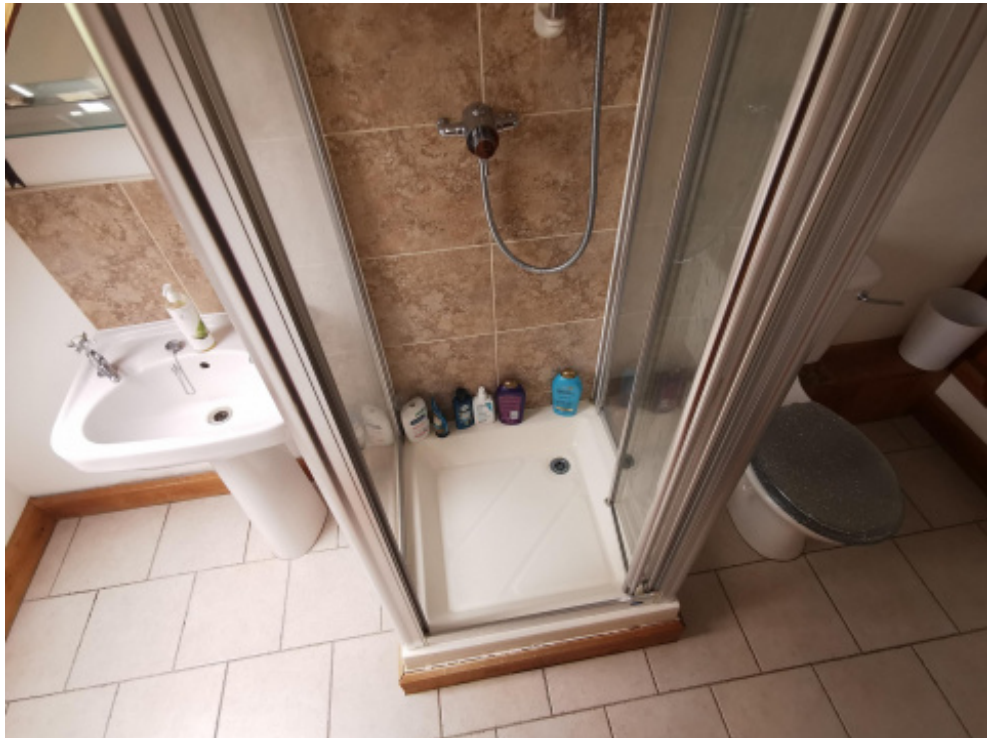
<b>5.8 Bathroom and Sanitary Fittings</b>	<b>Condition rating</b>	<b>1</b>
<b>Construction &amp; Type</b>	<p>The main bathroom is on the first floor and comprises a bath, WC and basin. There are two ensuite shower rooms to the top floor with a shower cubicle and shower, basin and WC.</p> <p>There is also a ground floor cloakroom with a WC and basin. All fittings are modern.</p>		
<b>Nature of inspection and Limitations</b>	<p>The fittings were checked for signs of damage, cracks, leaking pipes and other common defects. Sealant joints were checked for undue wear and failure. All fittings were checked for normal operation – WC's were all flushed at least twice to ensure correct drainage and flow.</p>		
<b>Condition</b>	<p>There is mechanical ventilation to all first-floor bathrooms/ensuites. These should be kept operational as they reduce the levels of moisture within the rooms and hence the risk of condensation to the walls and ceiling structures.</p> <p>No significant defects are noted, all fittings operated as required with water pressures at fair levels.</p>

<b>Action Required</b>	<p>Regular maintenance of all seals to the bath and shower to prevent water displacement.</p>		
	<div style="text-align: center;">

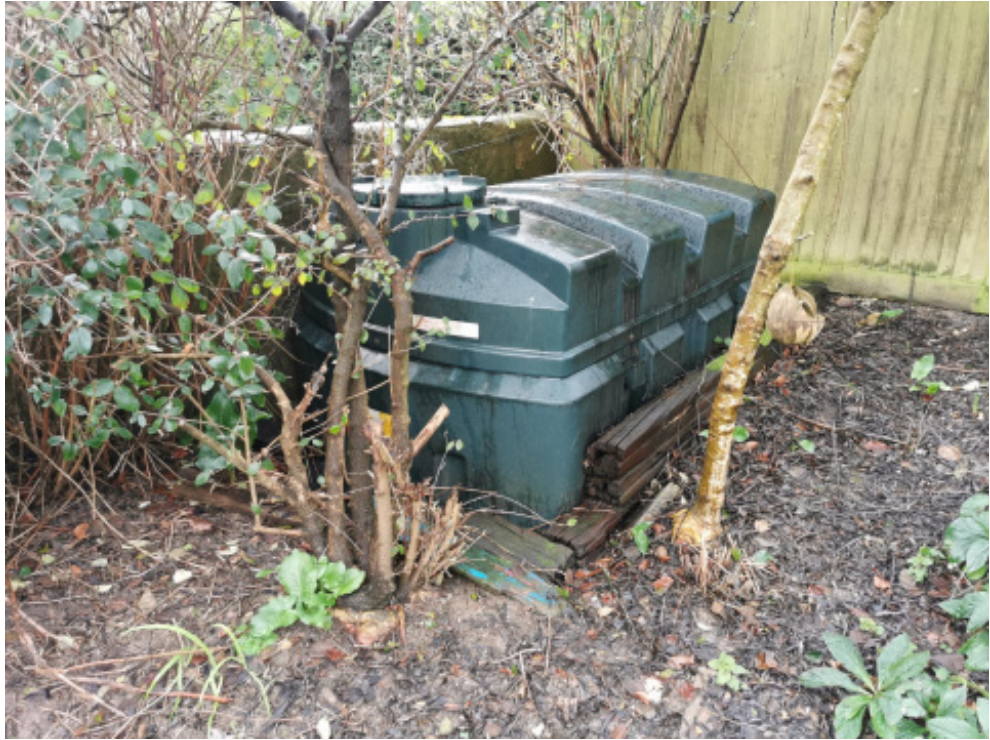
oil tank

<b>6.2 Gas / Oil</b>	Condition rating	<b>HS</b>
<b>Construction &amp; Type</b>	Oil is supplied to the property from the tank in the front garden.		
<b>Nature of inspection and Limitations</b>	The system was inspected for any obvious signs of leakage and damage to the supply pipes where visible.		
<b>Condition</b>	No significant defects were noted but see health and safety advice below.		
<b>Action Required</b>	<p>Advice: All appliances and boilers should be inspected and serviced according to manufacturers' guidance, but at least once a year. At the time of the survey, no documentation was seen to verify that an inspection or servicing has been carried out within the last 12 months but the vendor advised that the boiler is on an annual service schedule. From a health and safety perspective, it is recommended that you validate any available certification, or commission an inspection and servicing of the oil installation and ALL appliances (including the boiler, fire ) prior to occupation of the property.</p> <p>As the property is currently inhabited the system should be in use. In addition, the boiler is a fairly recent model. These observations reduce the risk of any hidden issues but it is still advisable to seek confirmation as to the operational safety of the complete system.</p> <p>The Gas Safe website called 'Buying a new home', it states:                      'Homebuyers cannot always be sure when the oil appliances in their new home were last safety checked and serviced. Ask your vendor for an annual safety record which shows that a registered engineer has checked the appliances. If your vendor cannot supply an up to date annual safety record, you should get a registered engineer to check the appliances before you move in.</p> <p>'Safety check' - As a minimum, this must check:</p> <ul style="list-style-type: none"> <li>•Appliances are positioned in the right place;</li> <li>•Any flue or chimney serving appliances are safe and installed correctly;</li> <li>•There is a good supply of combustion air (ventilation) to appliances;</li> <li>•The appliances are on the right setting and are burning correctly; the appliances are operating correctly and are safe to use.</li> </ul>

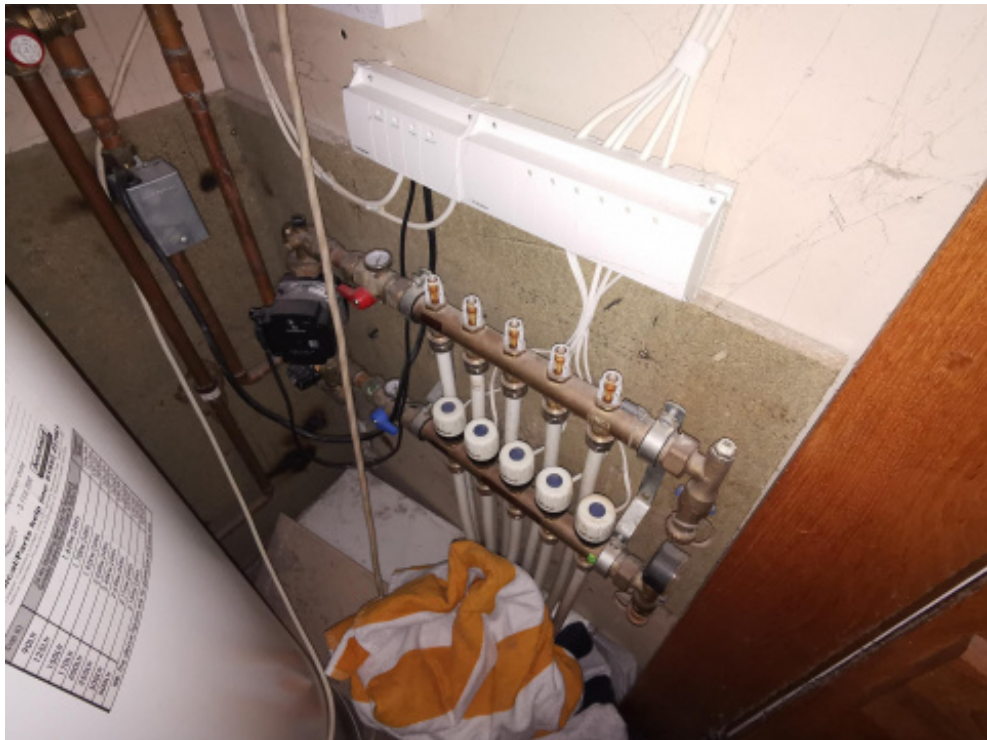
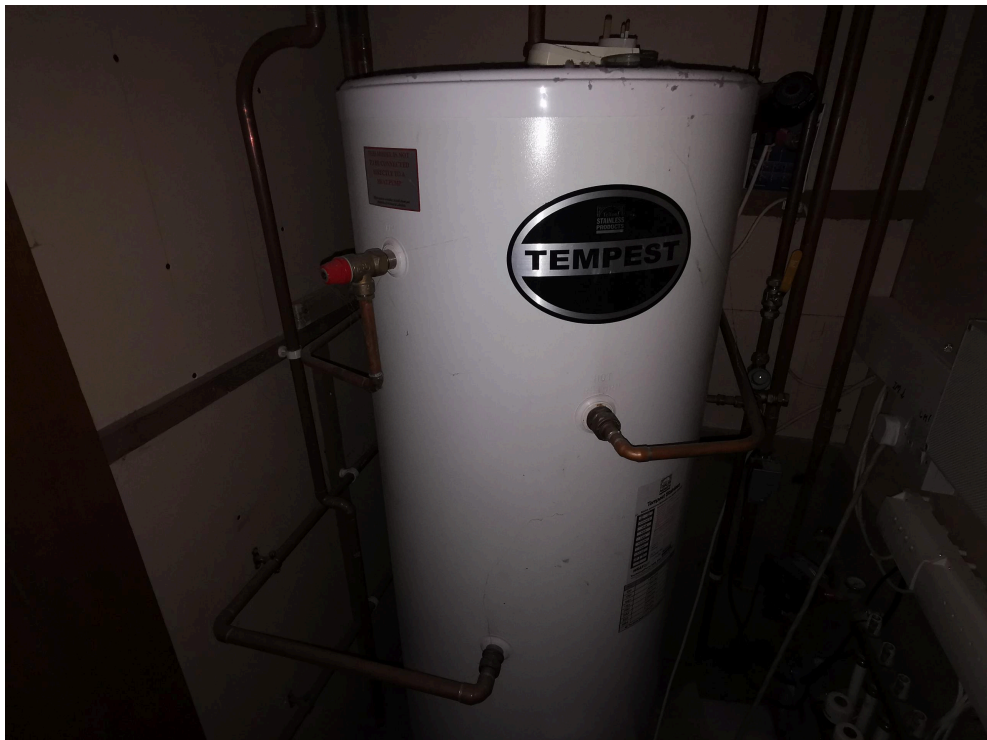
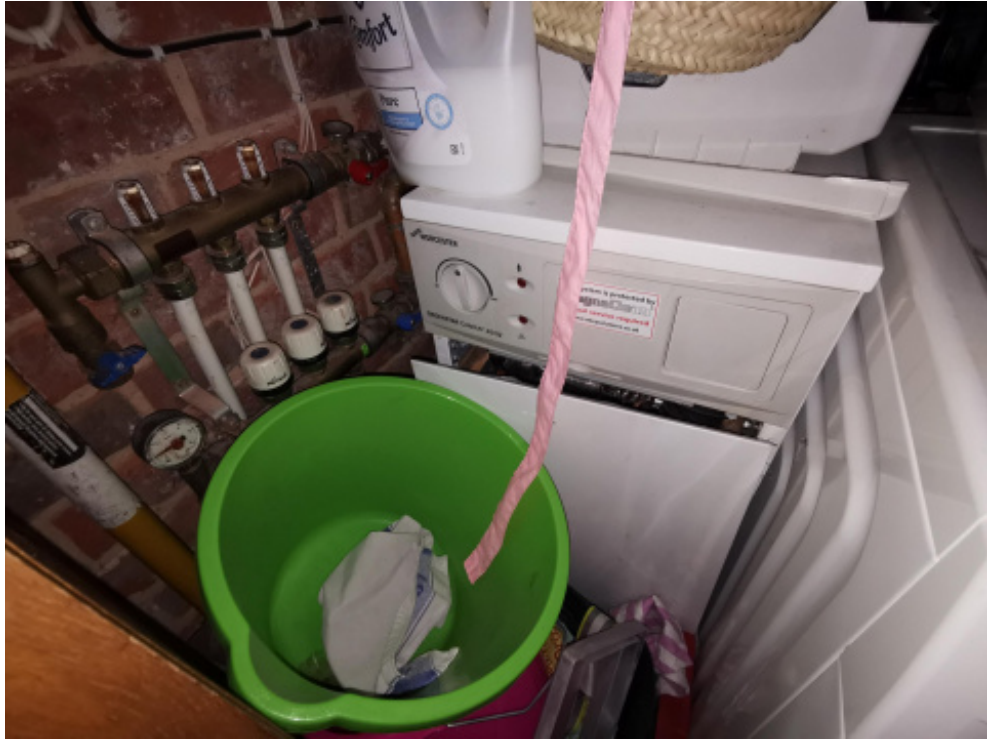
<b>Condition</b>	<p>It is recommended that you establish the service history of the boiler before you purchase, as only regular servicing by a competent person can ensure efficiency and safety. If these questions suggest that previous maintenance has been poor, you should instruct a competent person to check the whole system before you purchase.</p> <p>Unvented hot water systems should only be installed and serviced by a qualified and competent person holding a current G3 Unvented Qualification. It is extremely important that the system is correctly installed, along with all essential safety controls. Building Regulations require all installations of unvented hot water cylinders to be notified to Building Control. If the installer is a member of a Competent Persons Scheme, notification should happen automatically following the installation, and the customer will receive a Building Regulation Compliance certificate. Unvented systems of this type should be serviced annually to ensure safe and efficient operation.</p>

<b>Action Required</b>	<p>Health and Safety – See also notes in 6.2 regarding the general safety and servicing of the complete system.</p>

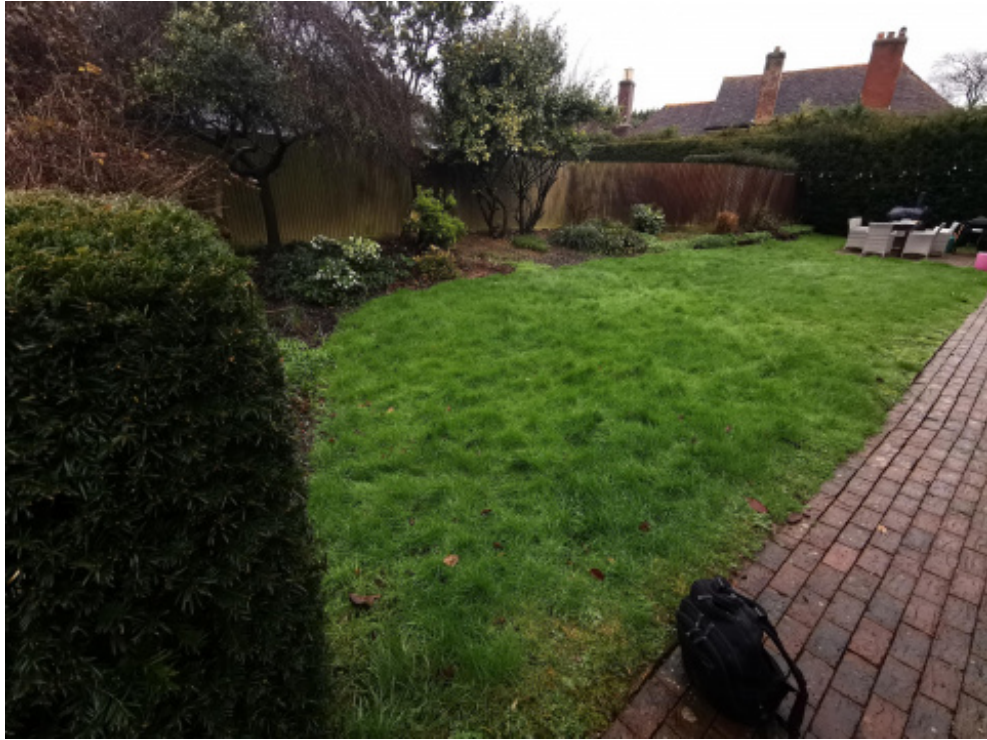
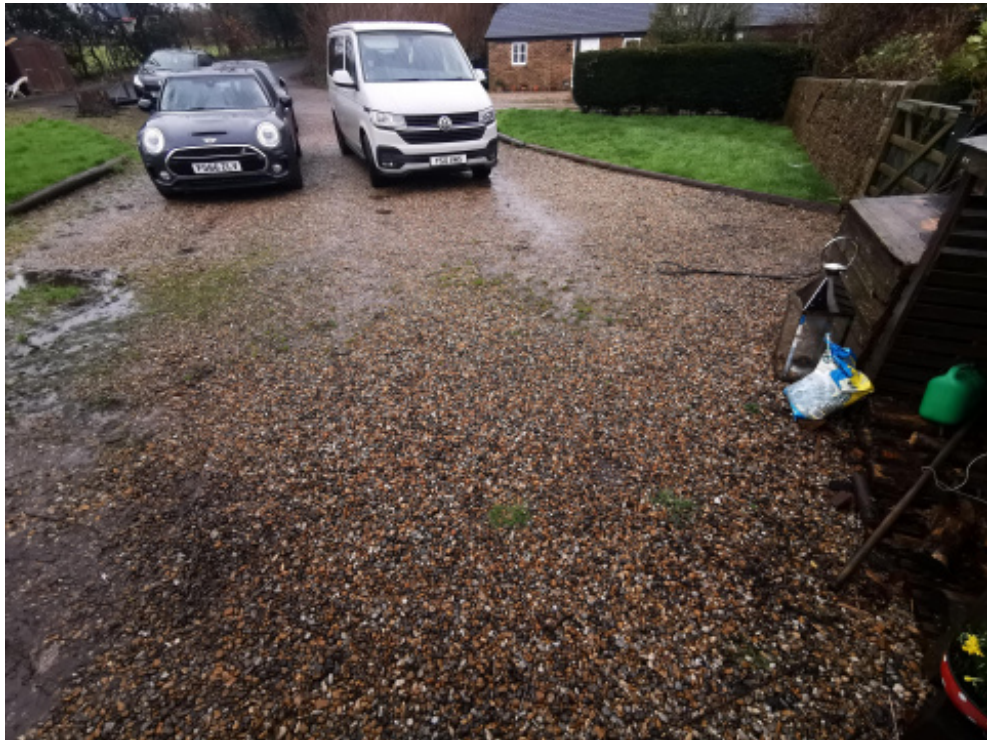
<b>Condition</b>	There is no evidence of any damage from flooding. The gardens are both presented in a maintained condition. The driveway surface is in a serviceable condition and is reasonably level. Some of the concrete walls have sizeable cracks in them which might affect their stability.		
<b>Action Required</b>	Normal Maintenance is Required.
