BUILDING SURVEY REPORT

SURVEY DATE 25 Mar 2020

REF 7278

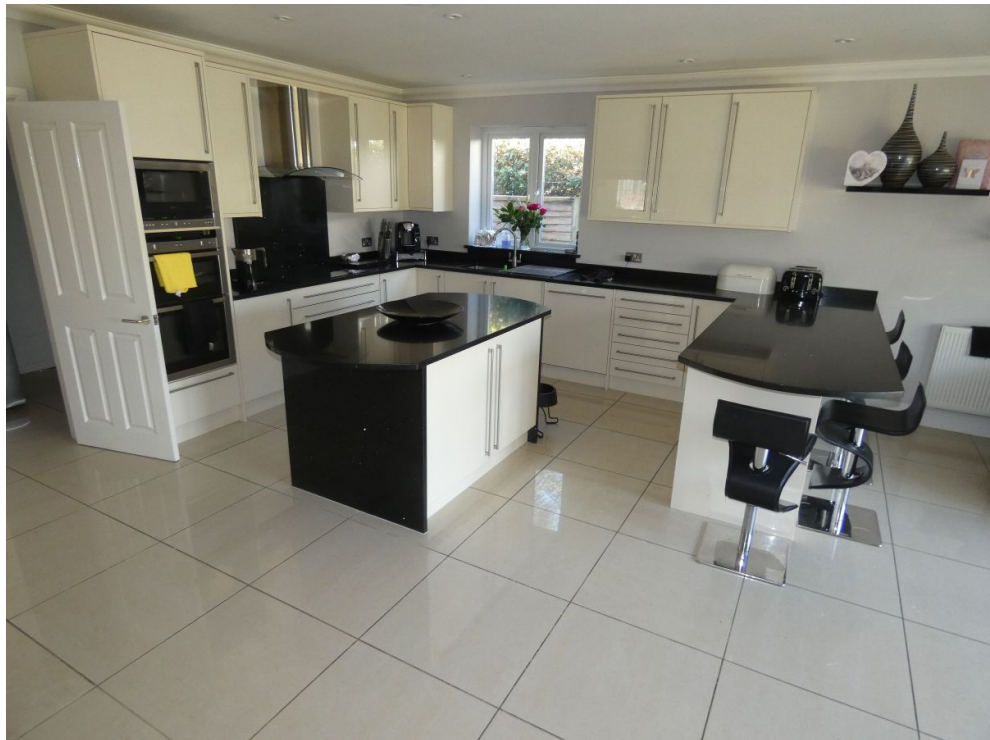
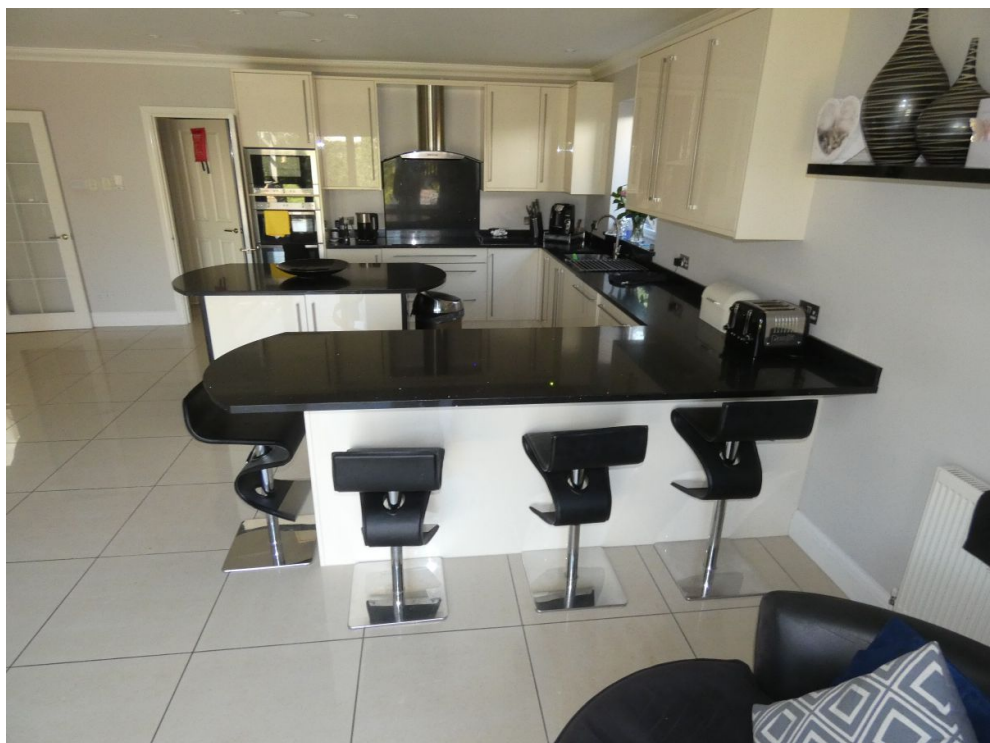
Kitchen

5.6 Built-In Fittings	Condition rating	1
Construction & Type	<p>The kitchen fittings are modern and the worktops are of granite, units are a mixture of wall-hung and floor standing. There is a utility room with similar units.</p> <p>The fitted wardrobes (and walk-in cupboards) are modern style.</p>		
Nature of inspection and Limitations	<p>The kitchen units and utility room were examined for general condition. A selection of cupboards and drawers were checked for normal operation. Built in appliances were not checked for operation or safety. No significant defects or damage was noted but some modernising and updating may now be required.</p> <p>Fitted wardrobes (and walk-in cupboards) were checked for general condition and door operation. No significant defects were noted but some modernising and updating may now be required.</p>		
Condition	No Significant Defects are Noted.		
Action Required	Normal Maintenance is Required

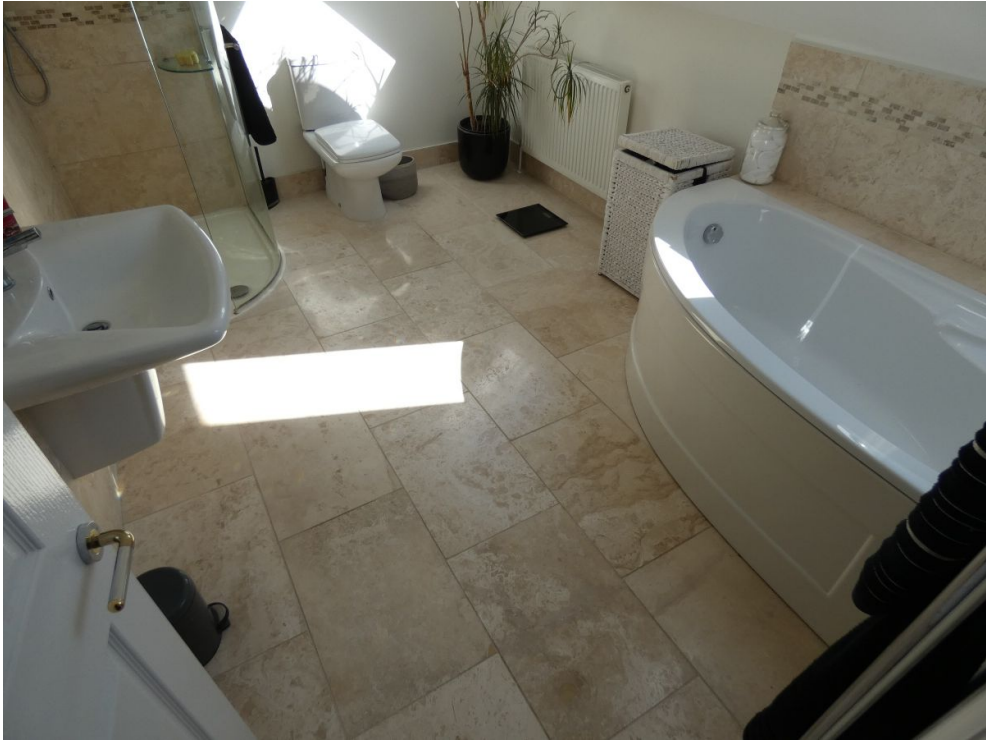
</div> <p style="text-align: center;">En suite</p>

5.8 Bathroom and Sanitary Fittings	Condition rating	1
Construction & Type	All 5 bathrooms/ensuites/cloakrooms are of modern design		
Nature of inspection and Limitations	The fittings were checked for signs of damage, cracks, leaking pipes and other common defects. Sealant joints were checked for undue wear and failure. All fittings were checked for normal operation – WC's were all flushed at least twice to ensure correct drainage and flow.		
Condition	<p>There is mechanical ventilation to all first floor bathrooms/ensuites. These should be kept operational as they reduce the levels of moisture within the rooms and hence the risk of condensation to the walls and ceiling structures.</p> <p>No significant defects are noted, all fittings operated as required with water pressures at fair levels.</p>		
Action Required	Regular maintenance of all seals to the bath and shower to prevent water displacement.

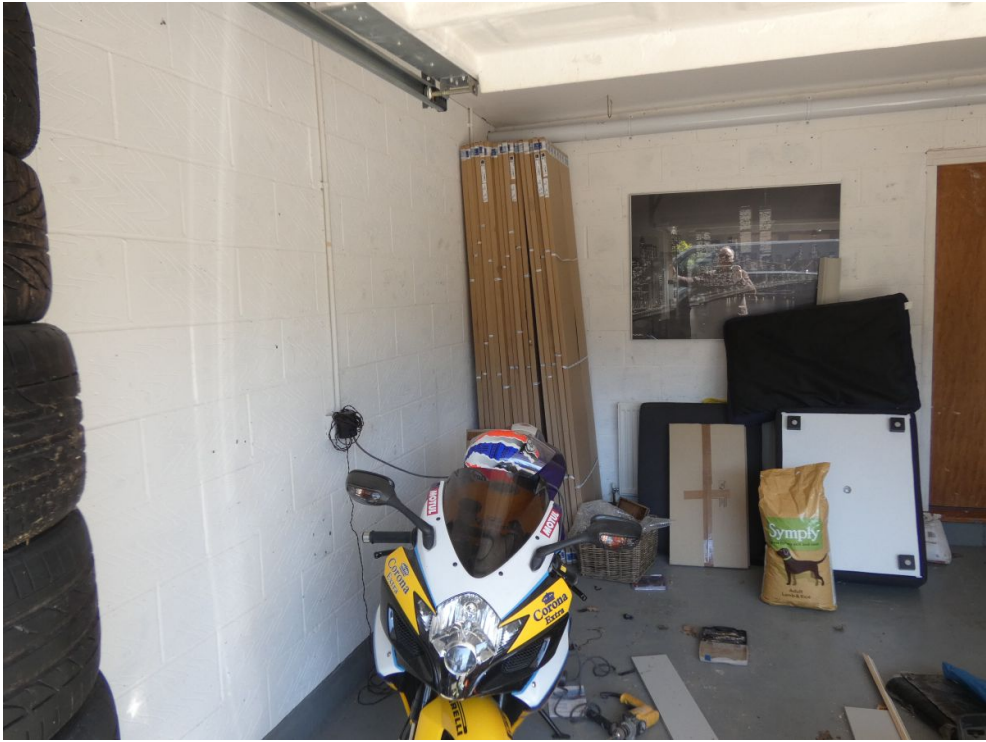
<p data-bbox="820 1547 1002 1581">Garage interior</p>

7.1 Garaging	Condition rating	1
Construction & Type	The garage is integral to the main property.		
Nature of inspection and Limitations	It was internally examined .		
Condition	All brickwork was in reasonable condition and the remote controlled door worked well.		
Action Required	Normal maintenance, including regular retreatment of the walls, is required.

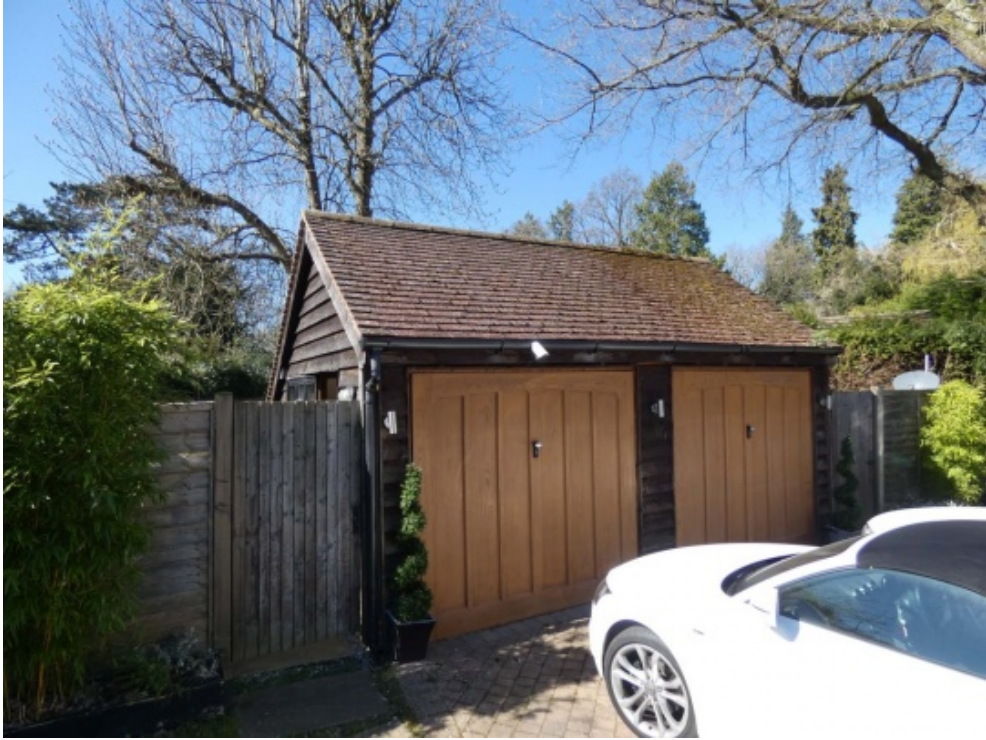
</div> <p data-bbox="794 1608 1023 1641">Timber outbuilding</p>

7.2 Outbuildings and Sheds	Condition rating	1
Construction & Type	There is a timber building to the front of the property which is currently occupied by someone who was being quarantined. There are also 2 timber sheds in the rear garden		
Nature of inspection and Limitations	The front timber building could not be inspected.		
Condition	The sheds are in a fair condition.		
Action Required	Normal maintenance, including regular retreatment of the walls, is required. Foliage and debris should be removed from the outside walls.		
	<div data-bbox="416 860 1406 1597">

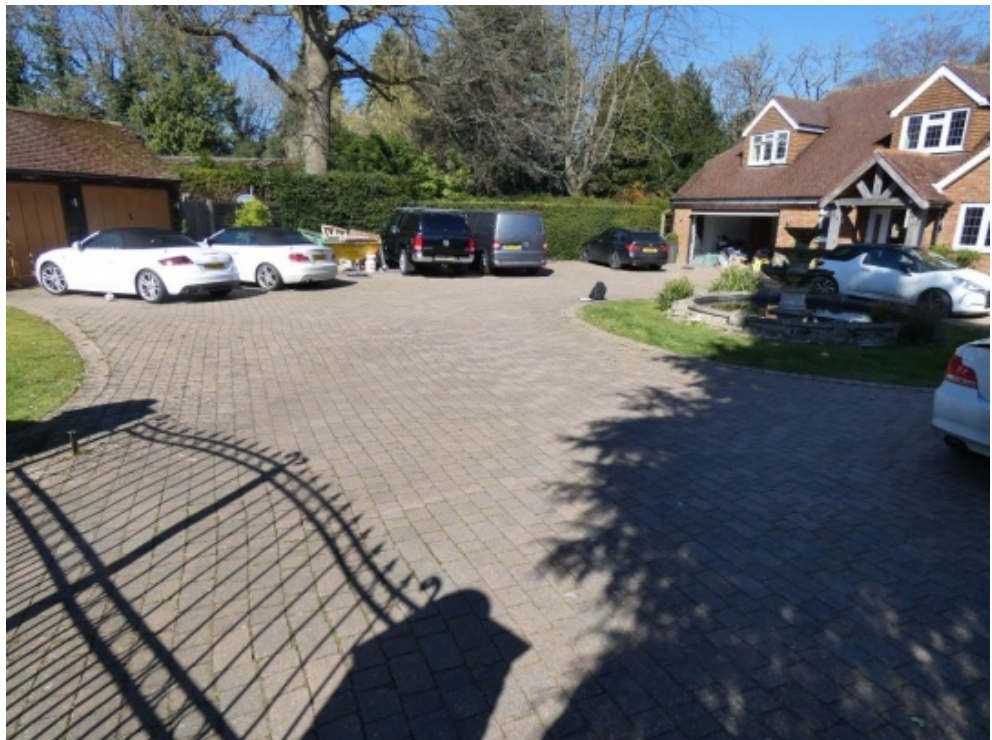
Driveway

Condition	<p>There is no evidence of any damage from flooding.</p> <p>The gardens are both presented in a well maintained condition.</p> <p>The driveway surface is in a serviceable condition and is reasonably level.</p> <p>The fencing is also presented in a fair condition.</p>		
Action Required	Normal Maintenance is Required.
