MI HOME BUYER SURVEY

# HOME BUYER SURVEY

SURVEY DATE 25 Aug 2020

REF 8629

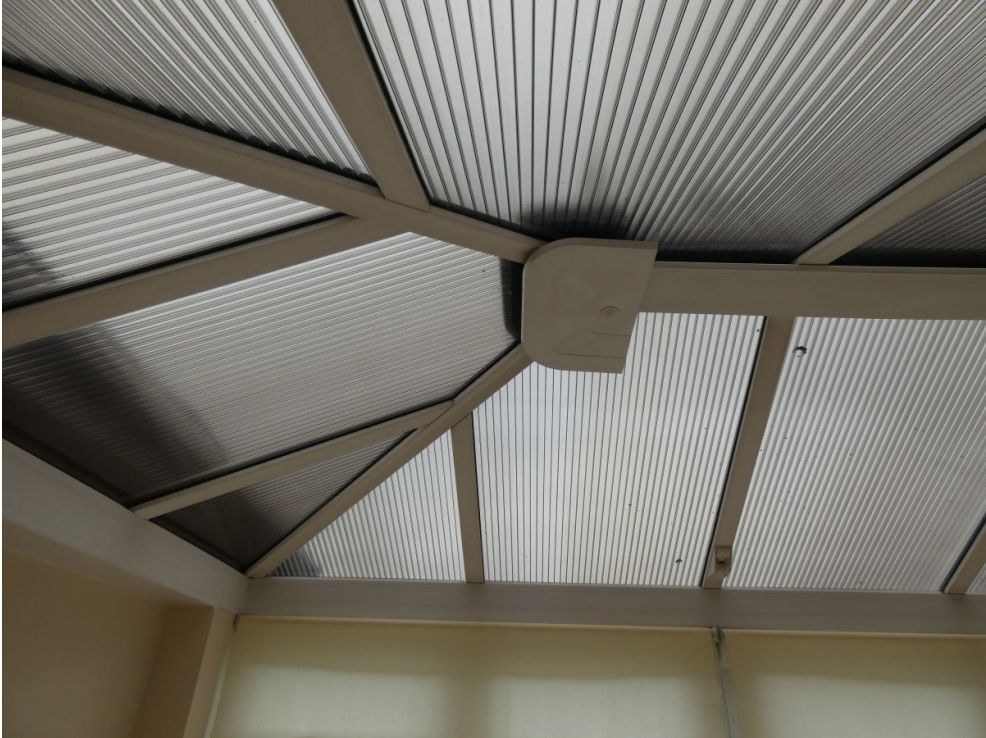
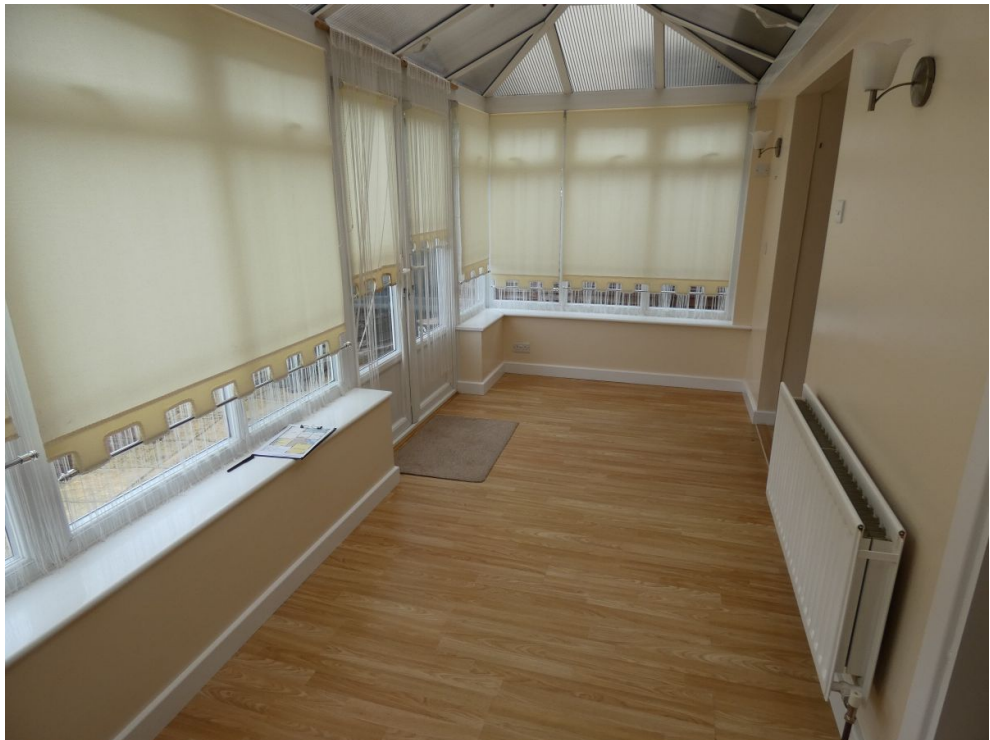
Inside Conservatory

4.7 Conservatories and Porches	Condition rating	1
<b>Construction &amp; Type and Limitations</b>	<p>There is a conservatory to the rear of the property. It is of uPVC construction with glazed sections on three sides, a pitched polycarbonate roof and is on a brick dwarf wall.</p> <p>The conservatory structure was examined for indications of leaking, bowing, leaning, cracking and undue movement, failure or damage of the floor, walls and roof, separation from the main building, and other defects.</p>		
<b>Condition</b>	<p>Access to the conservatory is gained by an open wall section with no external quality doors between the two parts. As this is open, building regulation approval would have been required in addition to any planning approvals gained. Your Legal advisor should check these matters during the conveyancing process.</p> <p>There is no horizontal cross-bracing of the side walls present inside the conservatory. Such bracing is often present to prevent the walls from spreading outwards at the top, and takes the form of metal tubing attached between the top of opposing walls. No evidence of spreading of the walls was seen but you should be aware that this can occur, and may choose to install some bracing as a preventative measure.</p>

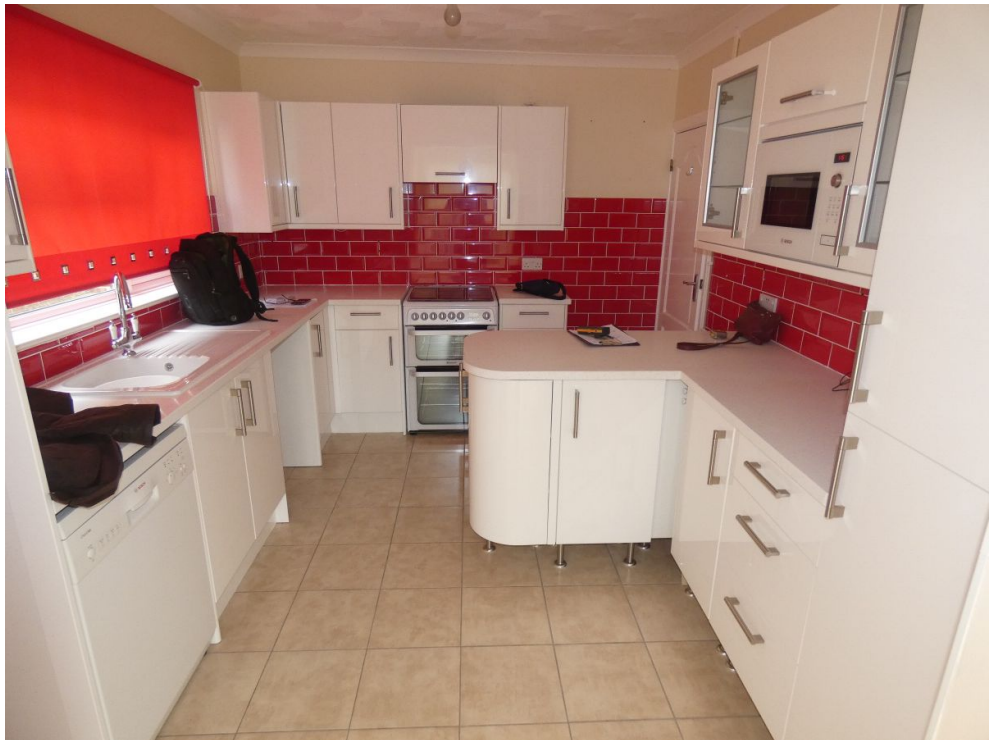
Kitchen

<b>5.6 Built-In Fittings</b>	<b>Condition rating</b>	<b>1</b>
<b>Construction &amp; Type and Limitations</b>	<p>The kitchen fittings are modern .</p> <p>The kitchen units were examined for general condition. A selection of cupboards and drawers were checked for normal operation. Built in appliances were not checked for operation or safety.</p> <p>Fitted wardrobes (and walk-in cupboards) were checked for general condition and door operation.</p>		
<b>Condition</b>	<p>No Significant Defects are Noted.</p> <p>Normal Maintenance is Required</p>

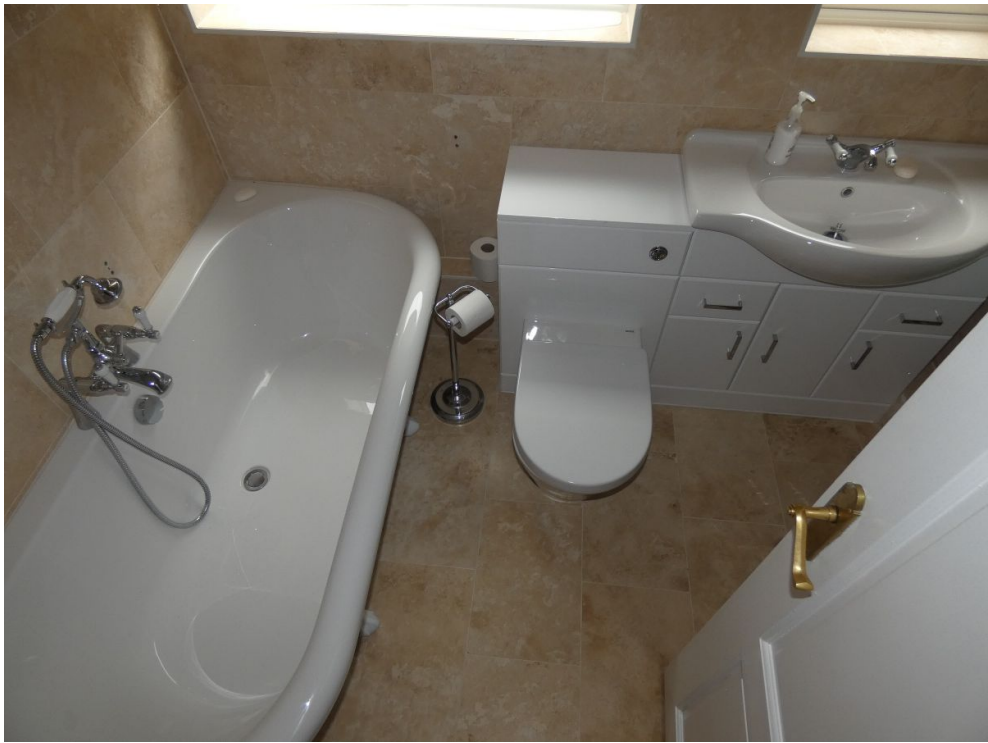
</div> <p style="text-align: center;">Bathroom</p>

<b>5.8 Bathroom and Sanitary Fittings</b>	<b>Condition rating</b>	<b>1</b>
<b>Construction &amp; Type and Limitations</b>	<p>The bathroom consists of a bath, shower enclosure, WC and basin.</p> <p>The fittings were checked for signs of damage, cracks, leaking pipes and other common defects. Sealant joints were checked for undue wear and failure. All fittings were checked for normal operation – WC's were all flushed at least twice to ensure correct drainage and flow.</p>		
<b>Condition</b>	<p>No significant defects are noted, all fittings operated as required with water pressures at fair levels.</p> <p>Regular maintenance of all seals to the bath and shower to prevent water displacement.</p>		
	<div data-bbox="430 660 1422 1400">

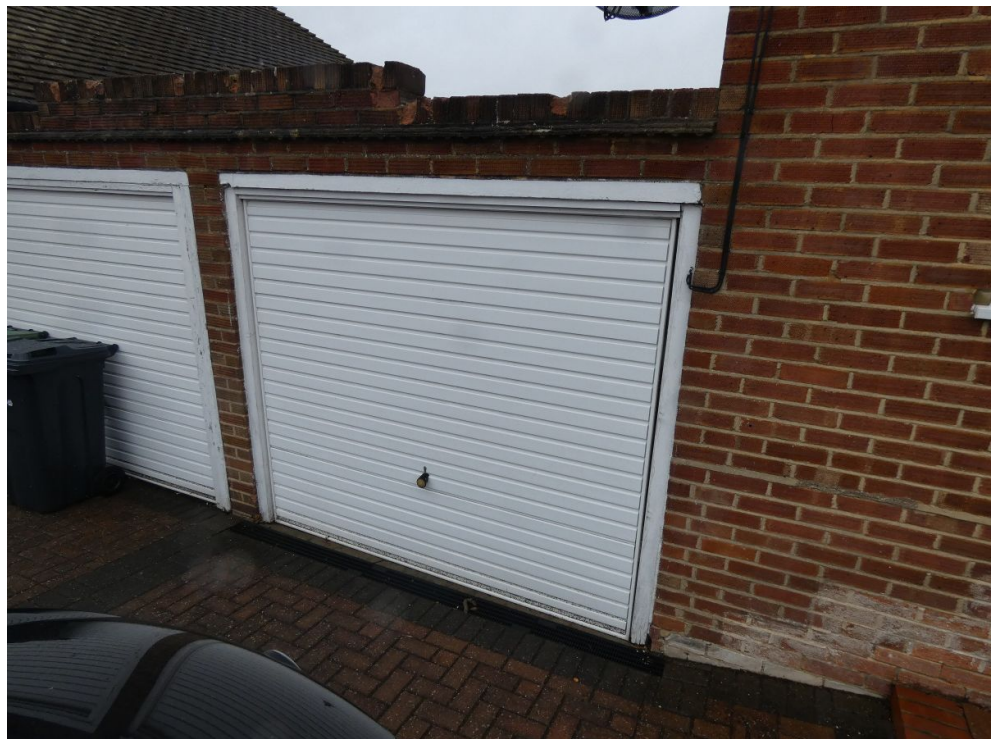
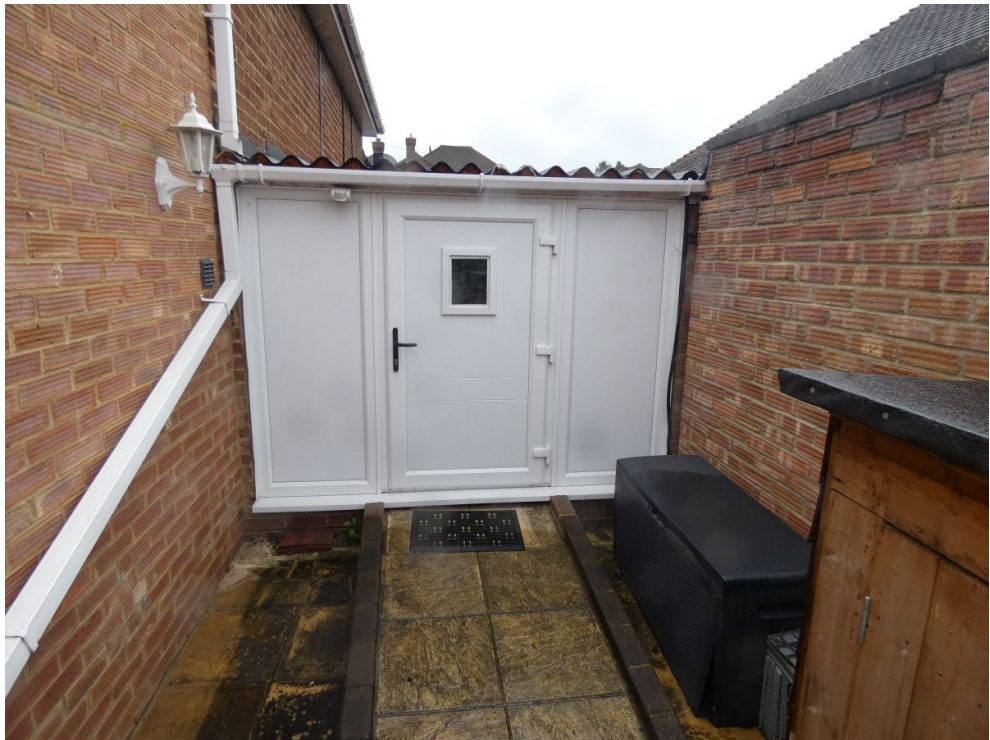
Garage

Some of the corrugated roof material contains asbestos.  
There are vertical cracks to the side of the internal walls which will need to be monitored carefully over time.

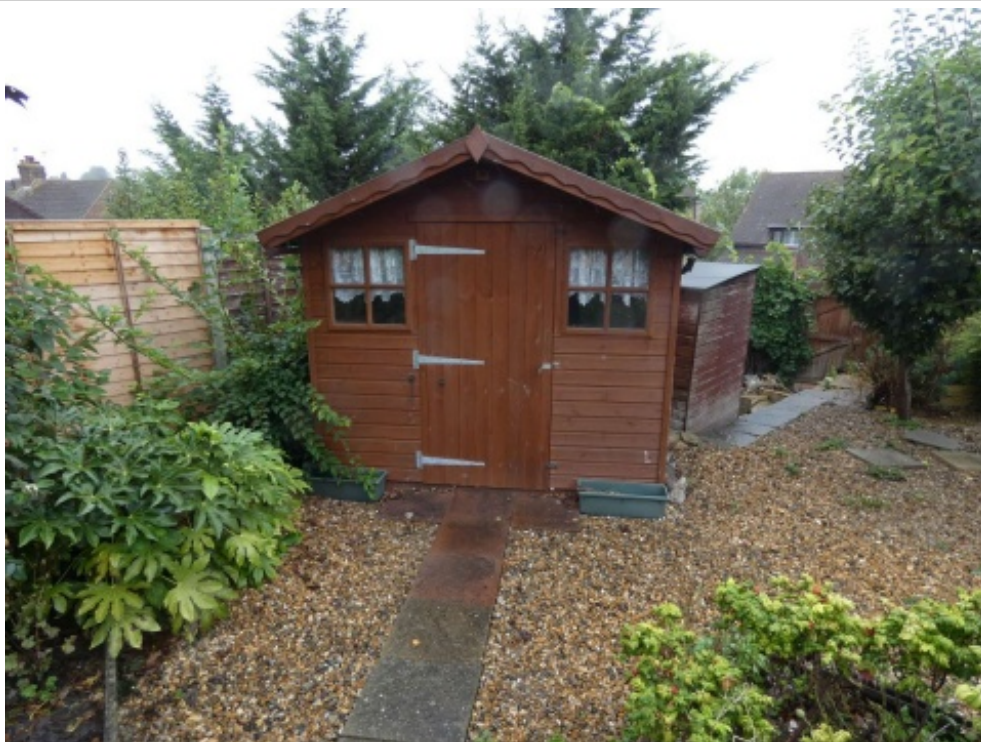
Garden Shed

<b>7.2 Outbuildings and Sheds</b>	<b>Condition rating</b>	<b>1</b>
<b>Construction &amp; Type and Limitations</b>	The garden sheds are of timber construction. None		
<b>Condition</b>	The sheds are in a fair condition. Normal maintenance, including regular retreatment of the walls, is required.

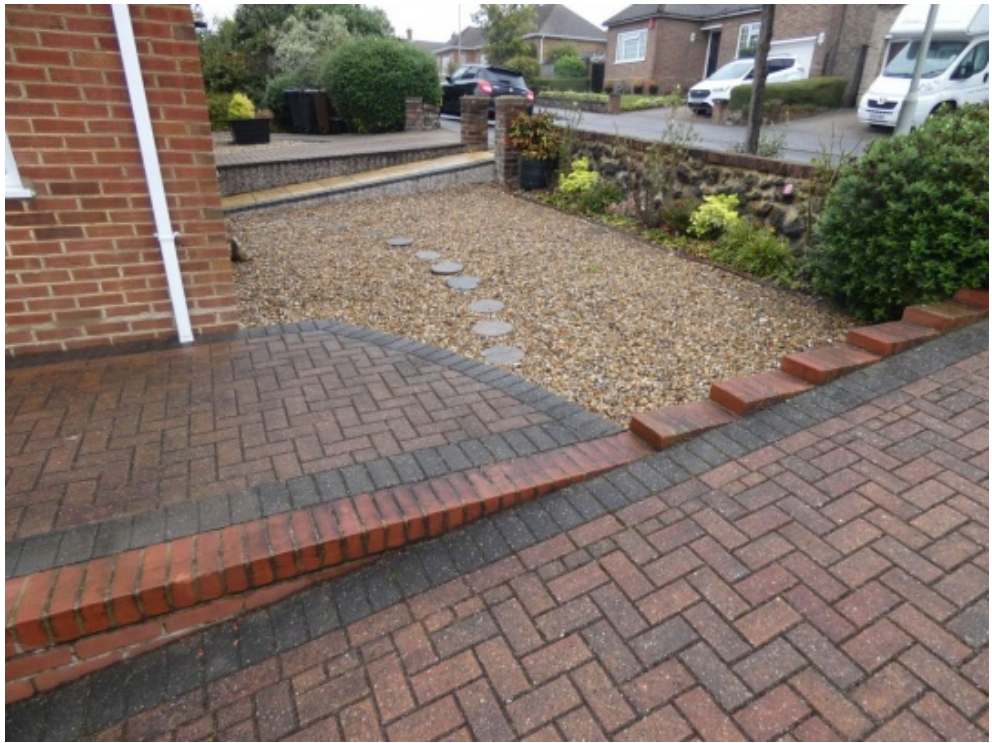
Front Garden

<b>Condition</b>	<p>There is no evidence of any damage from flooding.</p> <p>The gardens are both presented in a maintained condition.</p> <p>The driveway surface is in a serviceable condition and is reasonably level.</p> <p>The fencing is also presented in a fair condition.</p> <p>Normal Maintenance is Required.</p>
	  <p>Drive</p>
