Domestic Property Surveys

BUILDING SURVEY REPORT

SURVEY DATE 30 Oct 2024

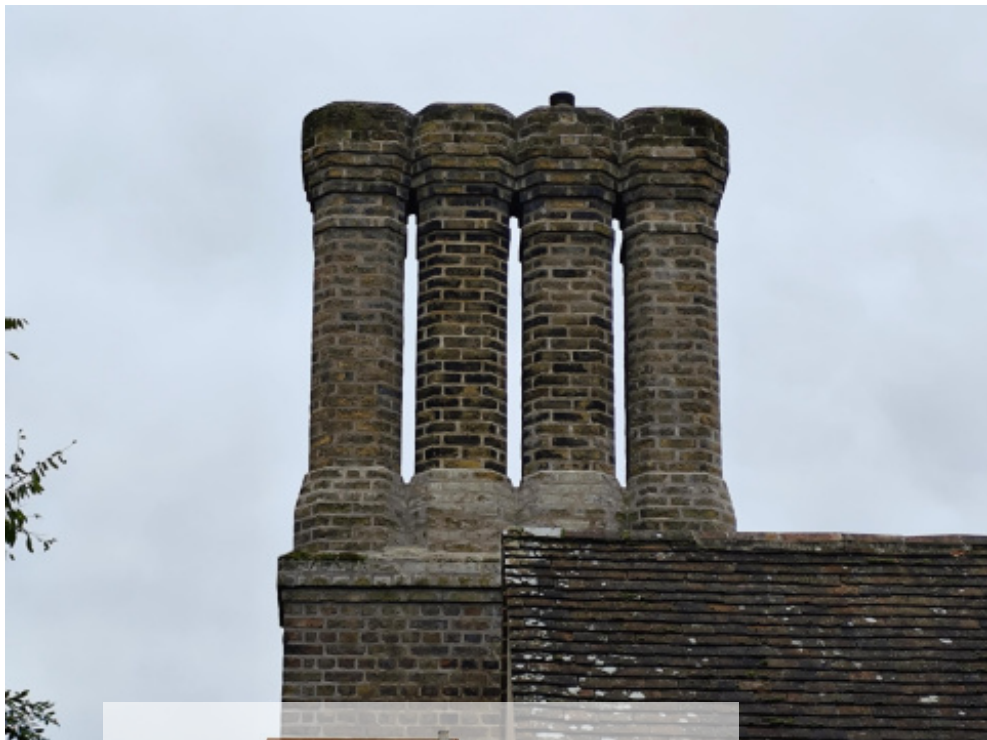
Rear stack

Action Required	<p>The chimney stack should be regularly monitored for any indications of damage, instability or other defects. Missing, loose or defective mortar should be re-pointed as necessary.</p> <p>Further investigation will be required to determine the exact cause of water ingress into the chimney breast directly below the stacks and quotes should be obtained for providing satisfactory remedies.</p>

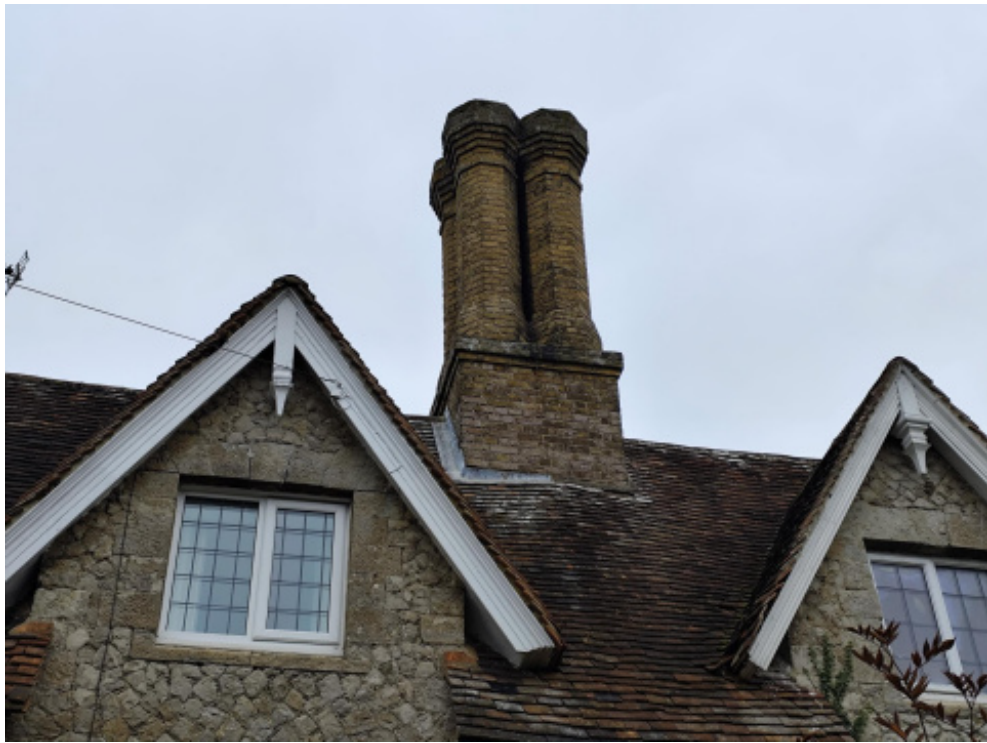
Main chimney Stack

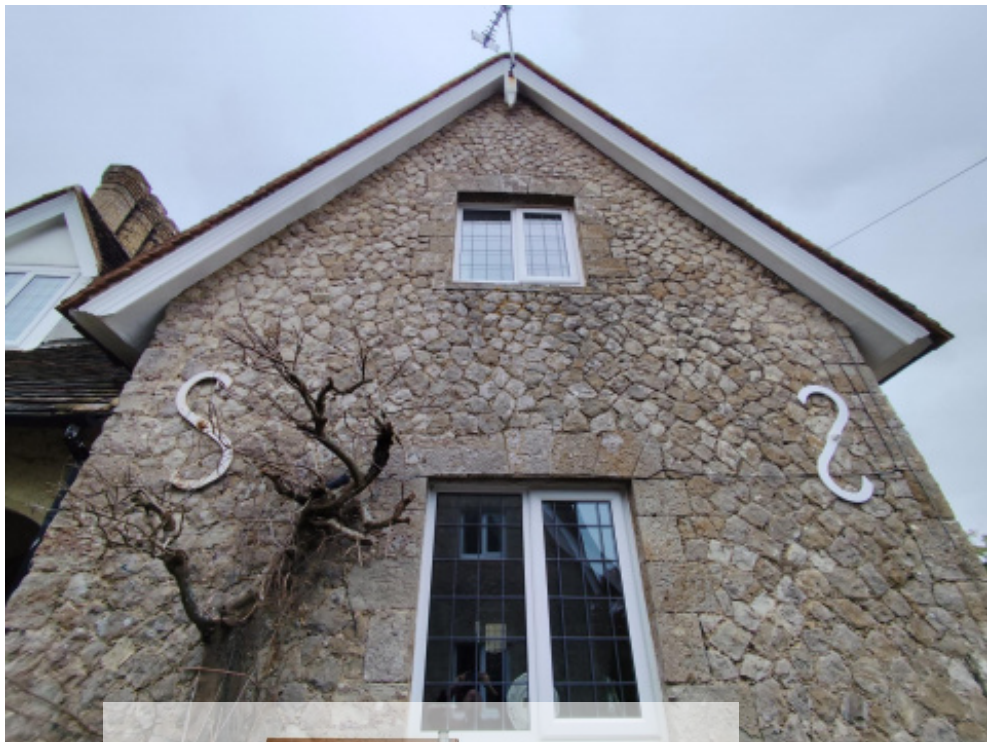
Tie bars at front

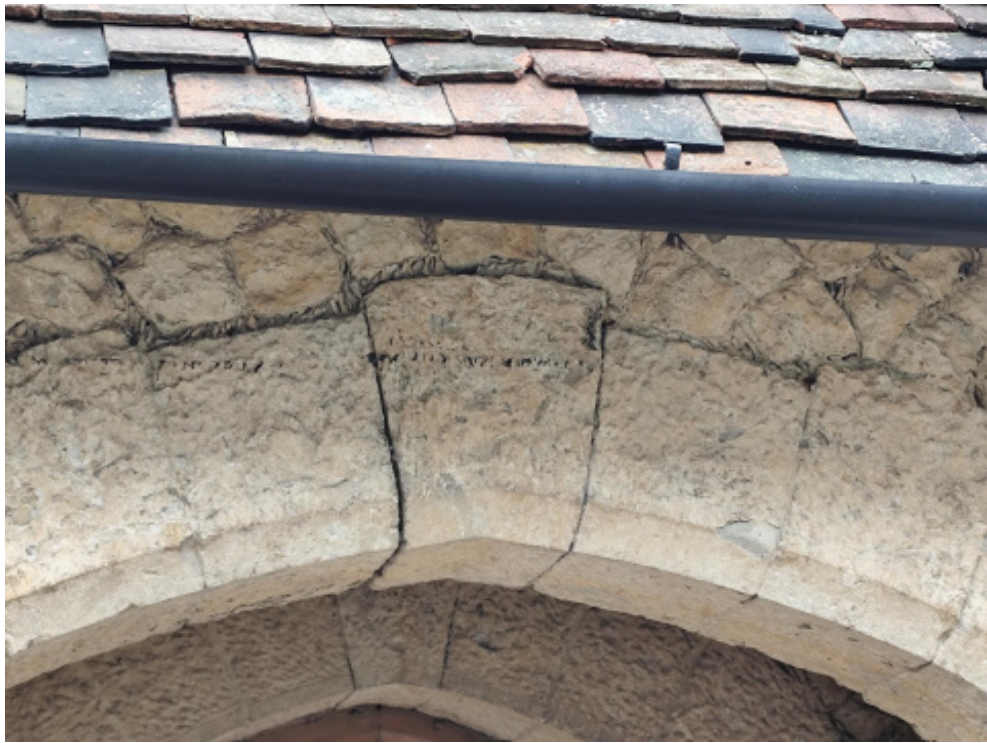
Slipped keystone above main entrance

<p>Action Required</p>	<p>Walls should be examined regularly to inspect for changes in the nature of any cracking or other defects that may become apparent.</p> <p>The keystones in both arches should be repositioned and the cracks to the front walls should be monitored and the cracks filled to prevent any water ingress.</p>

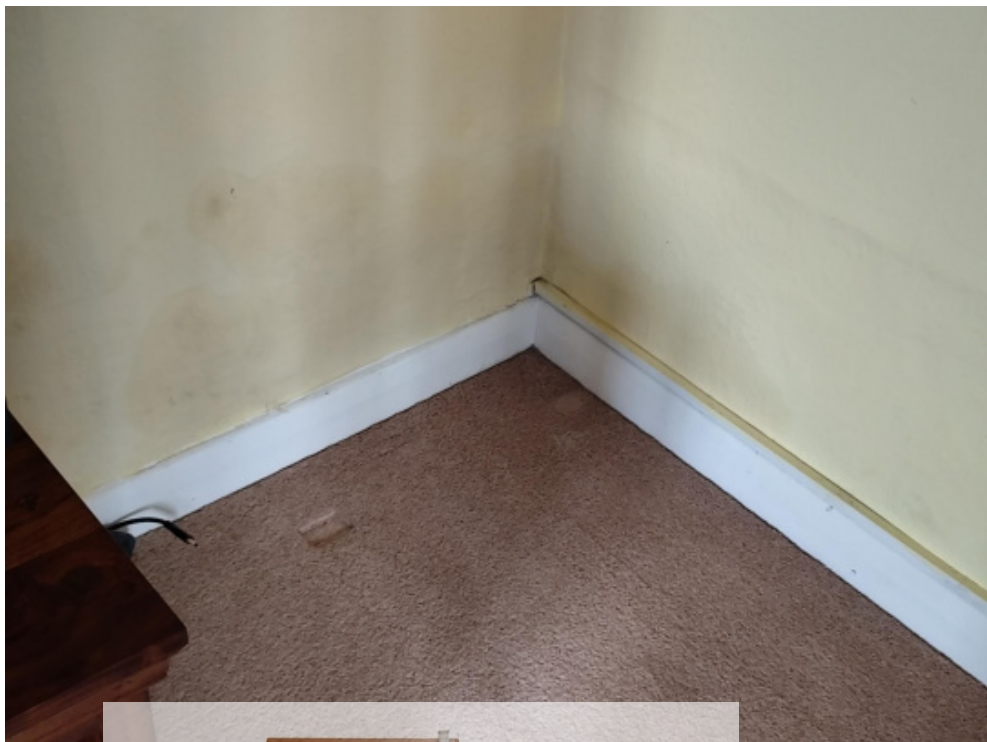
Damp wall

Action Required	<p>Remedies for the high level of moisture in some of the internal walls on the ground floor should be sought and quotes from local reputable damp proofing specialists obtained.</p> <p>Normal maintenance is required, including filling and redecorating cracks as necessary.</p>

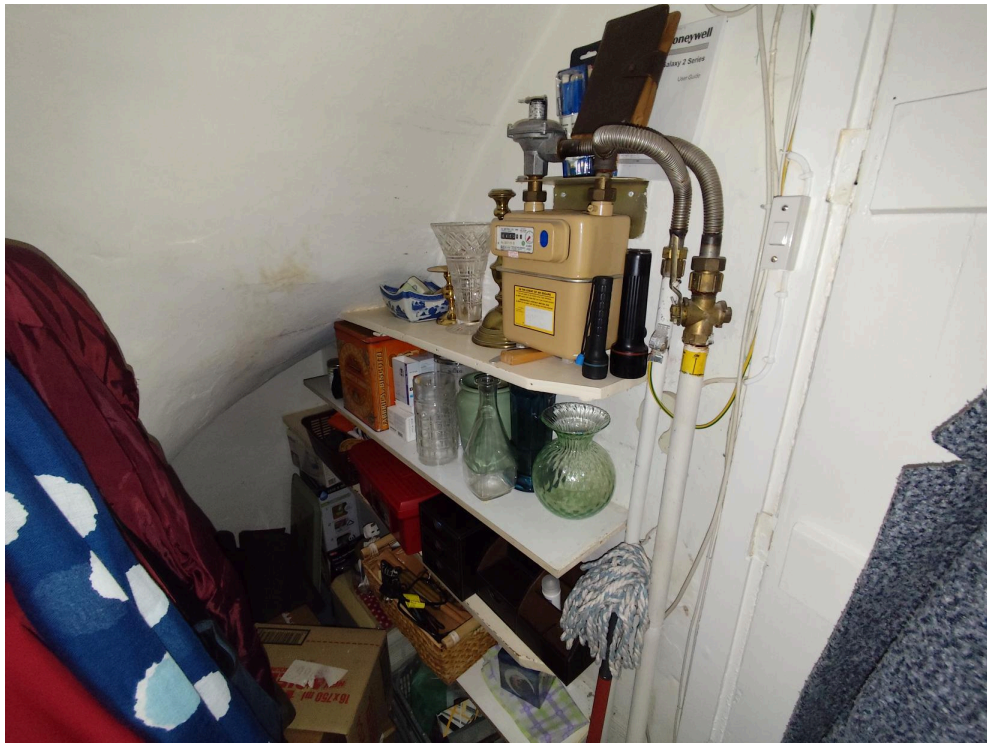
Gas Meter

6.2 Gas / Oil	Condition rating	HS
Construction & Type	There is a mains gas supply and the meter and valve are located in a cupboard under the stairs.		
Nature of inspection and Limitations	The system was inspected for any obvious signs of leakage and damage to the supply pipes where visible.		
Condition	No significant defects were noted but see health and safety advice below.		
Action Required	<p>Advice: Gas Safe recommends that all gas appliances and boilers are inspected and serviced according to manufacturers' guidance, but at least once a year. At the time of the survey, no documentation was seen to verify that an inspection or servicing has been carried out within the last 12 months but the vendor advised that the boiler is on an annual service schedule. From a health and safety perspective, it is recommended that you validate any available certification, or commission an inspection and servicing of the gas installation and ALL appliances (including the boiler, gas fire and gas hob) prior to occupation of the property.</p> <p>As the property is currently inhabited the system should be in use. In addition, the boiler is a fairly recent model. These observations reduce the risk of any hidden issues but it is still advisable to seek confirmation as to the operational safety of the complete system.</p> <p>The Gas Safe website called 'Buying a new home', it states: 'Homebuyers cannot always be sure when the gas appliances in their new home were last safety checked and serviced. Ask your vendor for an annual gas safety record which shows that a Gas Safe registered engineer has checked the gas appliances. If your vendor cannot supply an up to date annual gas safety record, you should get a Gas Safe registered engineer to check the gas appliances before you move in. This check should include the gas boiler, oven, and hob and gas fire. The registered engineer will give the vendor a gas safety record, which they should hand over to you before you move in. Better Gas Safe than sorry. Poorly maintained or badly fitted gas appliances can put you at risk from gas leaks, explosions, fires and carbon monoxide poisoning.'</p> <p>'Safety check' - As a minimum, this must check:</p> <ul style="list-style-type: none"> •Appliances are positioned in the right place; •Any flue or chimney serving appliances are safe and installed correctly; •There is a good supply of combustion air (ventilation) to appliances; •The appliances are on the right setting and are burning correctly; the appliances are operating correctly and are safe to use.

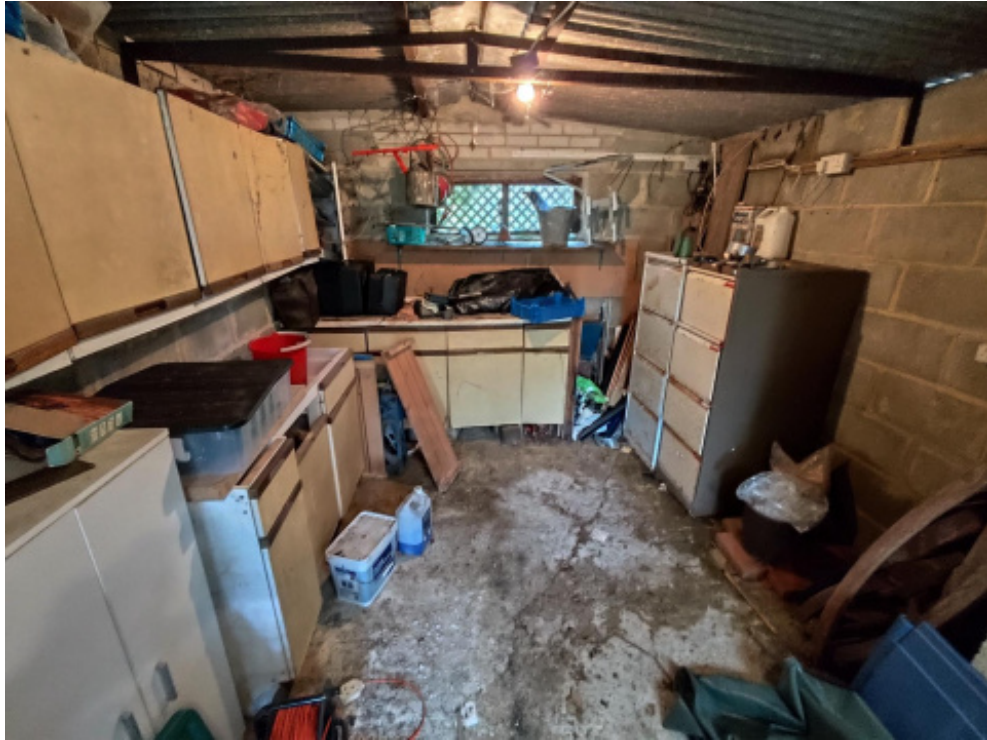
Garage interior

7.1 Garaging	Condition rating	2
Construction & Type	The garage is of block and concrete panel construction with a flat roof covered in a corrugated material that probably contains asbestos material. The garage is accessed via a vehicle metal up-and-over door to the front.		
Nature of inspection and Limitations	It was examined from ground level for signs of bowing or leaning of walls, damaged brickwork, render and pointing, internal defects, and the condition of the roof both internally and externally.		
Condition	<p>There is no evidence of moisture penetration and/or rot</p> <p>There is no cracking to the external walls</p>		
Action Required	Normal maintenance, including regular retreatment of the walls, is required.

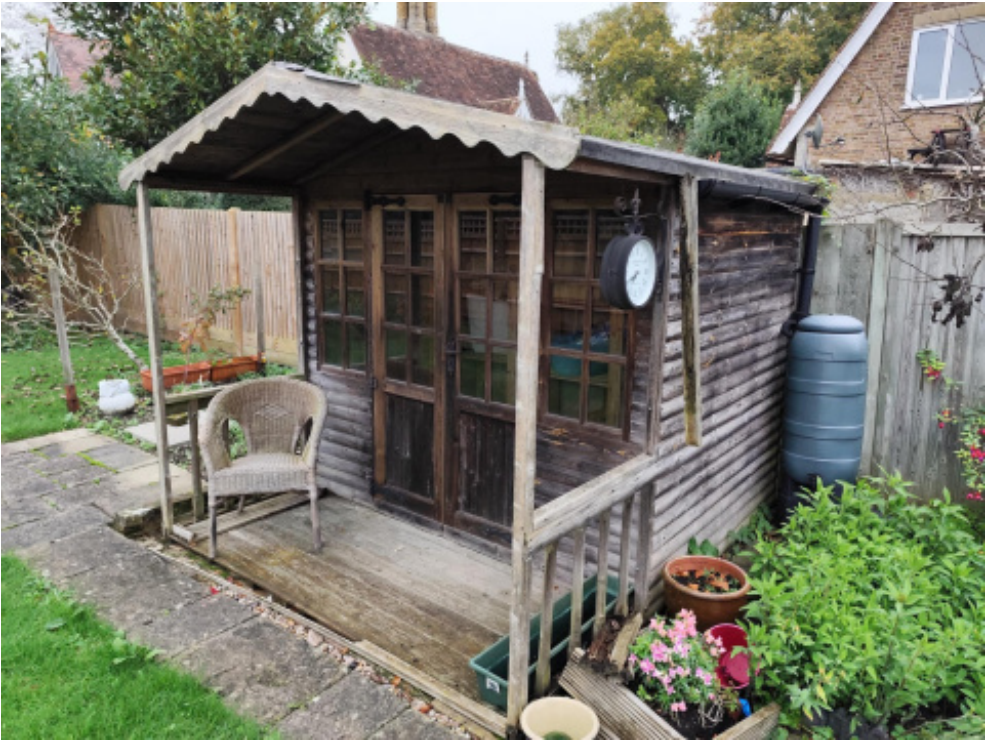
<p style="text-align: center;">Summerhouse</p>

7.2 Outbuildings and Sheds	Condition rating	2
Construction & Type	The garden sheds and Summerhouse are of timber construction.		
Nature of inspection and Limitations	It was not possible to access the rear of the sheds due to the proximity of the boundary and foliage growth.		
Condition	The sheds is in a fair condition for their age.		
Action Required	Normal maintenance, including regular retreatment of the walls, is required.

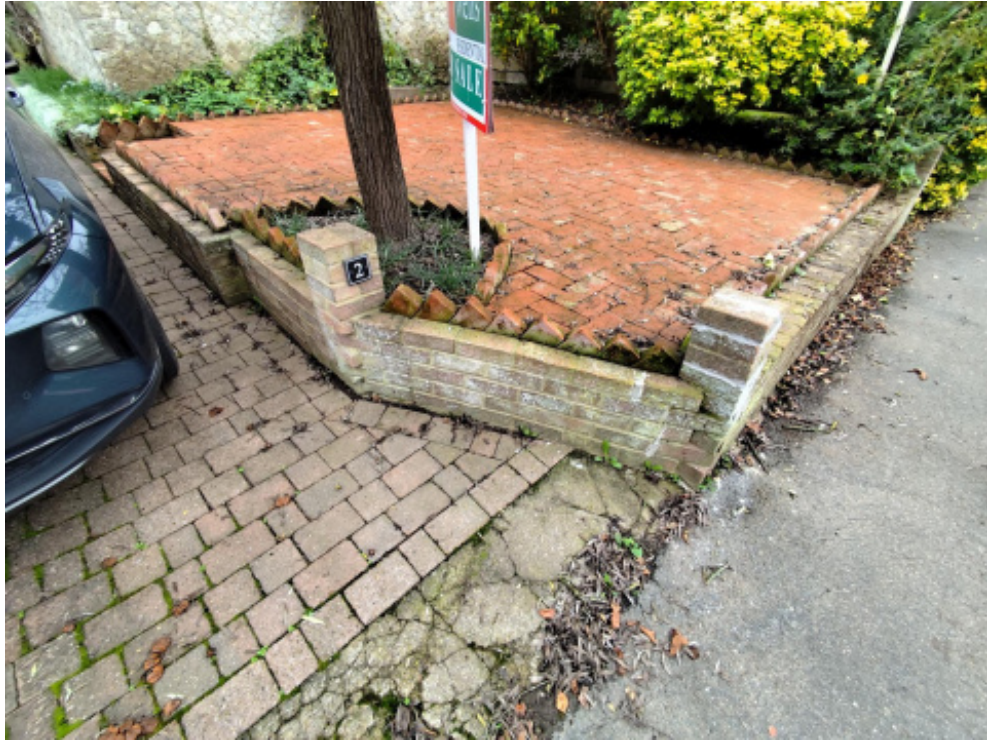
Front Garden

Condition	<p>There is no evidence of any damage from flooding.</p> <p>The gardens are both presented in a maintained condition.</p> <p>The driveway surface is in a serviceable condition and is reasonably level.</p> <p>The boundary fences are presented in fair condition but some minor repairs are required to some panels. (There is no indication of the ownership of any of the boundary walls, fences or hedges, and in most cases, this is not specified by the deeds or title documents. Often, responsibility for boundaries to one side or another has been assumed by subsequent owners. You should ask your conveyancer to advise on any indications of ownership included in the title documents.)</p>		
Action Required	Normal Maintenance is Required.
