HOME BUYER SURVEY

SURVEY DATE 23 Oct 2024

REF ME17 4QB

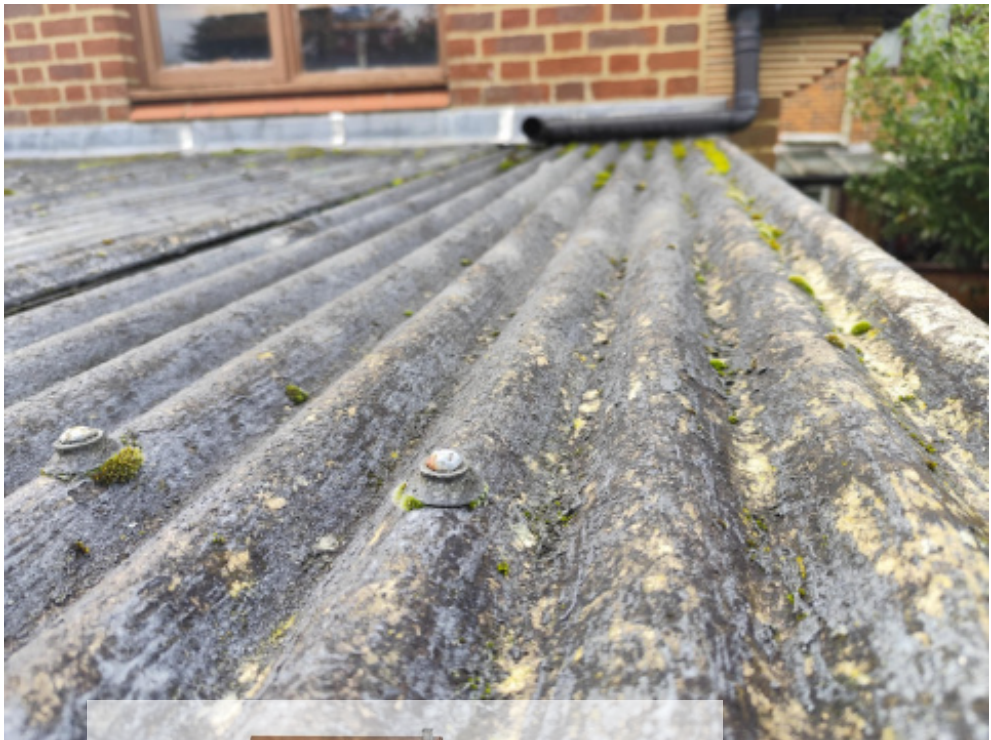
Asbestos sheeting in garage(2)

Corrugated roof containing asbestos material.

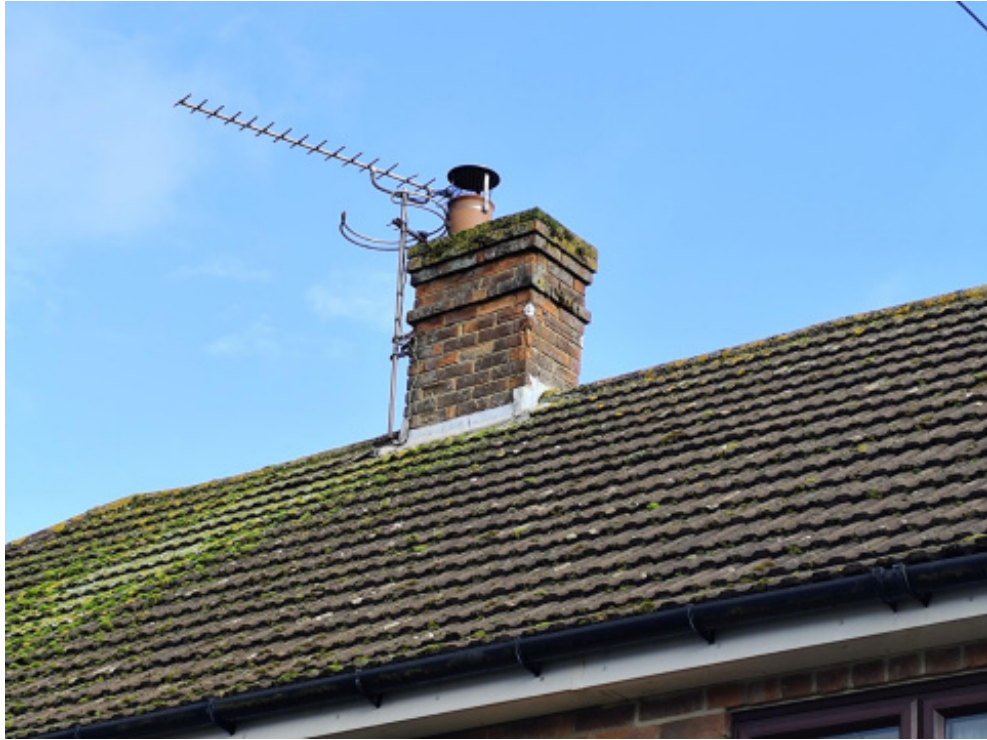
Main chimney Stack

Condition	<p>All visible flashings, brickwork and pointing were in a fair condition.</p> <p>No Repair is currently needed. The property must be maintained in the normal way.</p> <p>The chimney stack should be regularly monitored for any indications of damage, instability or other defects. Missing, loose or defective mortar should be re-pointed as necessary.</p>

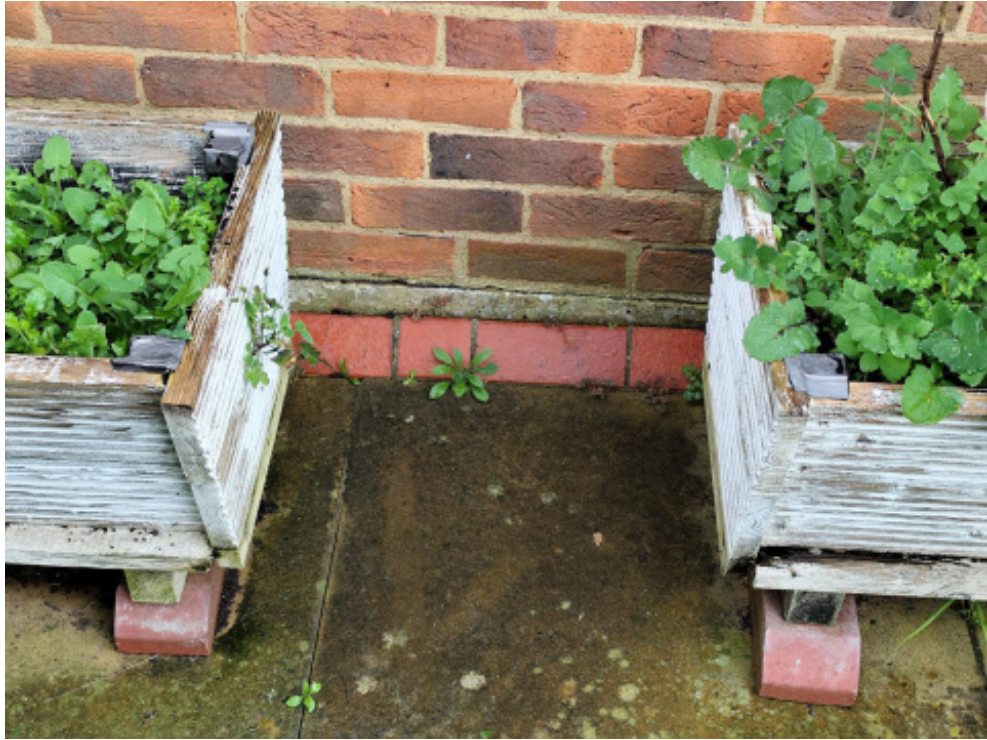
Damp Proof Course Line - uPVC

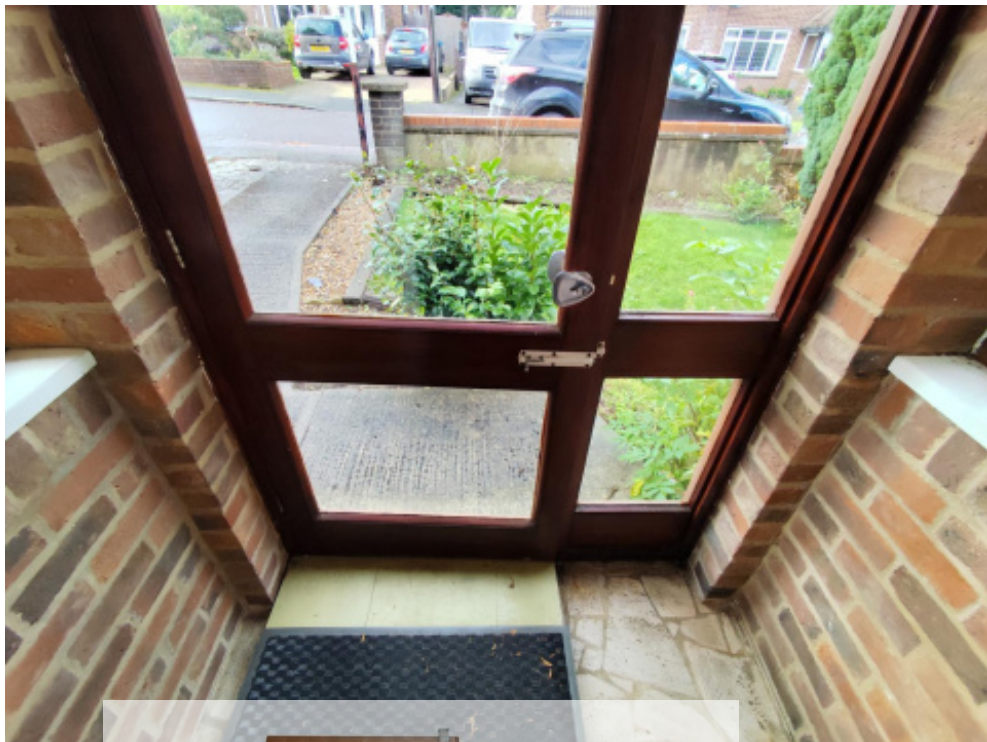
Front door

<p>Condition</p>	<p>Doors No significant defects were noted, all doors operated effectively on opening and closure. All locks functioned correctly.</p> <p>Windows WOOD FRAMES As expected the frames are affected by minor splitting and isolated softening. The frames are in overall serviceable condition although would benefit from future re-painting and attentive repair.</p> <p>uPVC frames can vary enormously in quality and an assessment of individual design is beyond the scope of this report. They are less suitable for piecemeal repairs whilst stay mechanisms and fixings can require an occasional overhaul. The double-glazed units appear serviceable but will need routine maintenance.</p> <p>Double-glazing has a limited life and is prone to deterioration at edge seals. This can sometimes be recognised by moisture between the panes but its presence is dependent upon atmospheric conditions that are, of course, variable. Such defects cannot always be diagnosed during a single inspection.</p> <p>According to records kept by FENSA (the Fenestration Self-Assessment Scheme, which was set up by the Glass and Glazing Federation (GGF) and other industry bodies in response to Building Regulations for double glazing companies in England and Wales), 3 new windows were installed in 2010. Each of these will carry a guarantee covering materials and labour.</p> <p>Under normal circumstances sealed double glazed units can be expected to last around 20 years before the seals begin to fail. This can occur more quickly where windows are in exposed or vulnerable situations. It is estimated that most of the windows currently fitted are approximately 10-15 years old and there is no evidence of any imminent failures. The condensation levels in certain weather conditions can disguise evidence of blown double glazed units, but no issues were noted or suspected.</p> <p>Any blown double glazing units will require replacement and it should also be considered that, where some sealed units within a window have failed, others may also fail in due course.</p> <p>Normal maintenance of frames, hinges and locks is required.</p> <p>Be aware that previous owners may have distributed multiple sets of keys for the windows and doors to individuals not known to you. When purchasing a property, you should consider the cost of replacing all of the door and window locks as soon as possible after you take up occupation. When doing this you should consult your insurers to ensure that you meet their requirements for security, and obtain any discounts that may be available by improving the security of the property.</p>

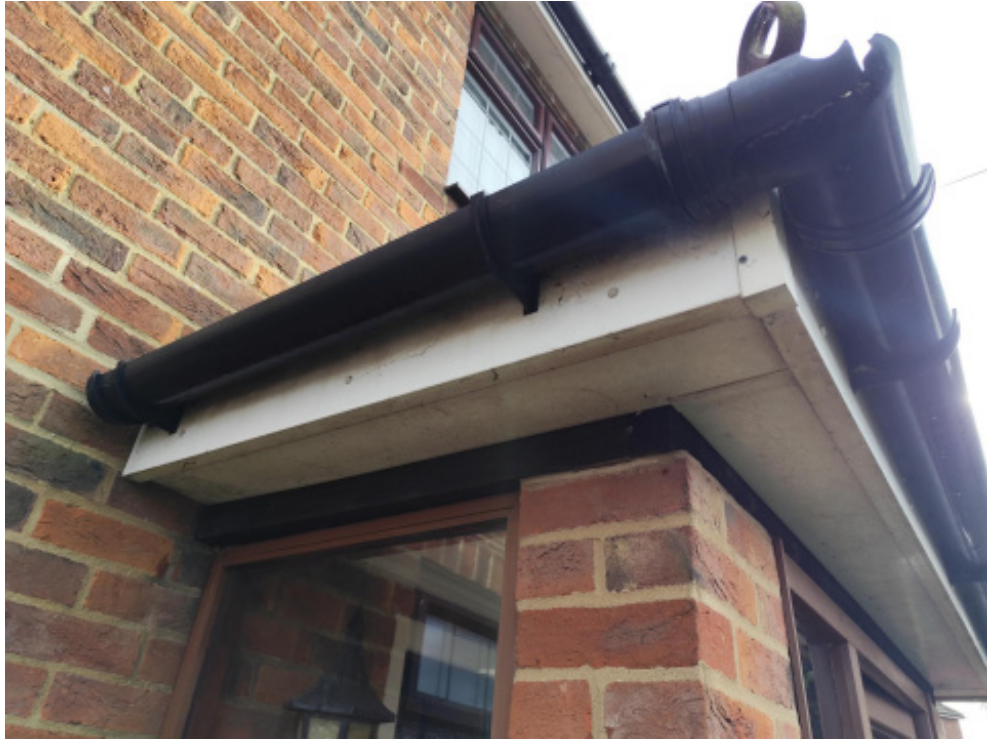
4.7 Conservatories and Porches	Condition rating	1
Construction & Type	The porch to the front is of brick construction with PVC windows and a pitched roof covered in tiles.		
Nature of inspection and Limitations	The porch structure was examined for indications of leaking, bowing, leaning, cracking and undue timber movement, failure or damage of the floor, walls and roof, separation from the main building, and other defects.		
Condition	No significant defects are noted to the structure.		
	<div data-bbox="376 683 1369 1422" data-label="Image">

Porch Structure

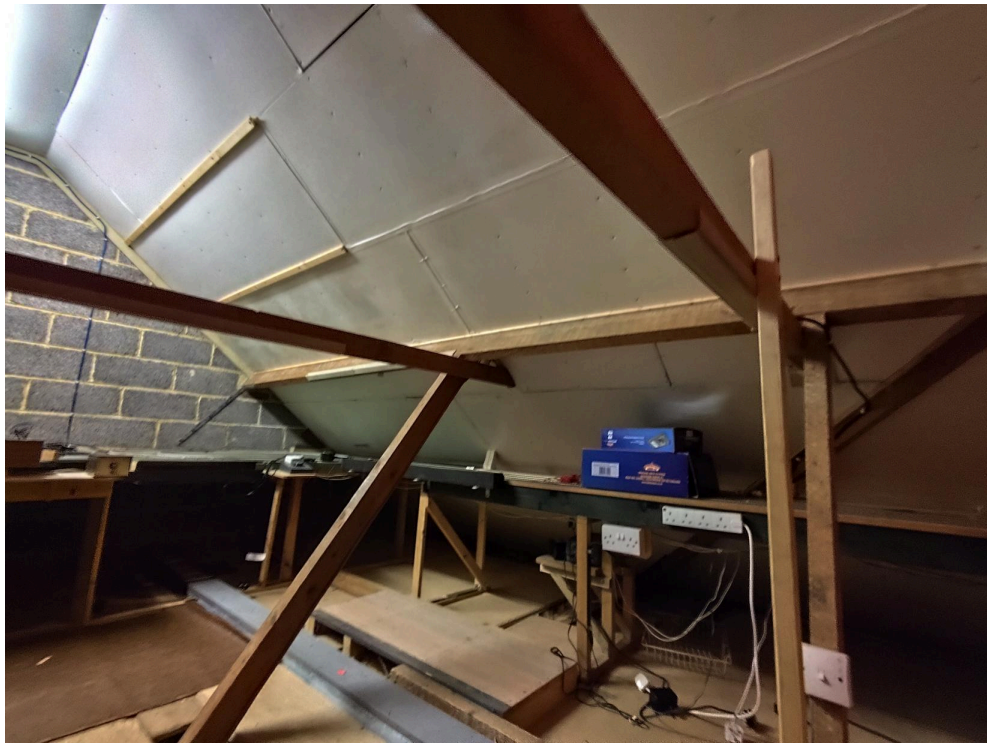
5.1 Roof Spaces	Condition rating	2
Construction & Type	The main roof is a traditional cut timber structure comprising rafters spanning from ridge to eaves supported by struts. It has been completely boarded out.		
Nature of inspection and Limitations	The underside of the roof was covered by timber boarding.		
Condition	<p>The roof structure is in a fair condition with reasonable quality timbers throughout. The rafters, purlins and strut timbers are complete with no evidence of any undue stress or cracking.</p> <p>The roof space is laid with about 100mm of wool type insulation at joist level. Increasing the thickness to the current recommendation of 270mm is advised for maximum energy efficiency</p> <p>Care should be taken when moving around, or storing heavy objects, in the roof space. The spaces between the floor joists will not support a persons weight, or that of large boxes etc. Where heavy items are to be stored it is important to distribute the weight evenly using fixed boards. Additional structural support may be required if you plan to store large quantities of heavy items in the roof space.</p>

Roof Structure

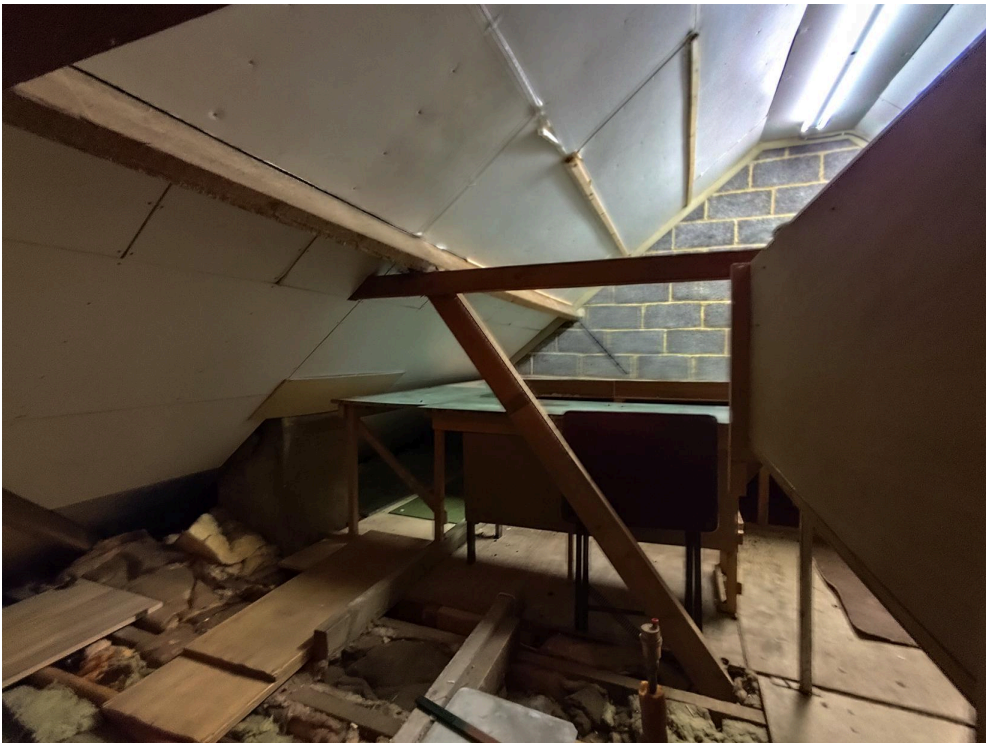
Roof Structure

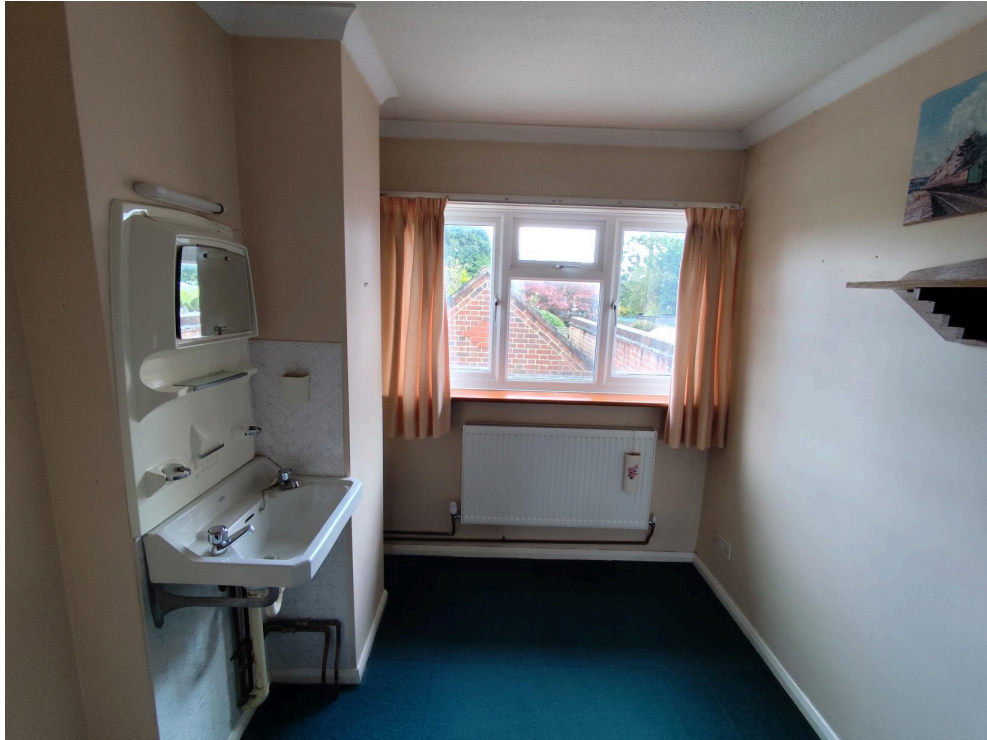
5.3 Walls	Condition rating	3
Construction & Type	The internal walls are of both solid and timber stud construction.		
Nature of inspection and Limitations	Internal walls were examined for indications of bowing, leaning, cracking and undue surface failure/damage. Moisture meter readings were taken at regular intervals where access and wall construction/location permitted.		
Condition	<p>There was no evidence of dampness to any of the internal walls or any of the internal faces of the external walls.</p> <p>Significant levels of cracking of the internal walls was noted on the first floor, particularly in the first floor extension. Further investigation is recommended as it could be symptomatic of settlement of the garage structure directly below the first floor extension.</p> <p>Supporting walls have been removed on the ground floor. Removal of internal load-bearing walls is a structural alteration and should be undertaken with Building Regulations consent. Your Legal Advisers should make further formal enquiries of The Local Authority to ascertain what paperwork is available to ensure compliance.</p> <p>It is possible that this has contributed to the cracking of the internal walls in the floor above.</p>

Bedroom walls

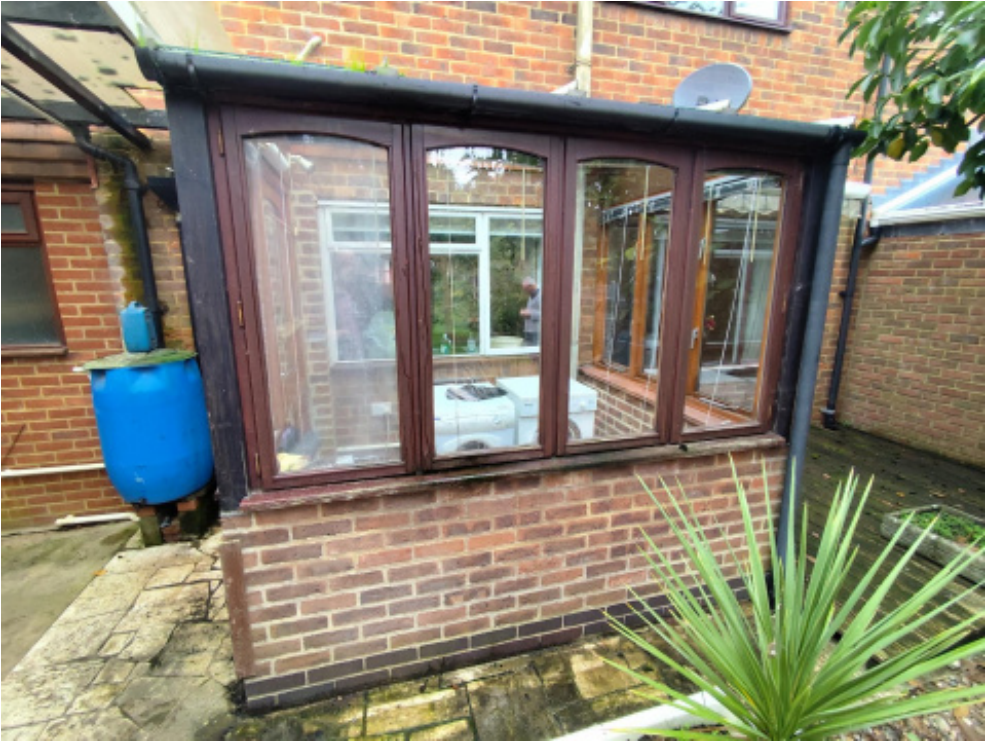
5.6 Built-In Fittings	Condition rating	2
Construction & Type	<p>The kitchen was basic.</p> <p>The utility area was located in a brick structure to the rear, accessed externally.</p>		
Nature of inspection and Limitations	<p>The kitchen units were examined for their general condition. A selection of cupboards and drawers were checked for normal operation. Built-in appliances were not checked for operation or safety. No significant defects or damage was noted but some modernising and updating may now be required.</p>		
Condition	<p>No Significant Defects are Noted.</p> <p>Normal Maintenance is Required</p>

<p>Utility room</p>

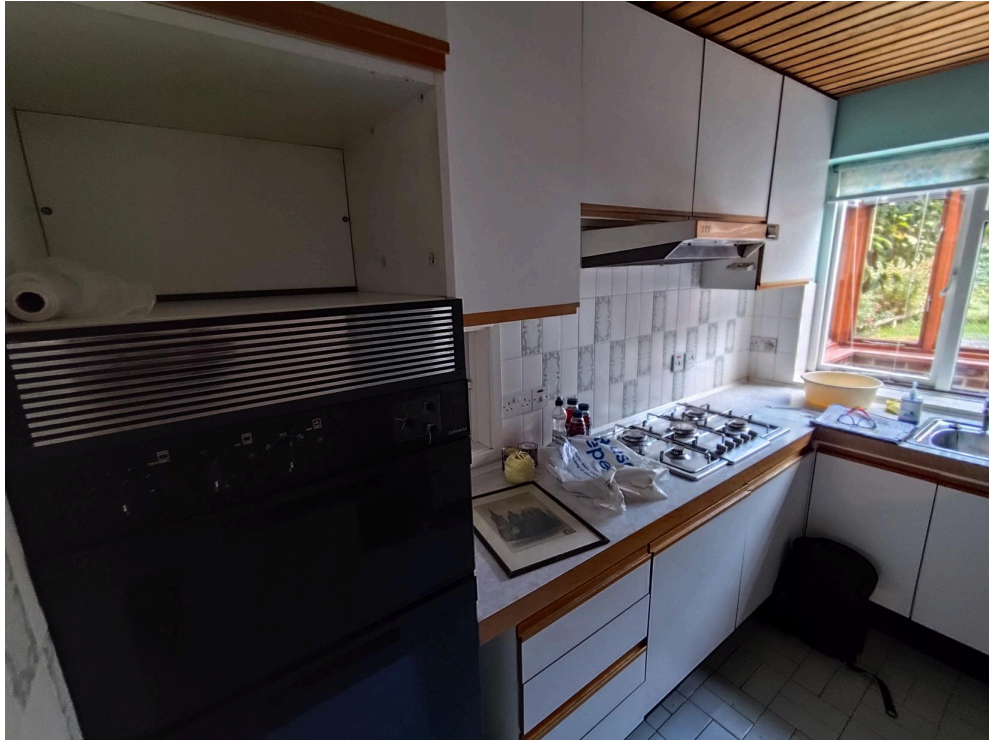
Kitchen

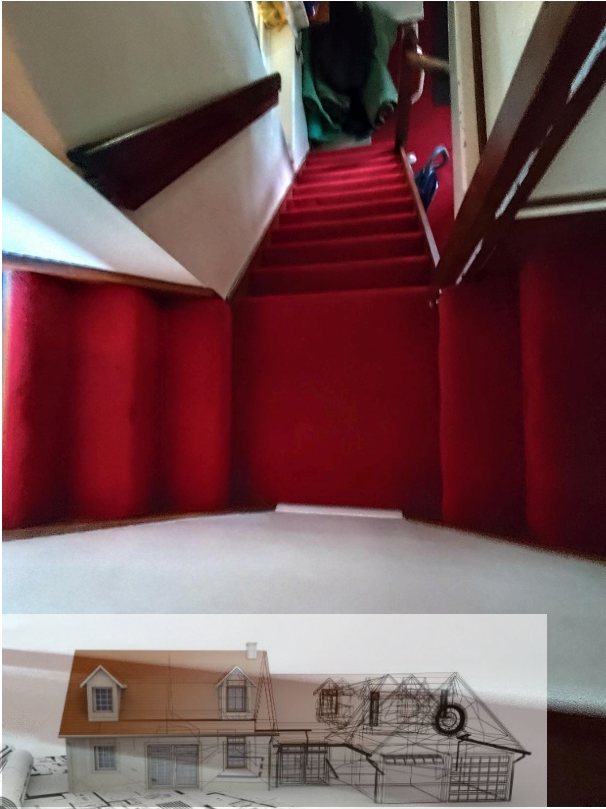
5.7 Internal Joinery	Condition rating	2
Construction & Type	The internal woodwork includes such items as: doors, frames, skirting boards, banisters and staircases.		
Nature of inspection and Limitations	<p>The internal doors were checked for normal operation and other woodwork examined for a range of defects.</p> <p>Woodwork was also examined for evidence associated with movement of the structure of the property, woodworm and other infestations, and general condition. Moisture meter readings were taken at regular intervals.</p>		
Condition	<p>The stair balustrades and handrails are of softwood construction and of suitable quality. All parts were firm with no undue levels of movement during usage. The gaps between the balustrades were much wider than normal(in this case there were none).</p> <p>As mentioned in 4.4 most properties are subject to slight settling down over the years as sub-soil consolidates and adjusts to changes in ground condition. This will frequently result in limited differential movement, which is often expressed as minor cracking or distortion of window and door openings and is rarely of structural significance. All internal doors were in fair alignment with no undue movement noticed to the frames. All doors operated effectively.</p> <p>Door hinges and locks should be regularly lubricated. Internal timbers should be inspected regularly for evidence of bowing or distortion, woodworm and other defects.</p>

<p>Staircase</p>

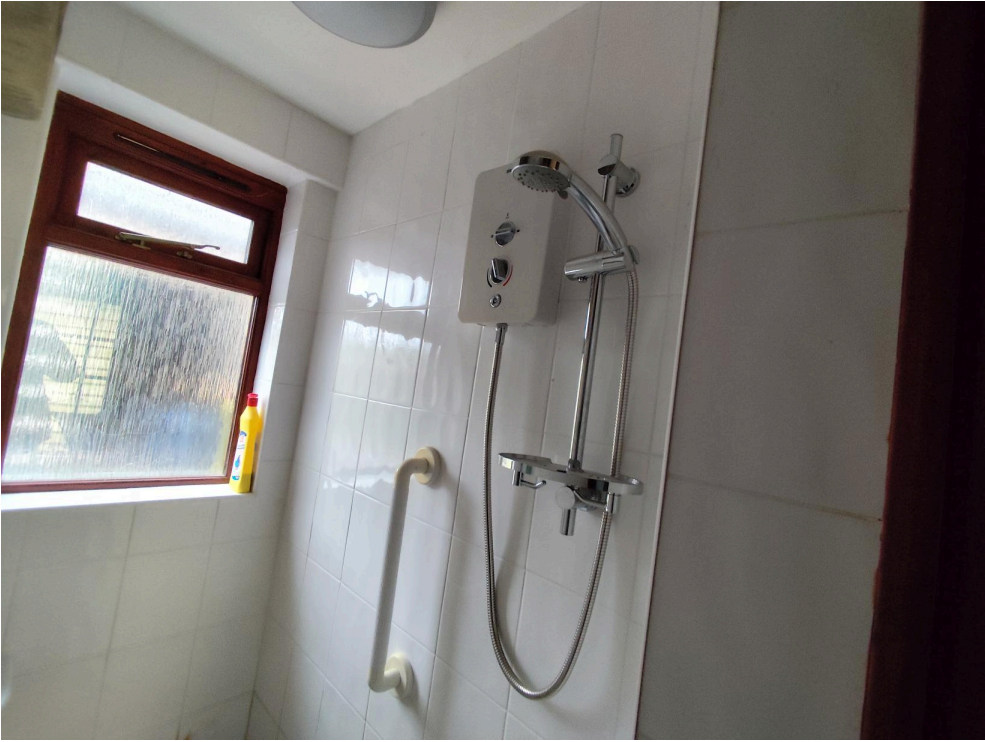
5.8 Bathroom and Sanitary Fittings	Condition rating	2
Construction & Type	There is a shower room on the top floor with a shower cubicle and shower, basin and an adjacent WC. There is a second on on the ground floor.		
Nature of inspection and Limitations	The fittings were checked for signs of damage, cracks, leaking pipes and other common defects. Sealant joints were checked for undue wear and failure. All fittings were checked for normal operation – WC's were all flushed at least twice to ensure correct drainage and flow.		
Condition	<p>There is no mechanical ventilation in any of the shower rooms. This increases the levels of moisture within the rooms and hence increases the risk of condensation to the walls and ceiling structures. It is strongly advisable to install an extraction fan to improve ventilation.</p> <p>Regular maintenance of all seals to the bath and shower to prevent water displacement.</p>

<p style="text-align: center;">Shower room</p>

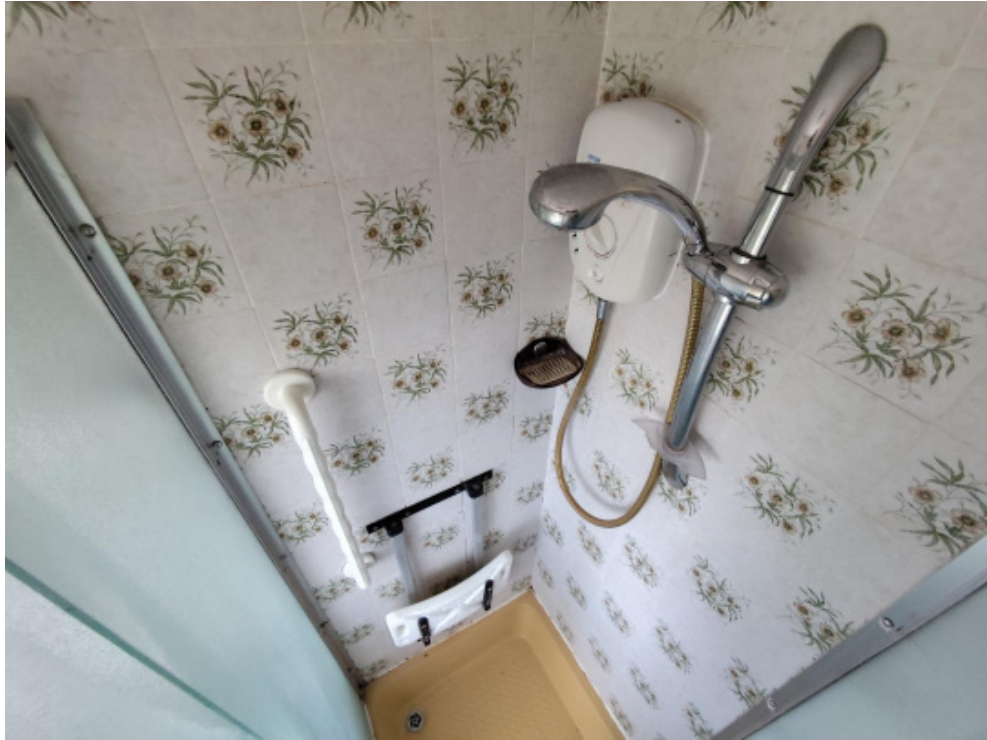
Shower room

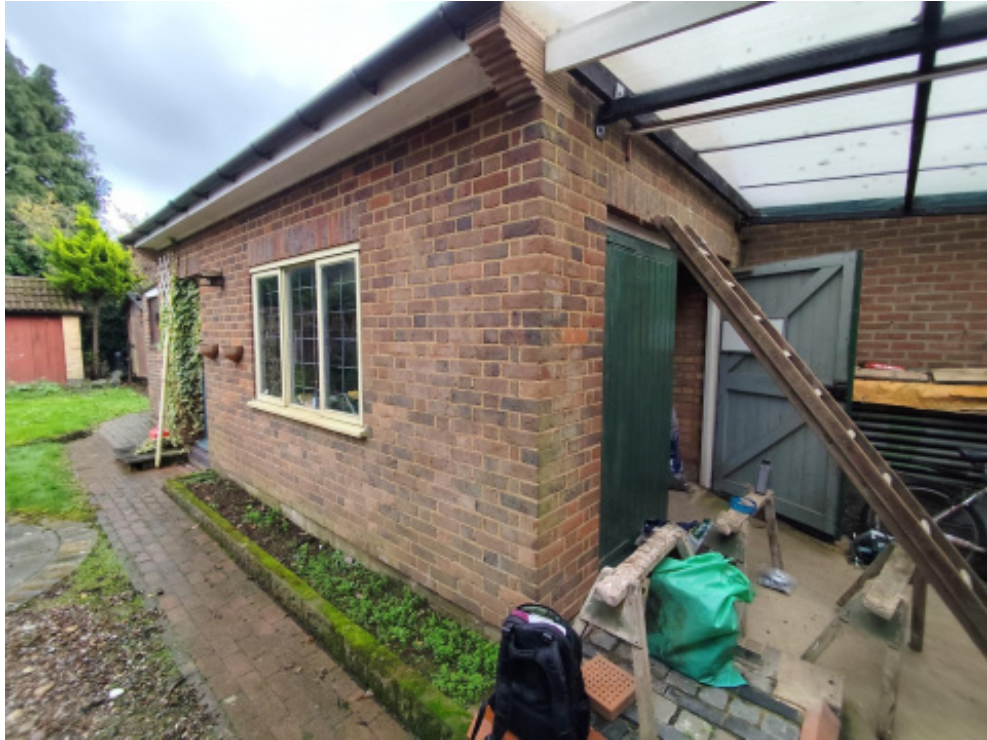
7.1 Garaging	Condition rating	2
Construction & Type	<p>One garage is integral to the main property and the external walls are brick and the floor is concrete. The ceiling is covered in material that may contain asbestos.</p> <p>The main garage is detached from the main property and the external walls are brick and the floor is concrete. The roof is pitched and is covered in tiles. The rainwater goods are plastic and the main doors are timber.</p>		
Nature of inspection and Limitations	<p>Both were examined from ground level for signs of bowing or leaning of walls, damaged brickwork, render and pointing, internal defects, and the condition of the roof both internally and externally.</p>		
Condition	<p>Normal maintenance is required.</p>

Garage

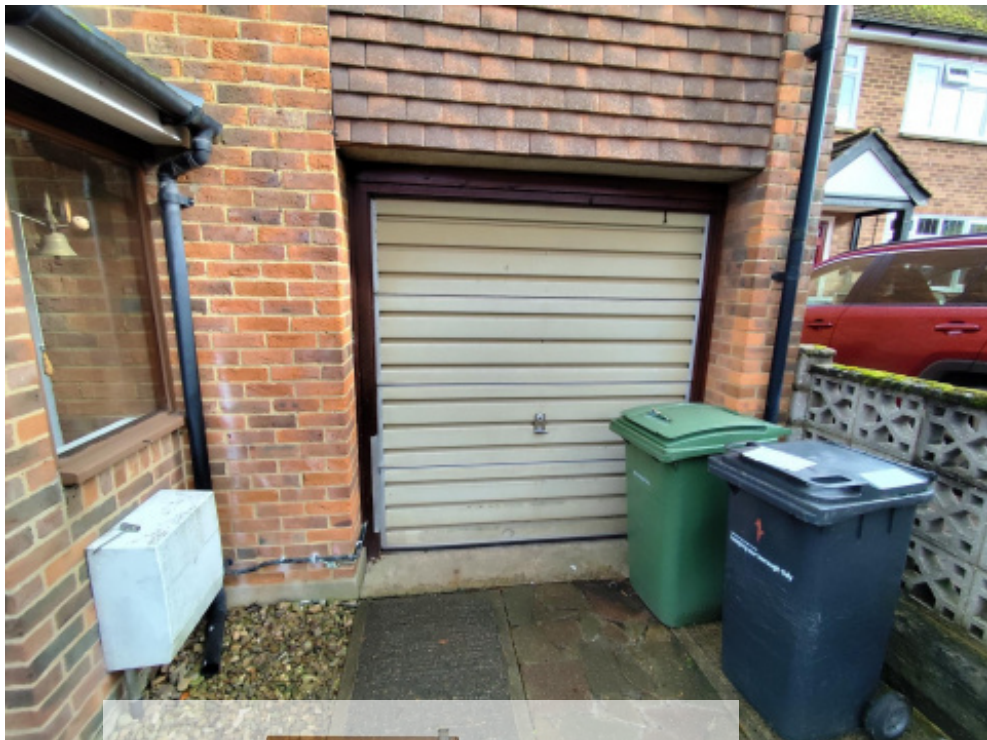
Garage(2)

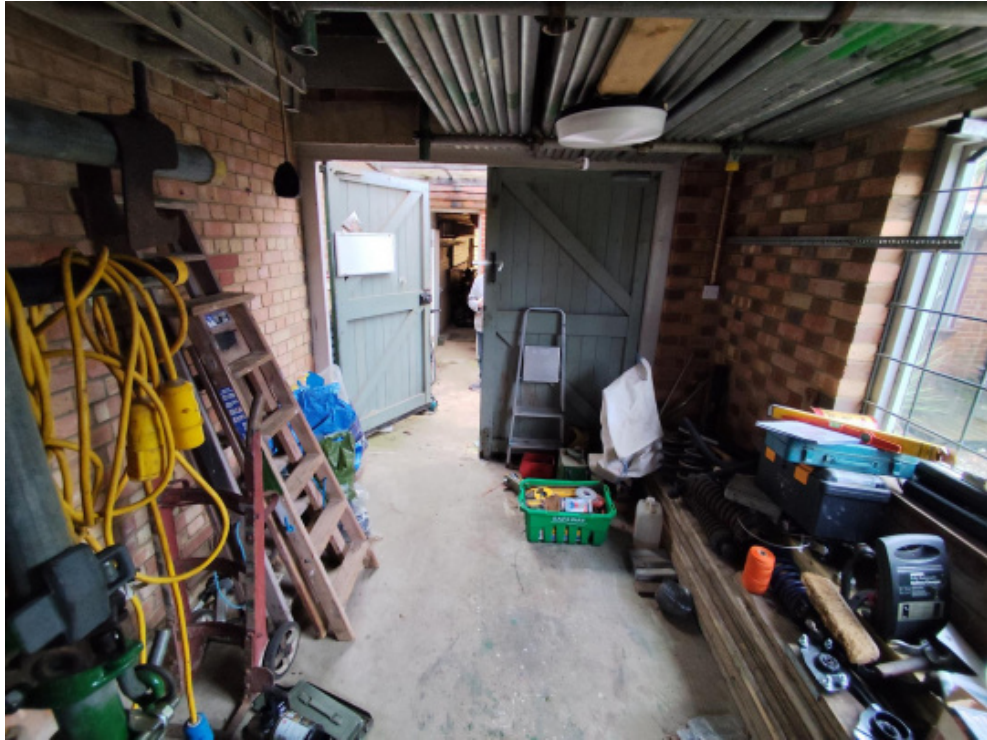
Garage interior

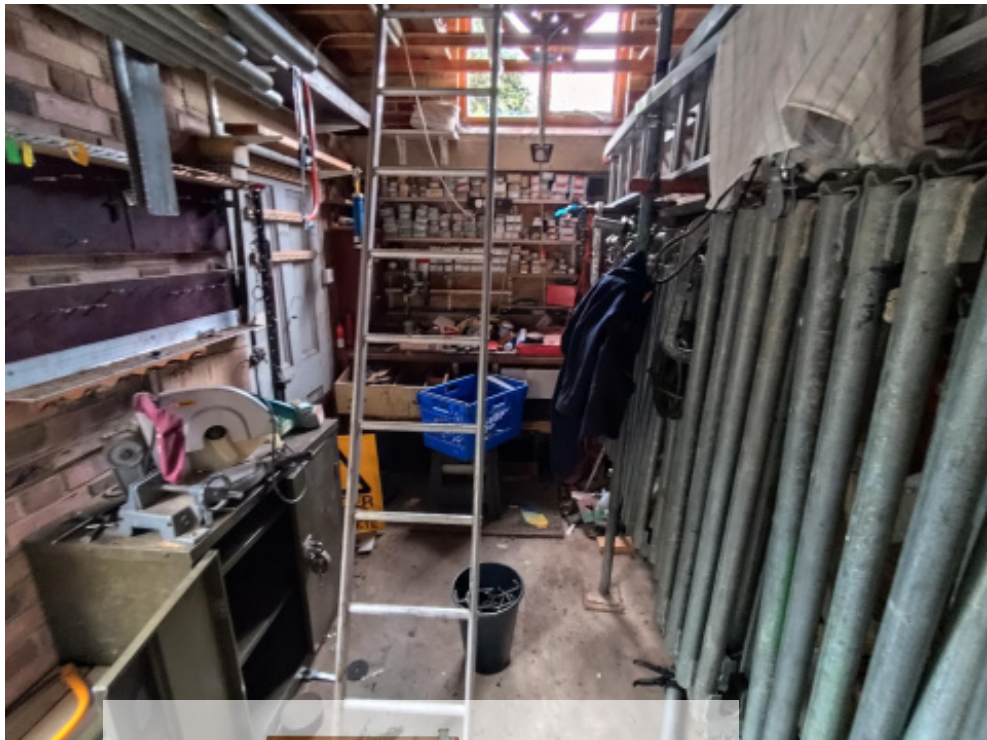
Garage interior

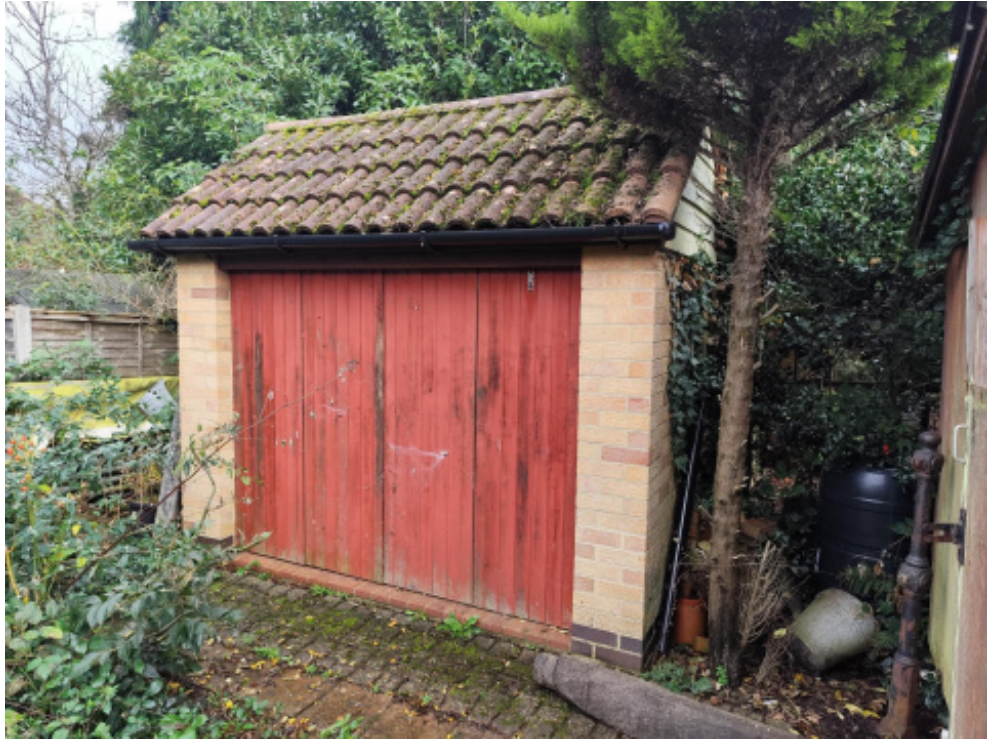
7.2 Outbuildings and Sheds	Condition rating	2
Construction & Type	<p>There are two brick built outbuildings, one of which is attached to the main garage and whose roof is covered in corrugated material that may contain asbestos.</p> <p>The garden shed is timber.</p>		
Nature of inspection and Limitations	NA		
Condition	The shed is in a poor condition and the two brick outbuildings are in a reasonable condition for their age.

Brick outbuilding

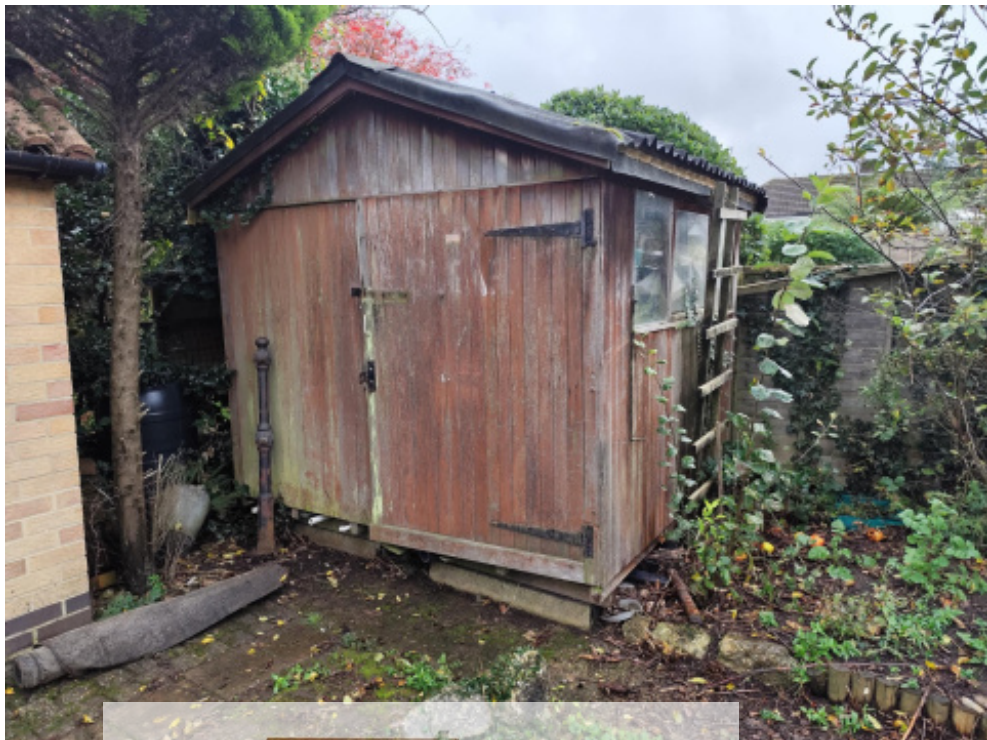
Garden Shed

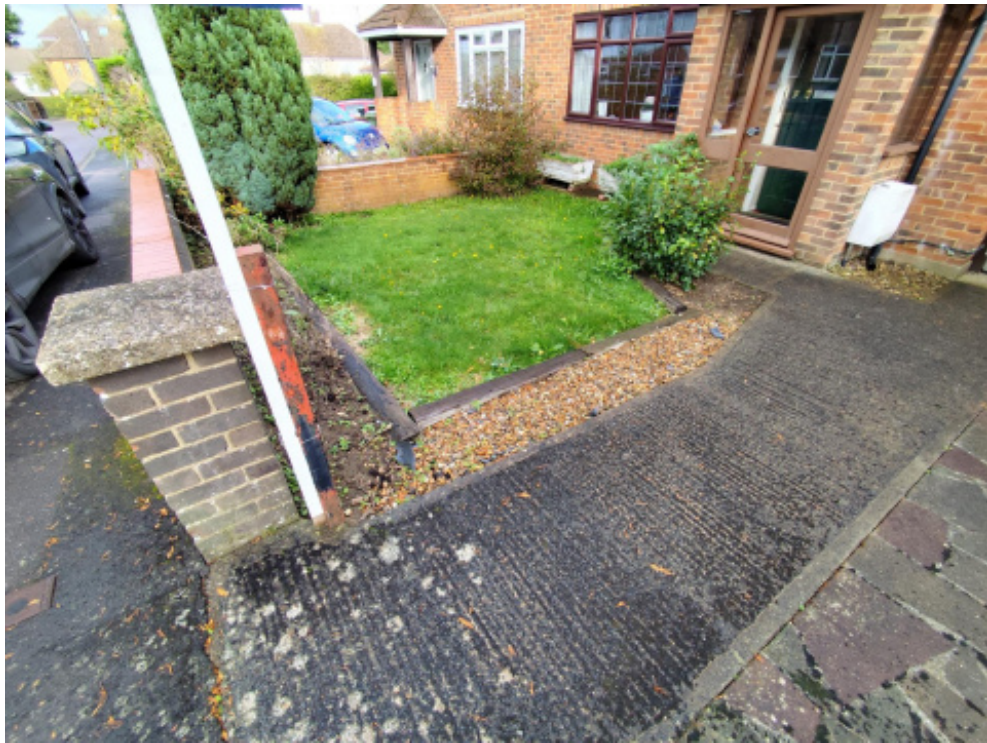
7.3 Grounds	Condition rating	2
Construction & Type	<p>There are gardens to the front and rear which are mostly lawned with surrounding borders.</p> <p>The rear boundaries are defined by timber panel fencing and the front by brick walls.</p>		
Nature of inspection and Limitations	<p>The grounds around the house were inspected for any indications of land failure or movement, or other defects that would have a material effect on the property as a whole.</p> <p>It should be noted that a full and detailed inspection for the presence of Japanese Knotweed cannot be carried out especially where the gardens are well stocked or have been recently cut and maintained. No evidence of the presence of Japanese Knotweed was seen during my inspection but you are advised to seek further advice if you believe it may be present or are aware that it is present in premises nearby.</p>		
Condition	<p>There is no evidence of any damage from flooding.</p> <p>The gardens are presented in fair condition.</p> <p>The boundary fences are presented in fair condition but some minor repairs are required to some panels. (There is no indication of the ownership of any of the boundary walls, fences or hedges, and in most cases, this is not specified by the deeds or title documents. Often, responsibility for boundaries to one side or another has been assumed by subsequent owners. You should ask your conveyancer to advise on any indications of ownership included in the title documents.)</p> <p>Normal Maintenance is Required.</p>

Front Garden

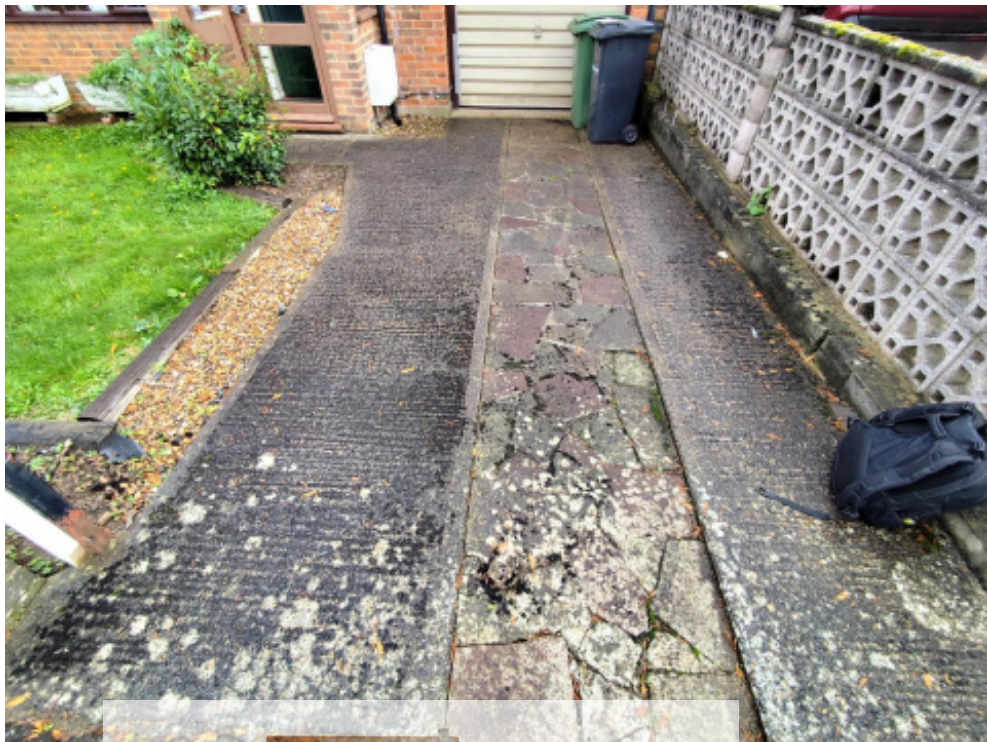
Front drive
